Tropical Cyclone Larry

Post Cyclone Coastal Field Investigation

Coastal Sciences technical report

April 2007

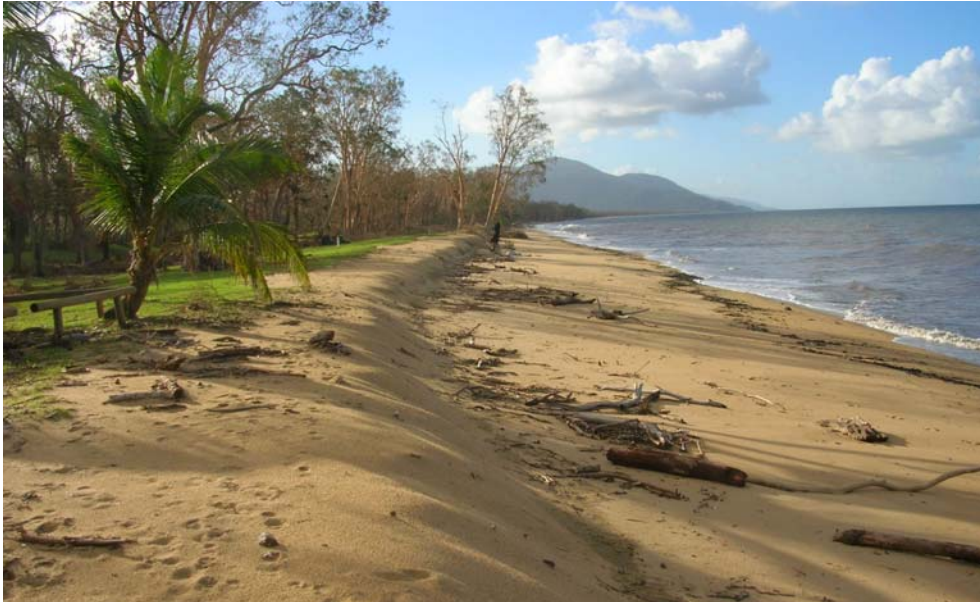
Bramston beach is located about 20km north of Innisfail. The inspection was to the direct south and north of the groyne. Examination of the picnic area to the north of the groyne indicates that the water levels just overtopped the foredune and beach sand had been washed over onto the grassed area some 10m behind the dune. There had also been some localised erosion on the northern side adjacent to the groyne.

Photo 1. Bramston beach looking north of the groyne, showing minor inundation over the dune.

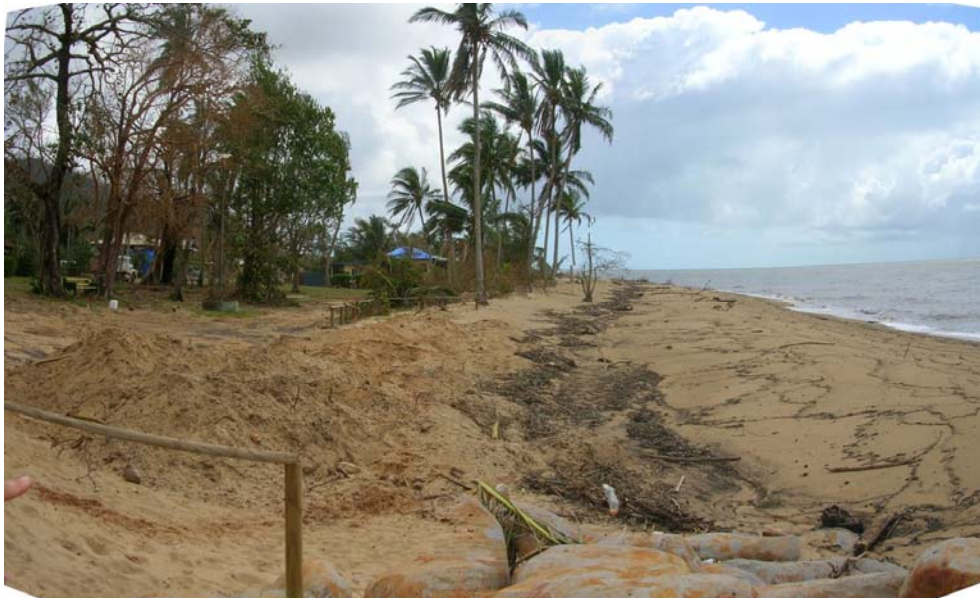
Flying Fish Point is situated just north of Innisfail and the Johnstone River. The southern beach area had beach sand washed over the foredune to the edge of the road. Abrasion on a tree trunk indicates that the water level overtopped the dune by less than 0.1m. To the north, a rock wall protects residential development. The rock wall experienced some damage with exposure of the geotextile membrane under the primary armour layer, and also undermining of the concrete capping behind the rock wall crest. Debris lines in the backyards of houses, undermining of the concrete capping, and inshore movement of smaller rocks (diameter about 0.4m) indicates that wave overtopping occurred.

Photo 2. South beach at Flying Fish Point.

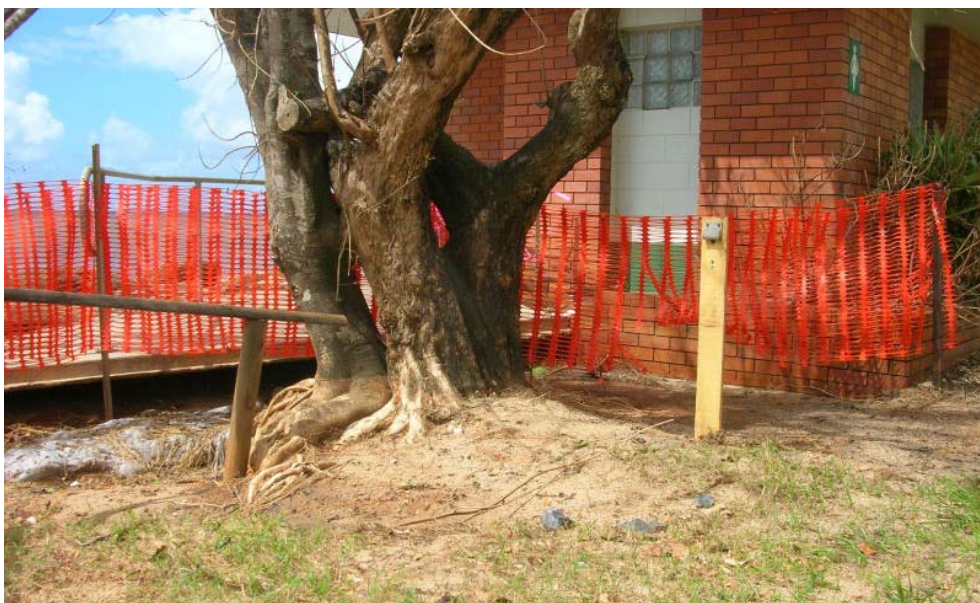
Photo 3. Abrasion marks on a tree at Flying Fish Point.

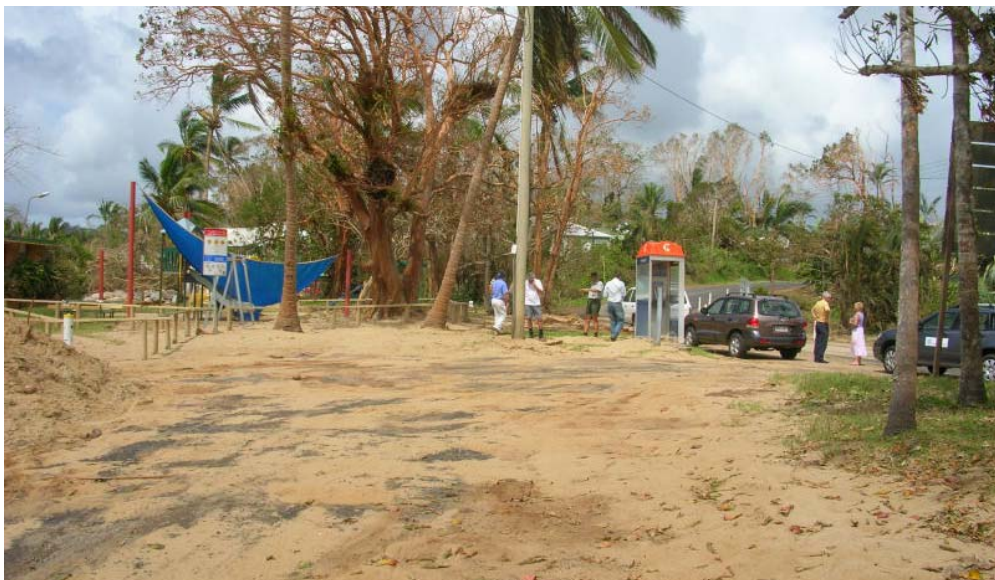
Photo 4. Beach sand washed across the park area at Flying Fish Point.

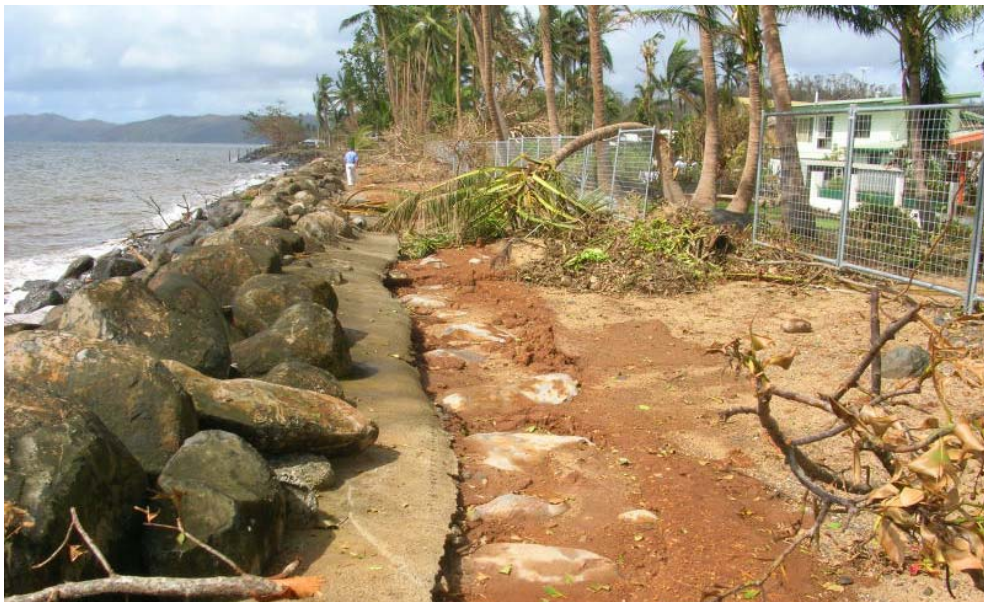
Photo 5. Undermining of rock wall at Flying Fish Point.

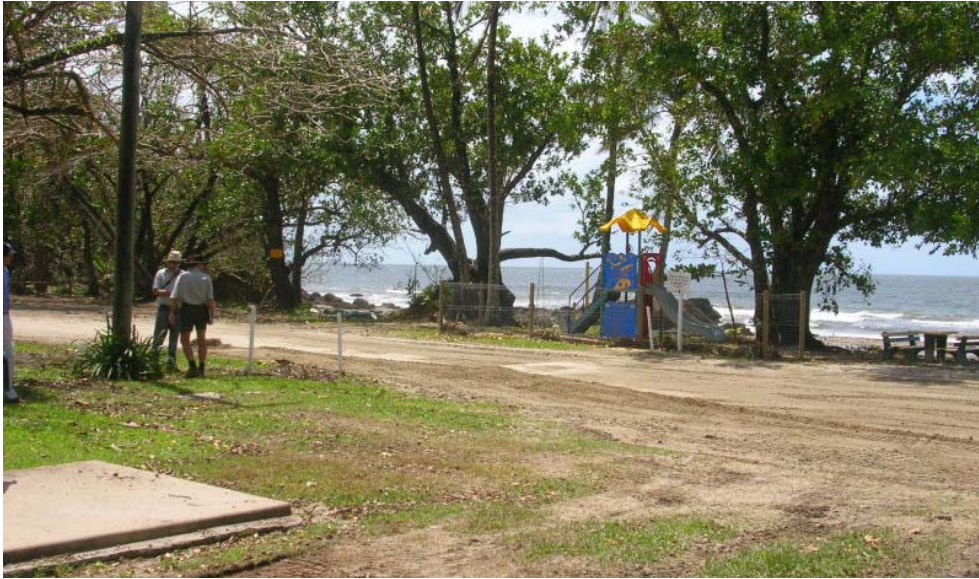
Photo 7. Debris line landward of pole at ETTY Bay.

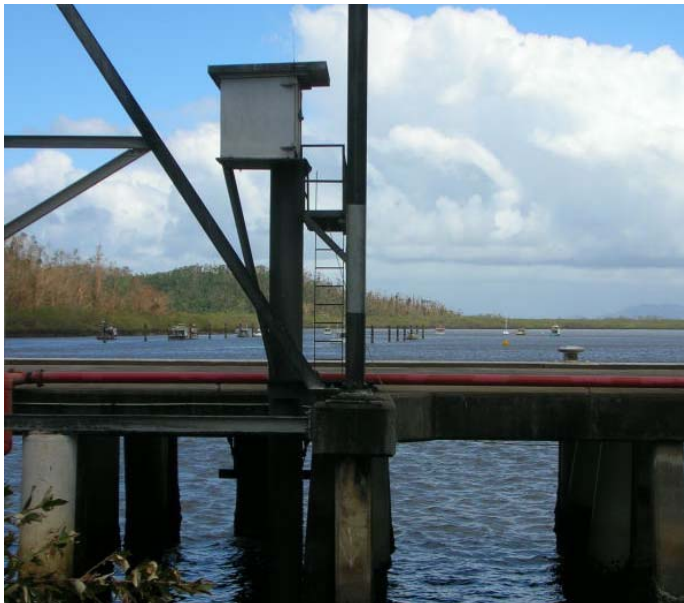
Mourilyan Harbour was visited to inspect the integrity of the storm tide gauge. There was no apparent sign of any damage to the housing structure. At the head of the rock wall, there are signs of wave run-up and minor overtopping with a line of smaller grade rocks (less than 0.2m in diameter) washed inland about 10m.

Photo 8. Storm tide gauge at Mourilyan harbour.

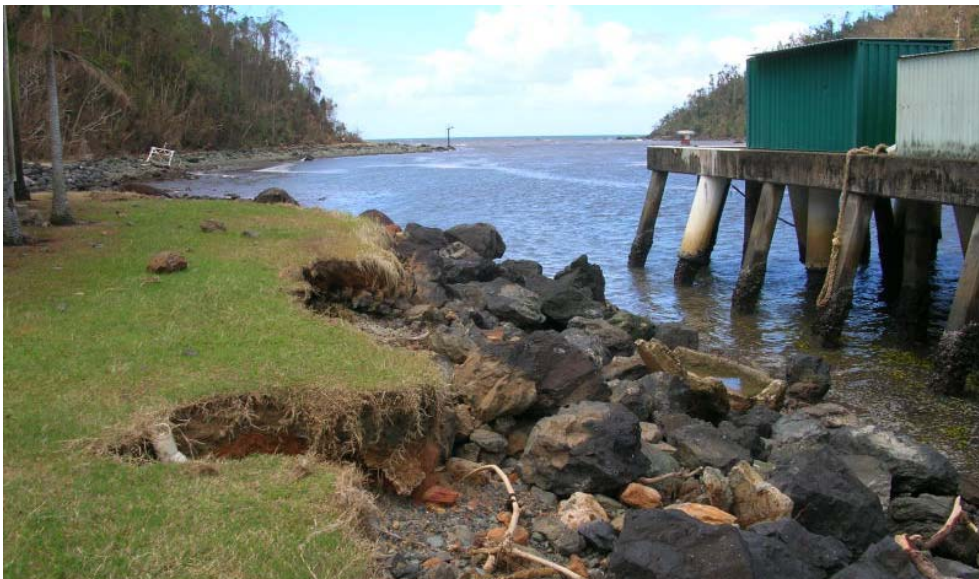
Photo 9. Erosion at Mourilyan harbour.

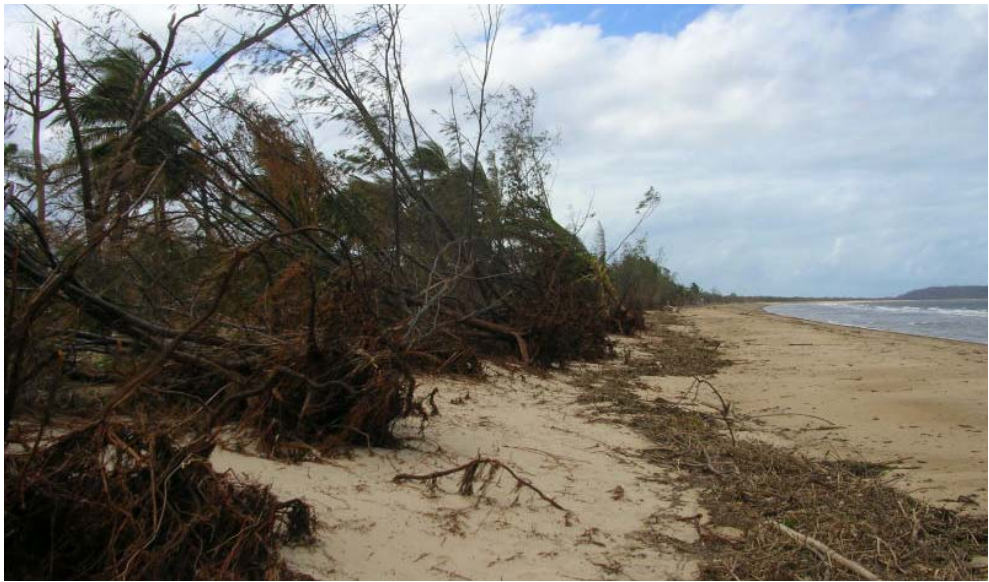
Photo 10. *Fallen trees and exposed roots at Cowley beach (viewed to the north).*

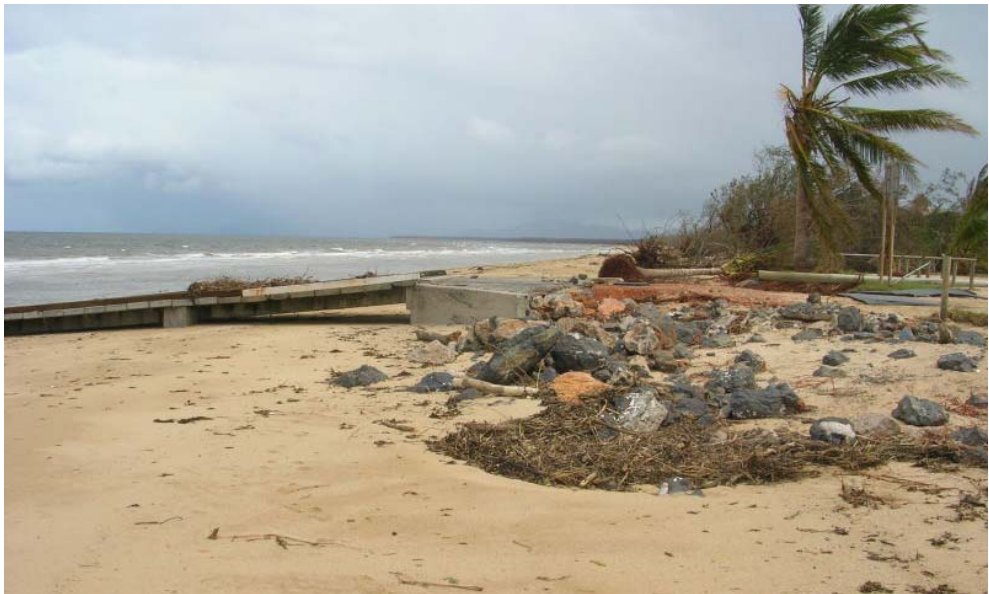
Photo 11. *Boat ramp on Cowley beach (viewed to the south).*

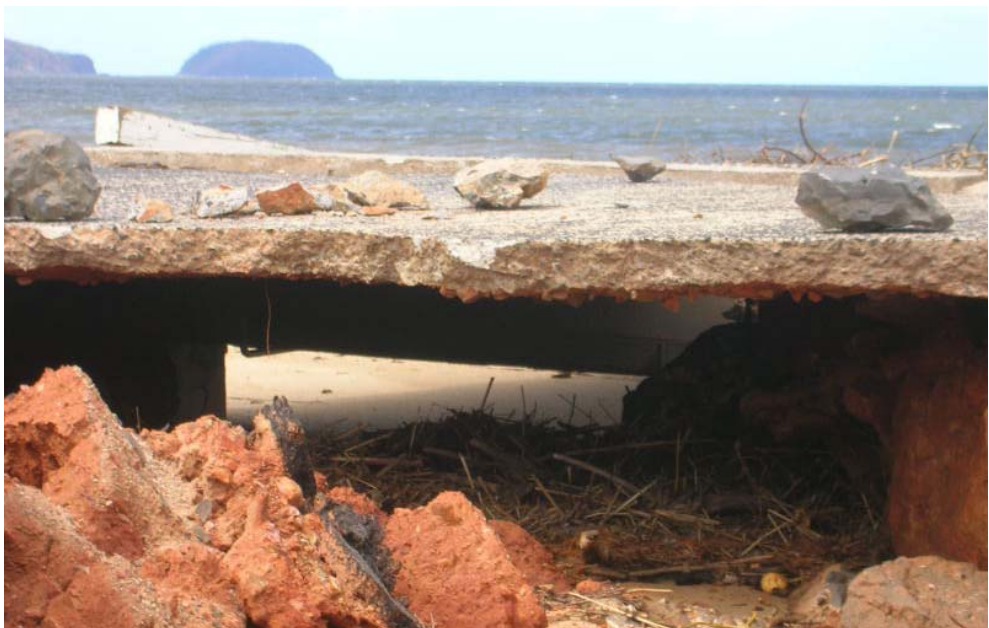
The concrete capping for the abutment of the boat ramp had been undermined from erosion of the soil beneath it by wave action. Clumps of bitumen from the boat ramp access road had been moved about 10m inshore. Sand had been washed over the esplanade road and there was debris (consisting mostly of pumice stone) along residential property boundaries (about 20m inshore of the foredunes).

Photo 12. *Eroded access road to the boat ramp at Cowley beach, undermined by wave action*

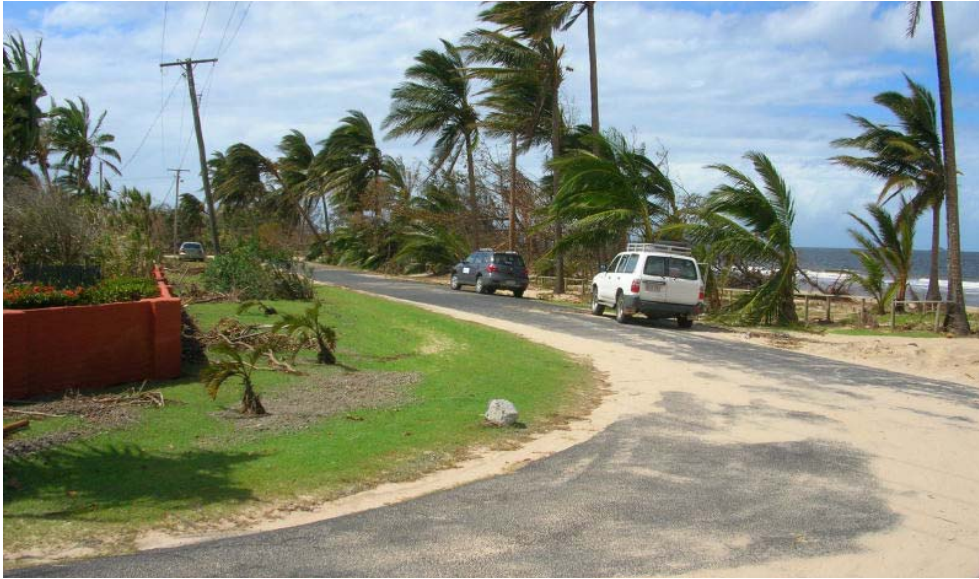
Photo 13. Debris lines along property boundaries at Cowley beach.

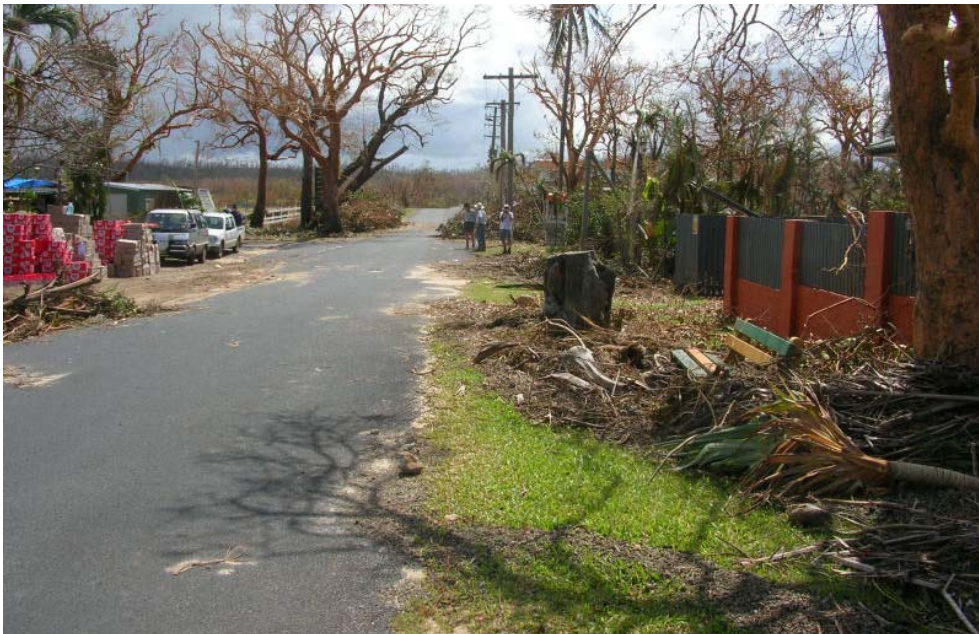
Photo 14. Pumice debris lines along Cowley beach road. The road slopes downward from the beach.

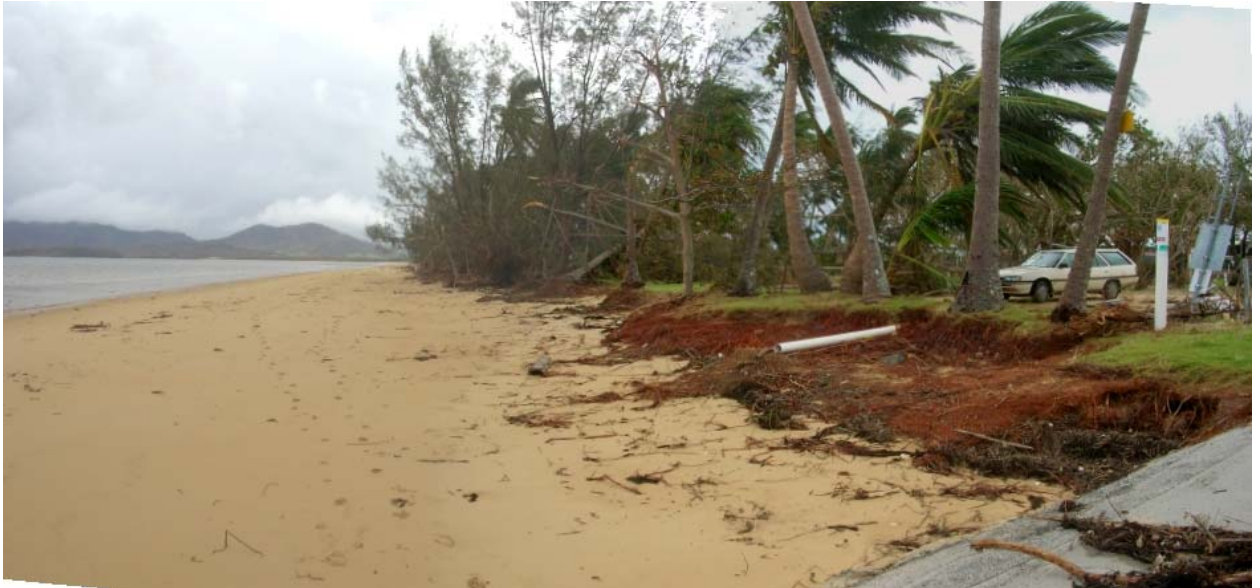
Photo 16. Kurrimine beach to the south, showing erosion of vegetation in the vicinity of the boat ramp.

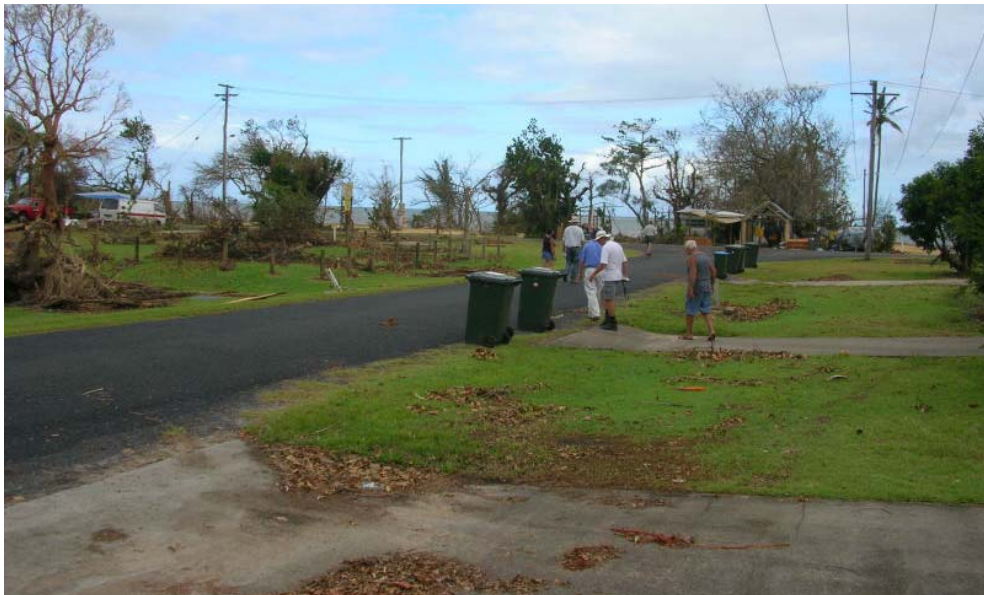
Photo 17. Debris lines along Bramble Street, looking towards the caravan park at Kurrimine.

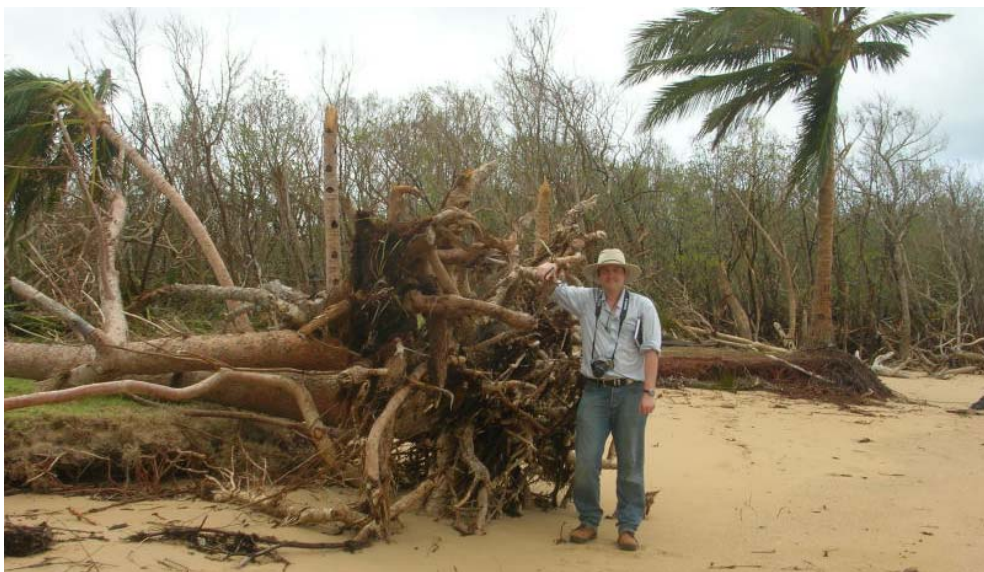
Photo 18. Seaweed amongst the roots of a fallen tree on Kurrimine beach indicates the storm tide level.

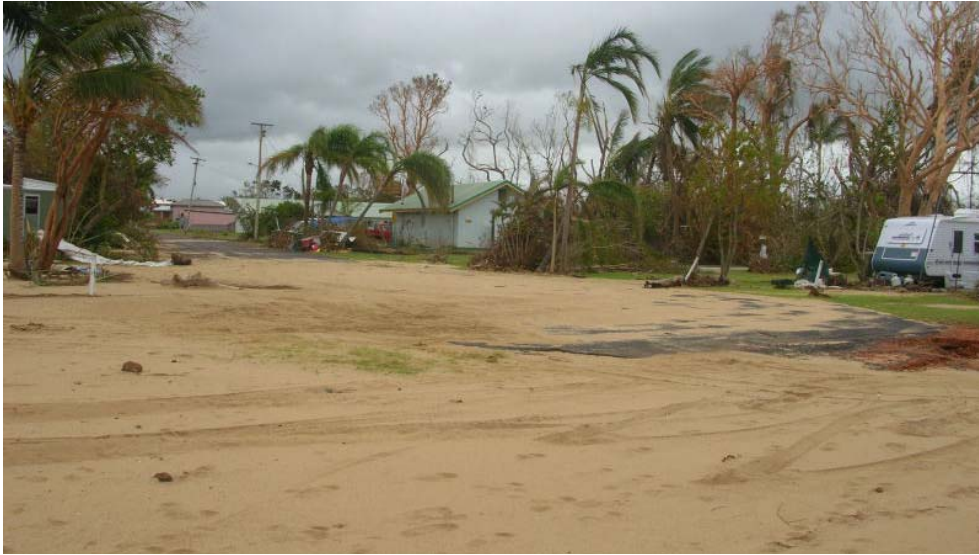
Photo 19. Beach sand was washed some 20m inland of Kurrimine beach at the caravan park.

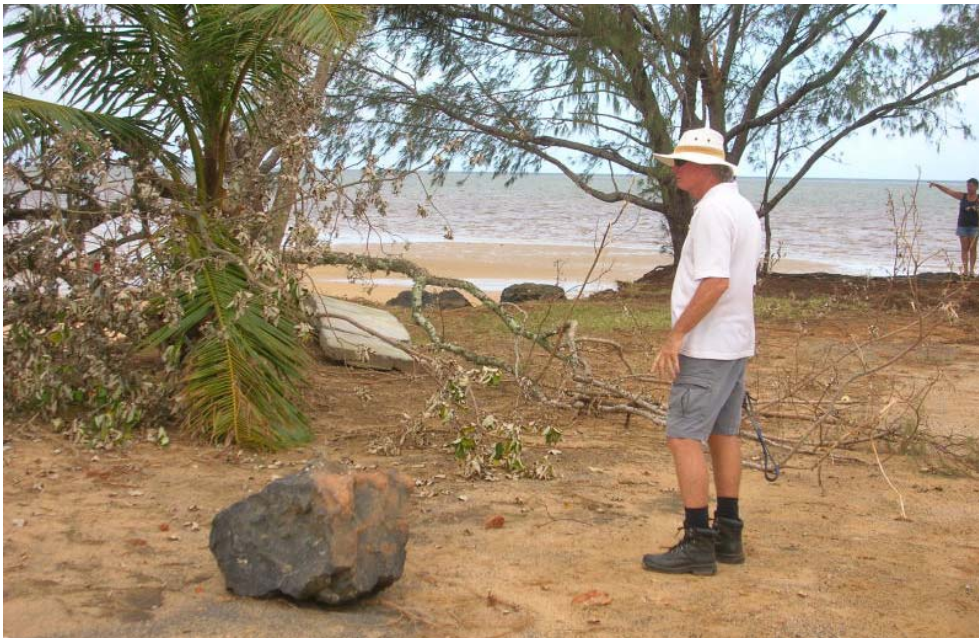
The caravan park was extensively damaged by the cyclone with some caravans totally destroyed. A water line inside one of the remaining caravans indicated a water depth of 0.56m, corresponding to an inundation level of 3.5m (AHD). Substantial quantities of sand and debris had been washed through the caravan park into the back vegetation. Seaweed caught in the mangroves to the north and fallen trees on the beach further supported the surveyed inundation level. A 3m slab of concrete was moved some 30m inland from near the boat ramp.

Photo 20. A concrete slab was moved from near the boat ramp by the storm tide. Also pictured is a boulder from the rock wall.

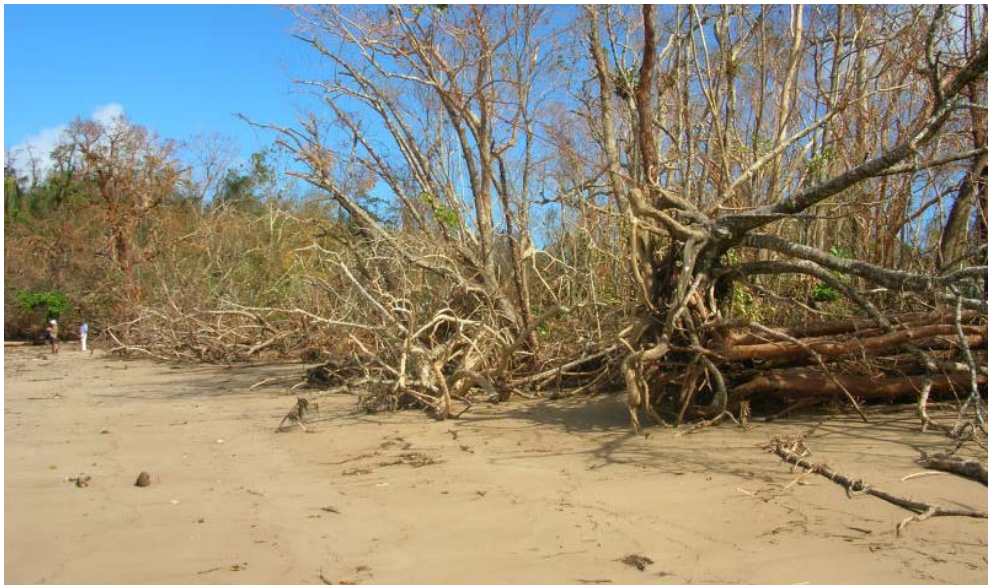
The orientation and shallow nature of the beach would have sheltered it from large wave action. There were 0.3 to 0.5m high erosion scarps along the foredune and extensive fallen defoliated trees. On the day of the inspection, the sand was damp up to the fallen vegetation, indicating no useable beach on a high spring tide.

Photo 22. Fallen trees along the vegetation line at Garners beach.

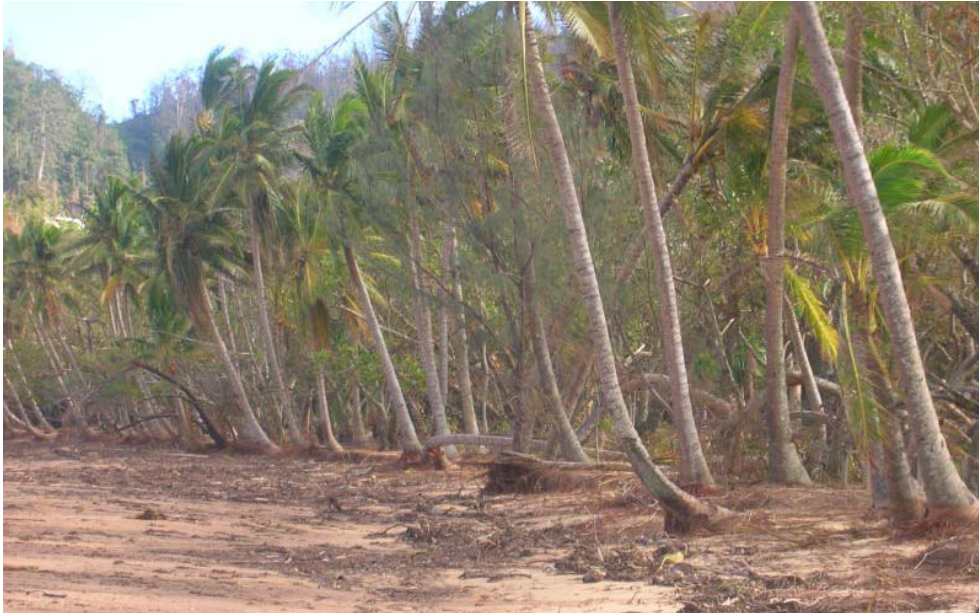
Photo 25. Erosion around the coconut palms at Bingil Bay.

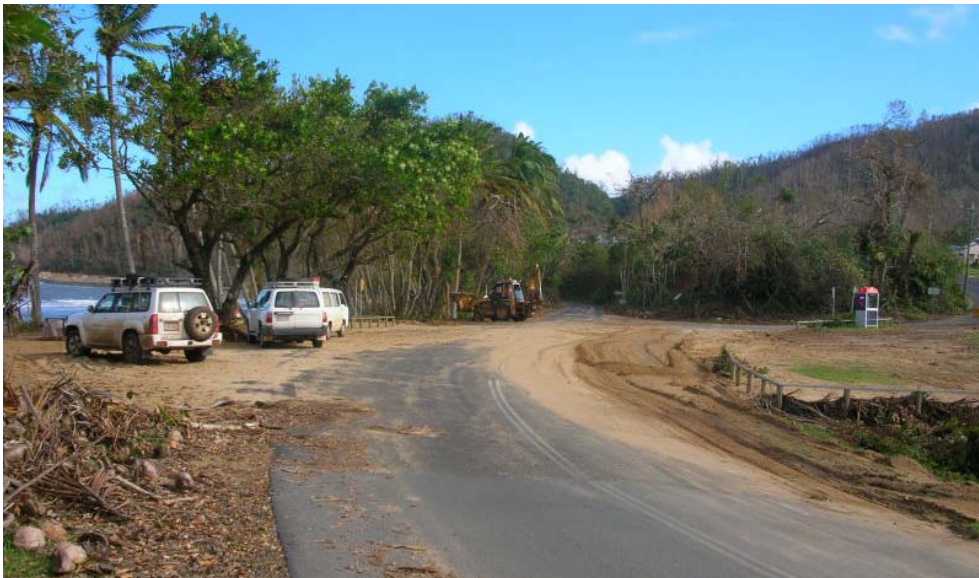
Photo 26. Beach sand washed some 20m inshore across Alexander Drive at Bingil Bay.

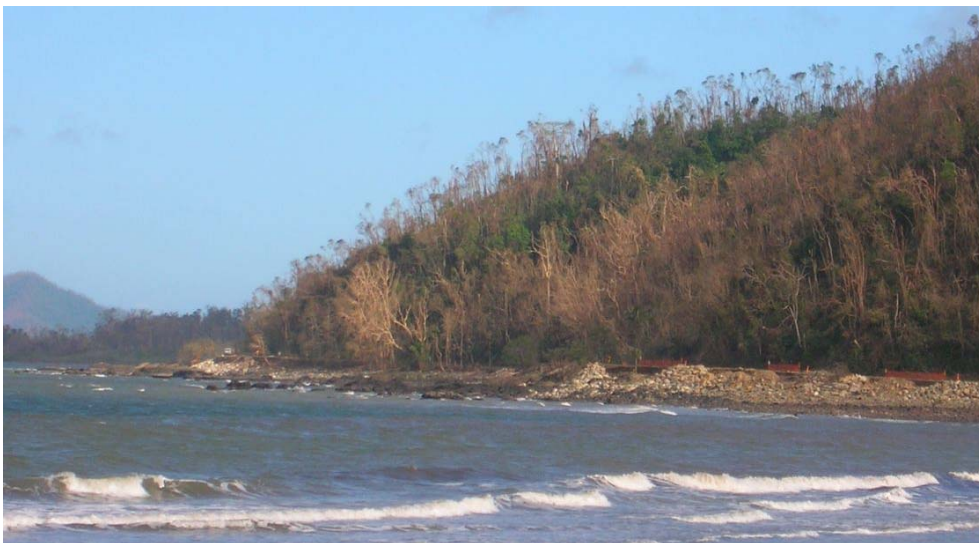
To the north, there is a small creek that cuts across the beach. To the south, there is up to a 0.5m scarp in front of the foredune. Sand has been washed over the dunes onto Alexander Drive and there is a pumice stone debris line about 10m landward of the road that is in the order of 5cm thick. At the southern end, a rock revetment protecting Alexander Drive around the headland has slipped.

Photo 27. A rock wall protecting the road around Clump Mountain failed (south of Bingil Bay).

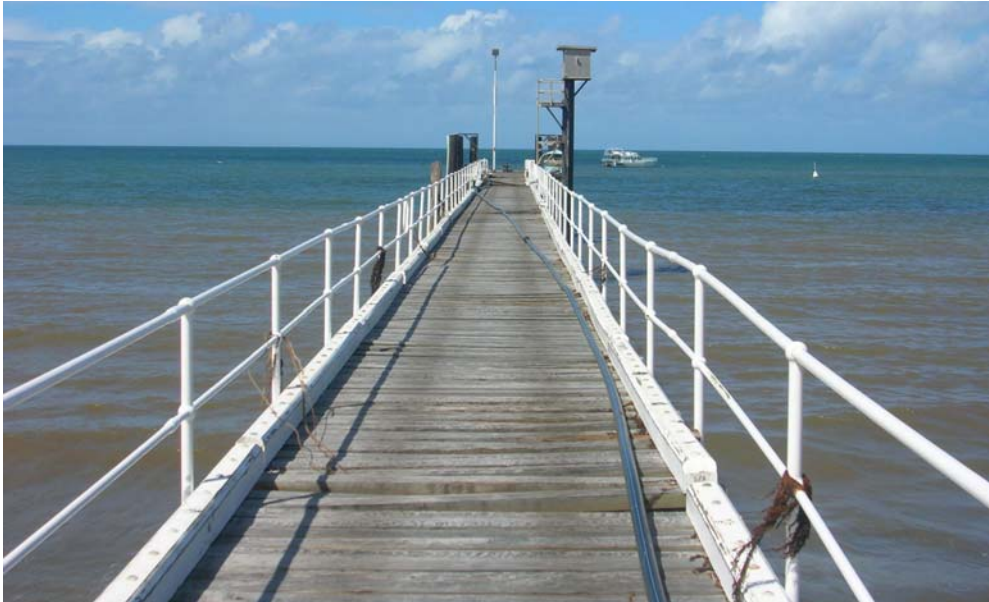
Clump Point was visited to inspect the integrity of the storm tide gauge. Although there was no apparent sign of any damage to the storm tide gauge and housing structure, the jetty structure and ancillaries were damaged. Seaweed on the lower rail and uplift of the timber decking on the jetty indicated that the combined storm tide and wave action exceeded the deck level. The recorded peak still water level at the Clump Point storm tide gauge of 4.25m (LAT) compared to the jetty deck level of 4.27m (LAT) still further supports this.

Photo 28. Clump Point jetty and storm tide gauge showing lifted timber decking and seaweed on the railing as a result of wave action.

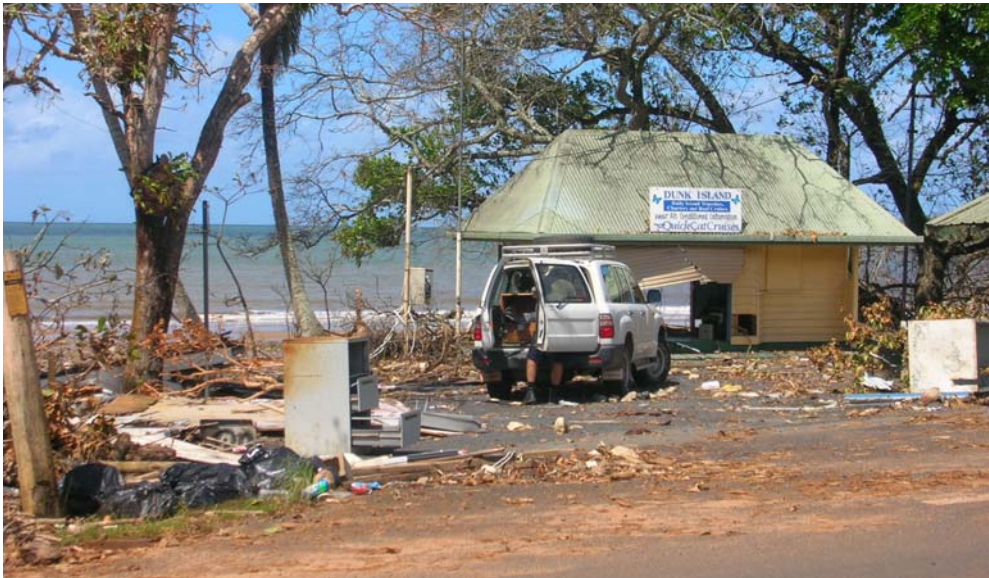
The charter boat office next to the jetty was extensively damaged with blown out roller doors, as well as holes and water damage to the lower sections of the internal cladding suggesting water depths of about 0.5m through the structure (about 3.5m AHD).

Photo 29. The storm tide caused structural damage to "Quick Cat Cruises" offices at Clump Point.

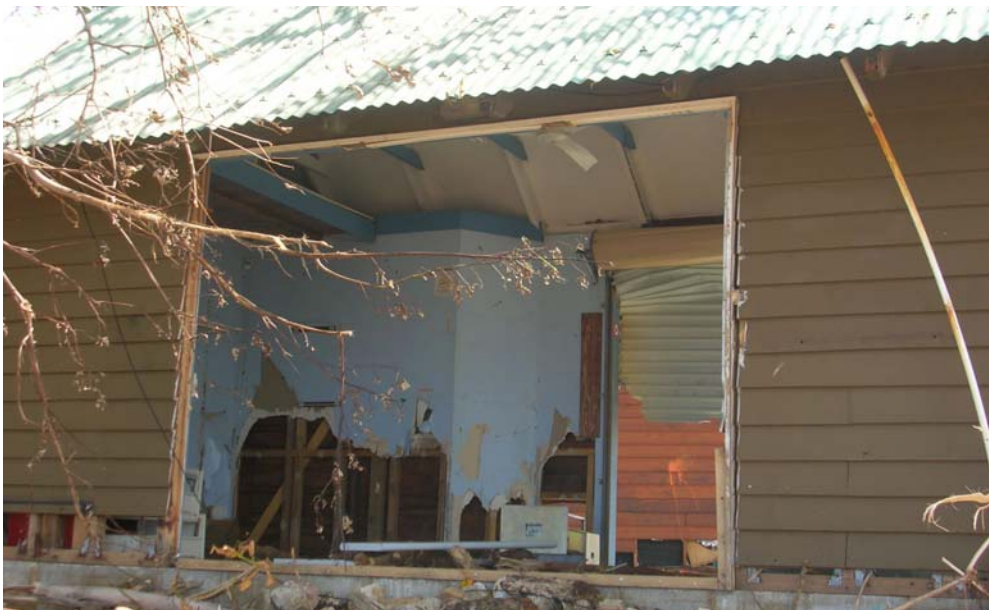
Photo 30. View of the interior damage to the building at Clump Point (picture taken from the ocean side of the building).

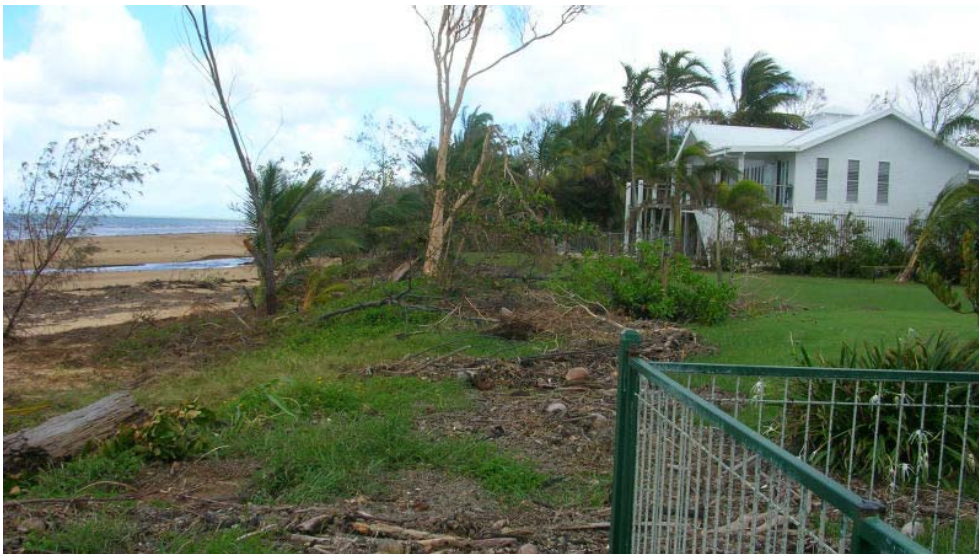
Photo 33. Debris lines at Wongaling beach near Wheatley Creek.

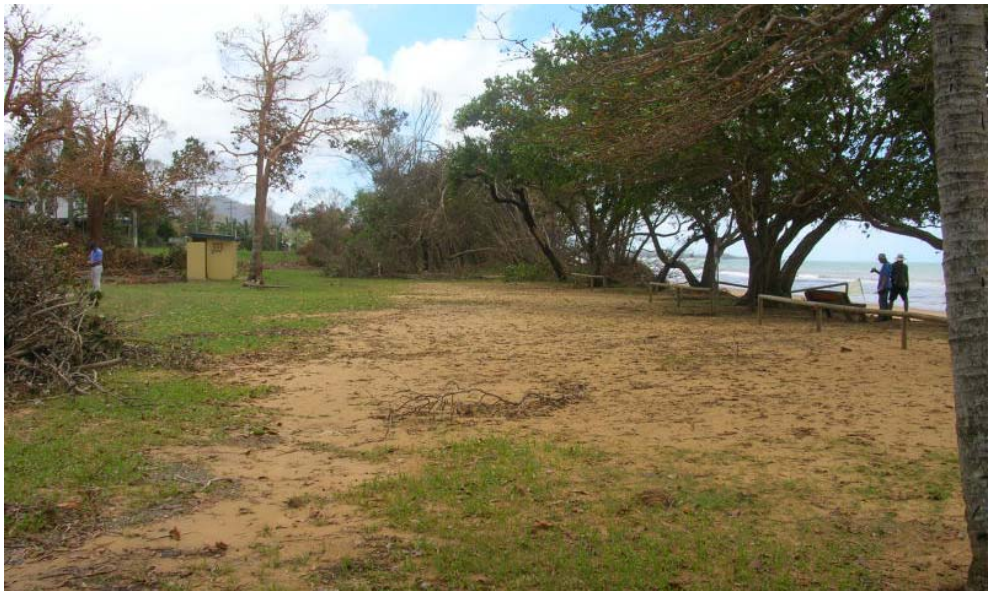
Photo 34. Beach sand washed inshore across the park area at the northern end of Wongaling beach.

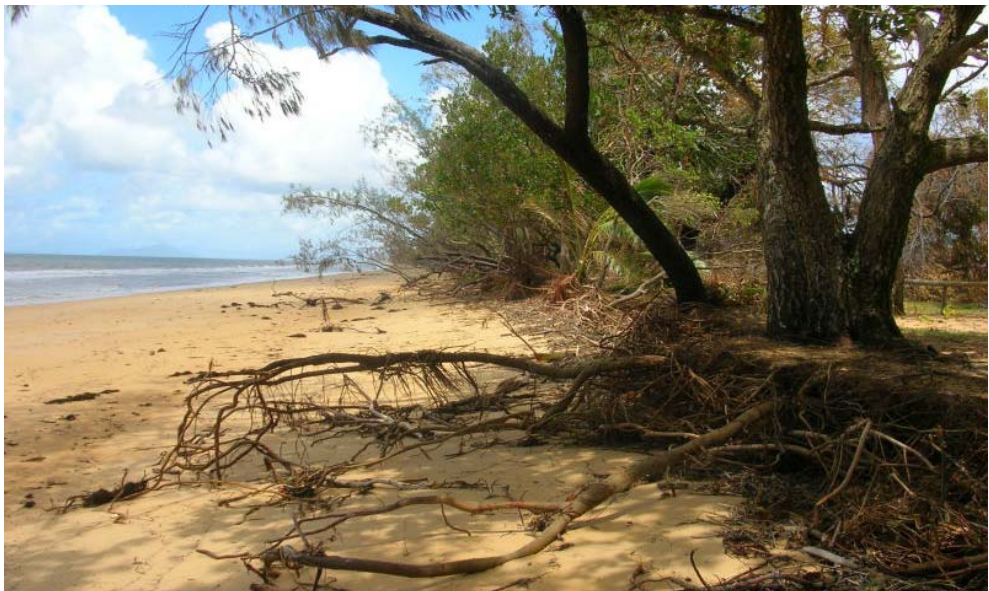
Photo 35. The highest erosion scarps were observed at Wongaling beach.

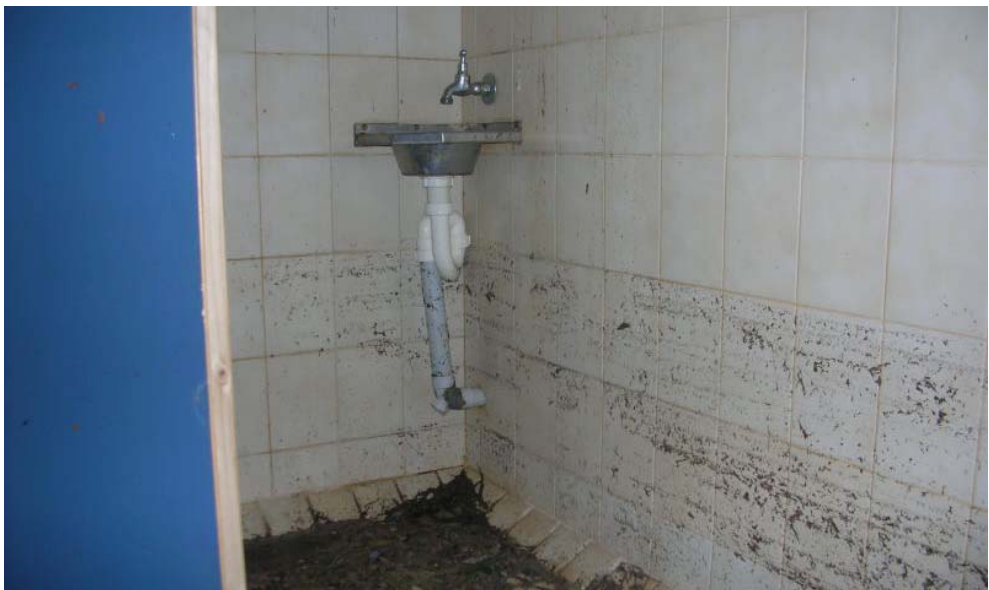
Photo 36. Inundation water levels within a public toilet block at Wongaling.

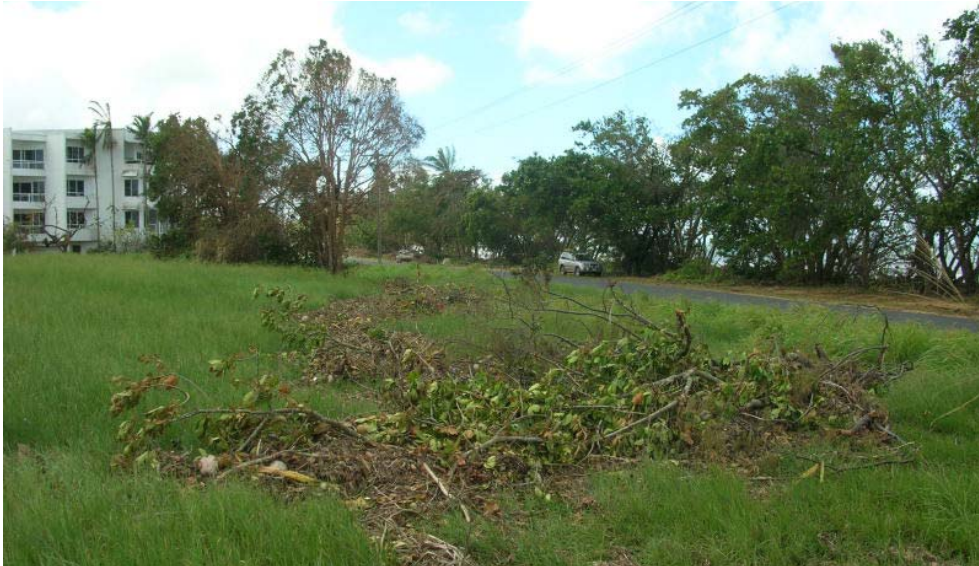
Photo 37. Debris lines inland of Banfield Parade located just north of Wongaling beach.

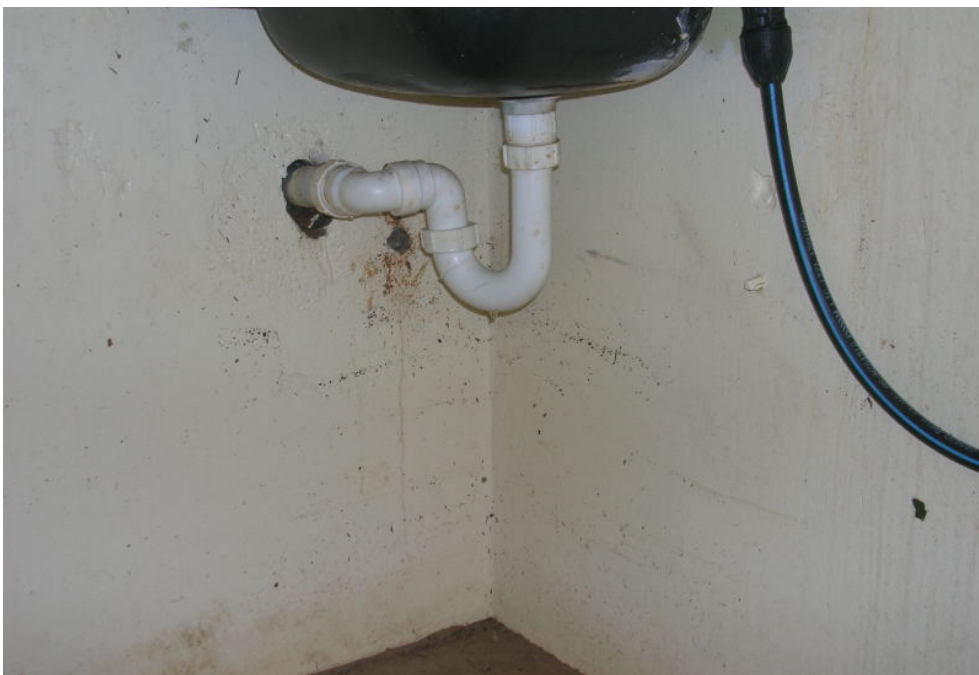
Photo 39. Inundation water levels within the public toilet block at South Mission beach.

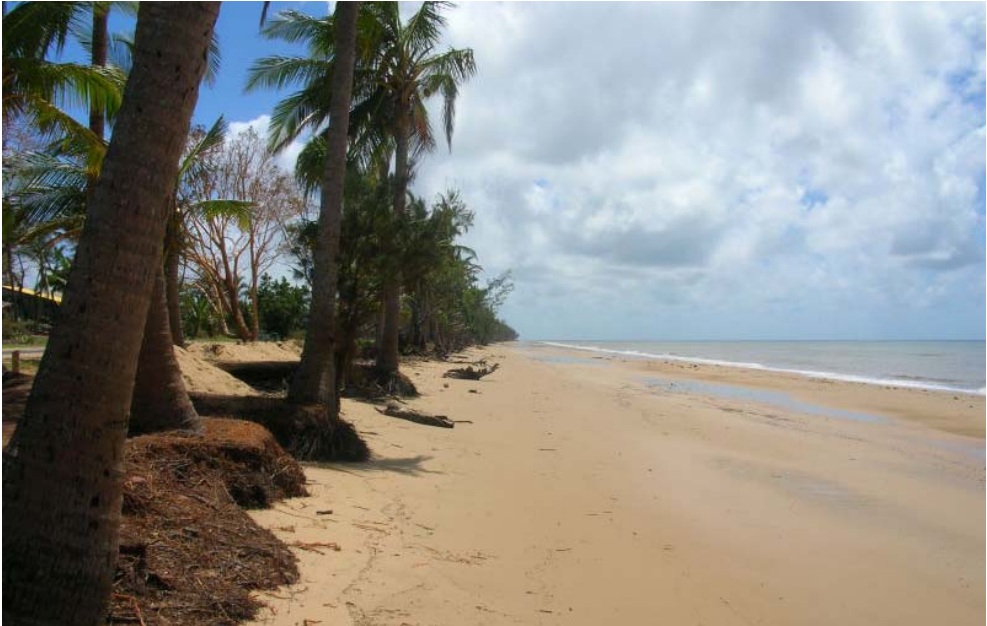
Photo 40. Erosion scarps at South Mission beach. Beach sand that had washed over the esplanade, had been piled between the palms.

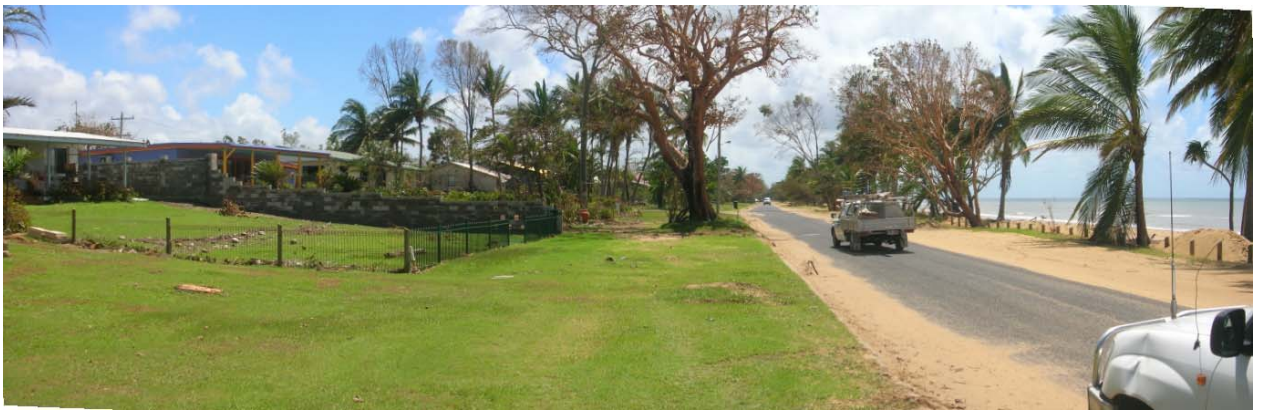
Photo 41. Inundation debris line at South Mission beach.

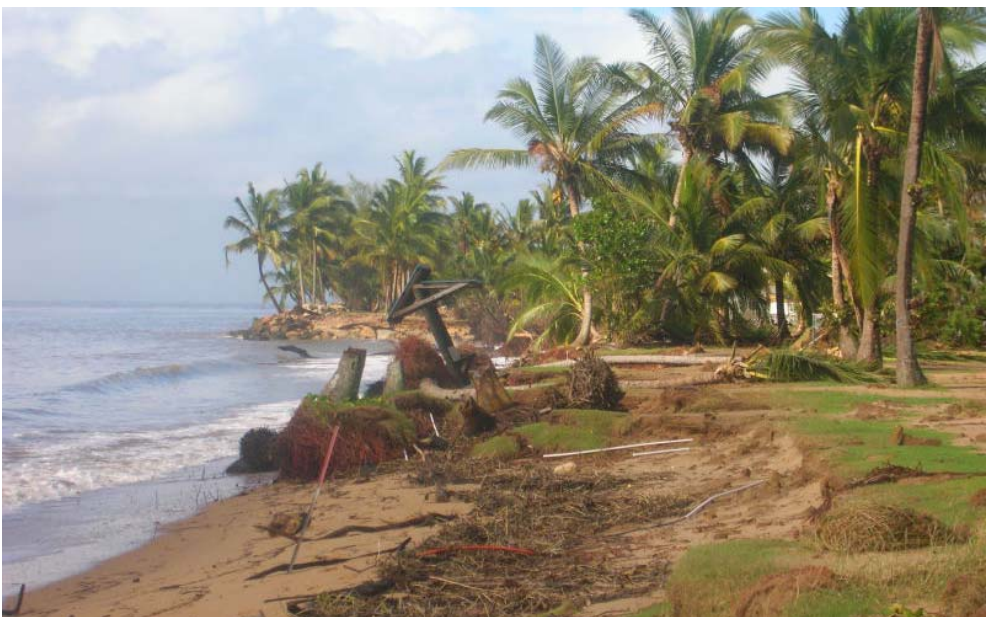
Photo 42. Beach erosion at Tully Heads (viewed to the south).

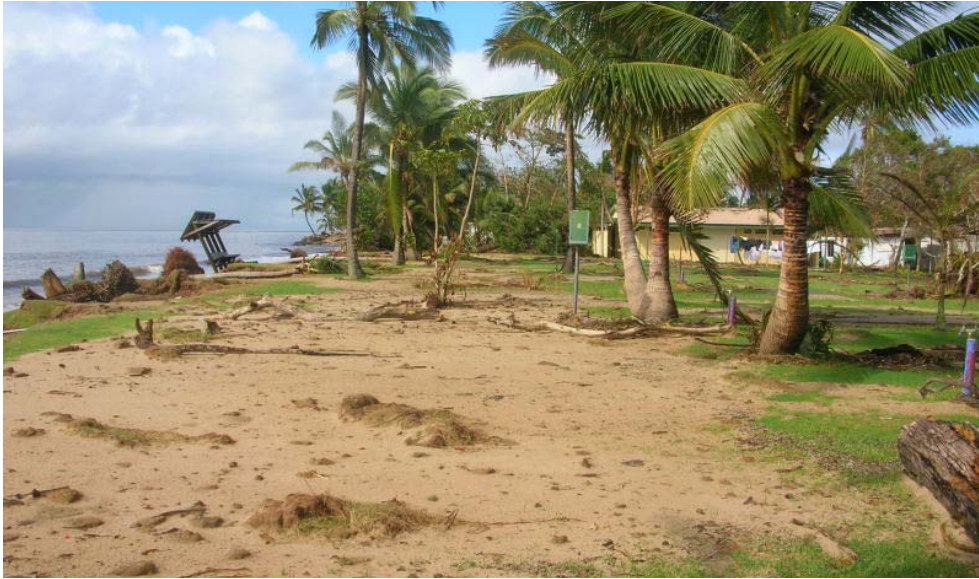
Photo 43. Beach sand was washed about 20m inland at Tully Heads.

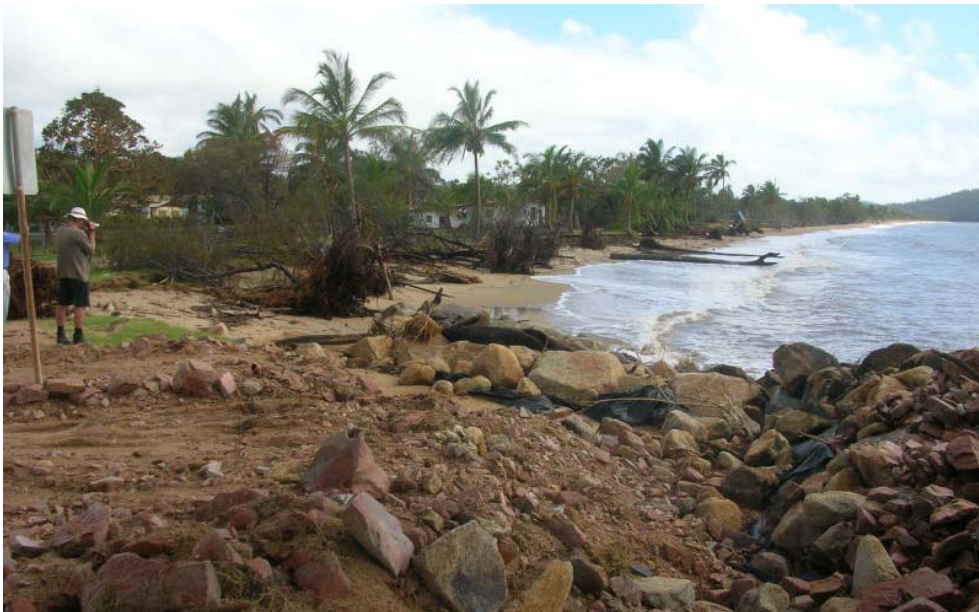
Some damage was sustained to the existing rock wall at the southern end of Tully Heads beach with slumping and exposure of the underlying geotextile fabric. Soil erosion behind the crest of the rock wall as well as the inland movement of sand and rocks (up 0.3m diameter) indicates there had been wave overtopping. recede

Photo 44. Slumping of the rock wall at Tully heads, exposing the underlying geotextile layer.
