Tropical Cyclone Larry

Post Cyclone Coastal Field Investigation

Coastal Sciences technical report

April 2007

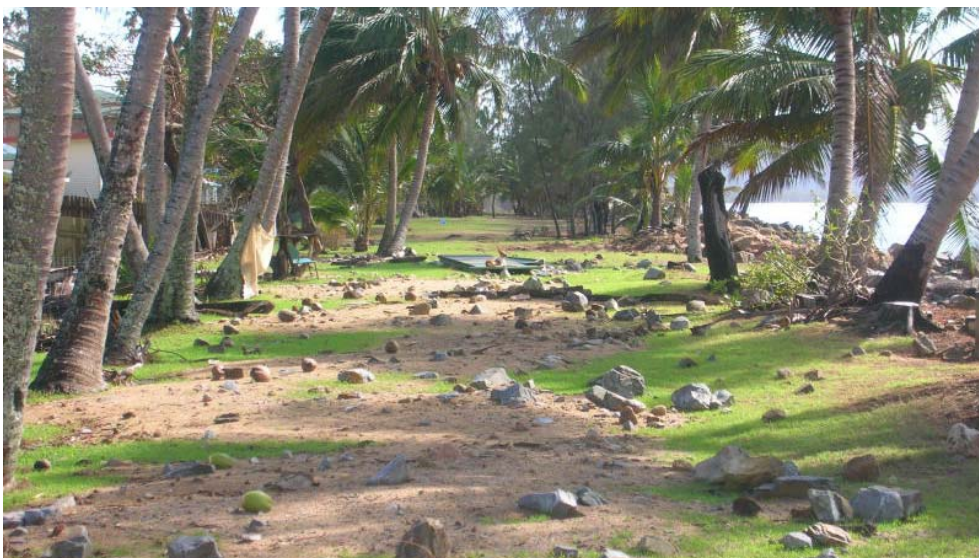
Photo 45. Sand and rocks washed inshore of the rock wall at Tully Heads by wave overtopping.

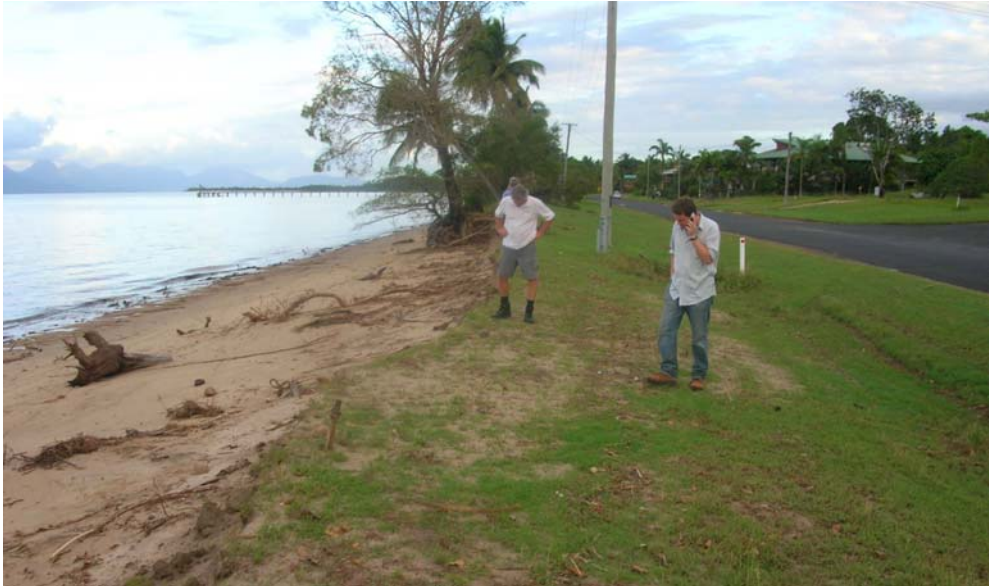
Photo 46. Debris line at Cardwell indicates slight overtopping of the dune.

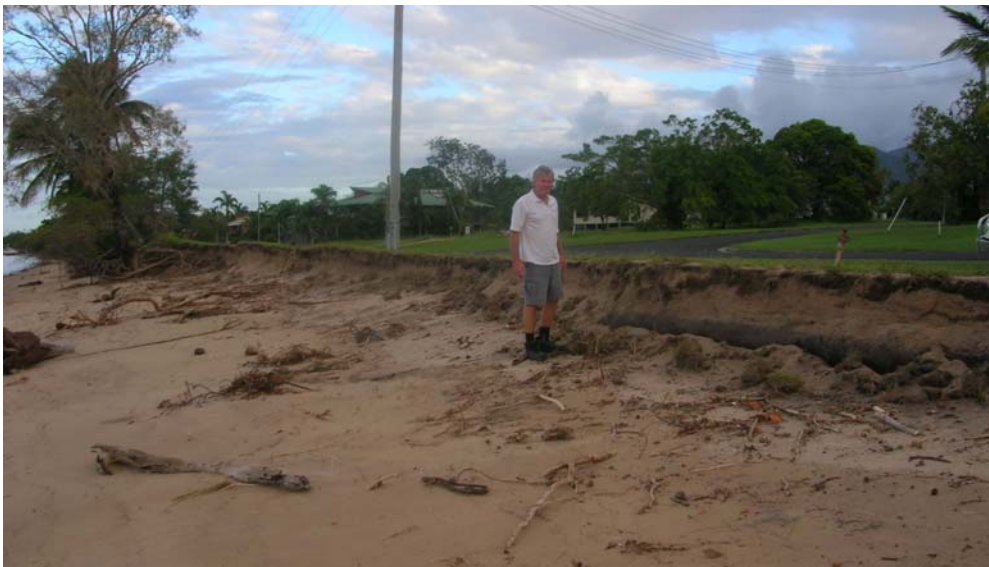
Photo 47. Erosion scarp along Marine Parade at Cardwell.
