Tropical Cyclone Yasi 2011

Post Cyclone Coastal Field Investigation

November 2012

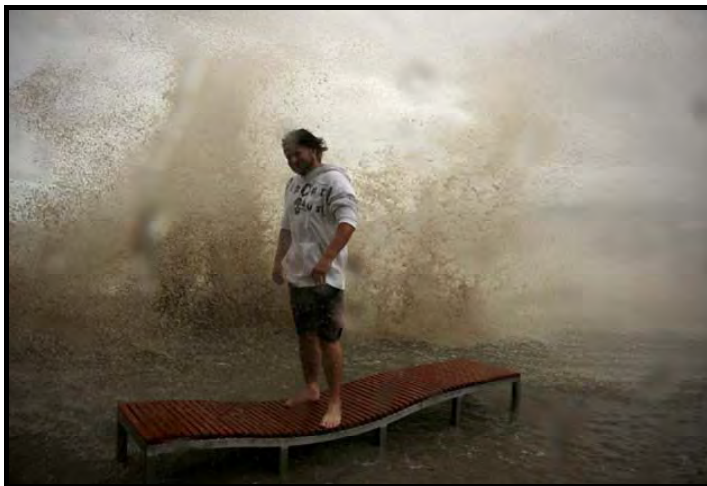
Photograph 2: (left): Localised flooding at Hull Heads caused by storm tide inundation and heavy rainfall during TC Yasi (Source: News Limited)

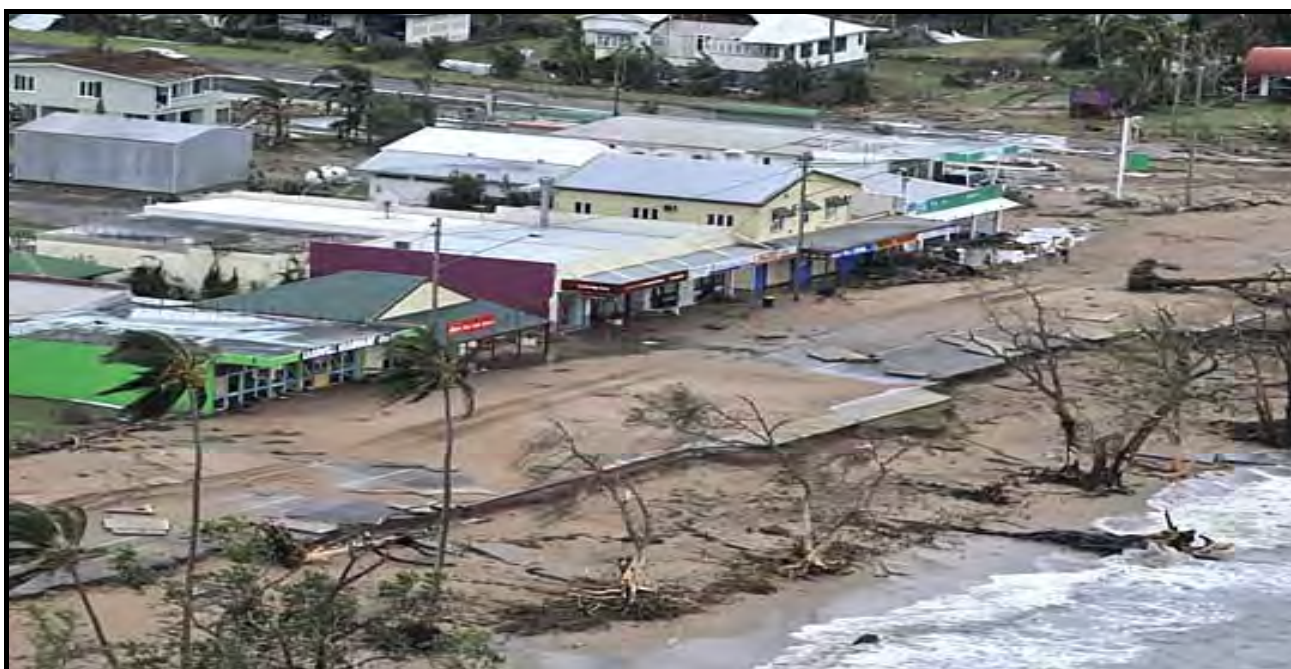
Photograph 3: Coastal erosion and damage to buildings and infrastructure at Cardwell following TC Yasi (Source: News Limited)

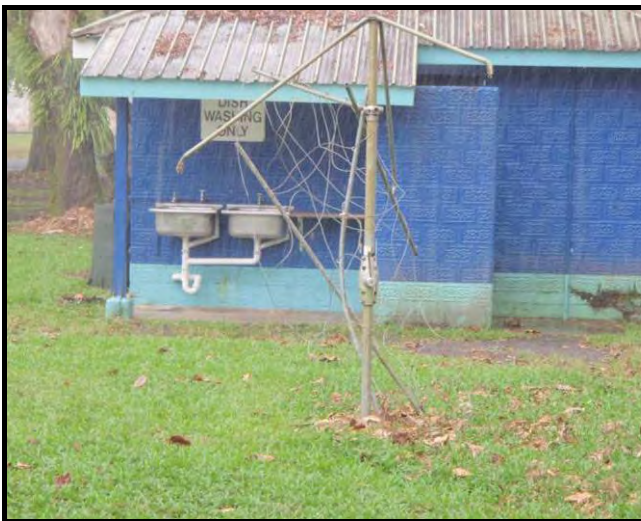
Cyclone impacts: Bramston Beach is located 60 kilometres north of where the eye of TC Yasi crossed the coastline resulting in comparatively minimal damage to this region. The inspection was carried out to the south and north of the groyne. Examination of the picnic area in the campgrounds to the south of the groyne indicated that the water level had overtopped the foredune and sand had been washed onto the grassed area some 10 metres behind the dune. There had also been some localised erosion on the northern side adjacent to the groyne, evident by fallen trees. Damage to the beach was minimal.

Photograph 5: Minor damage - Caravan Park toilet block at Bramston Beach (Source: DSITIA)

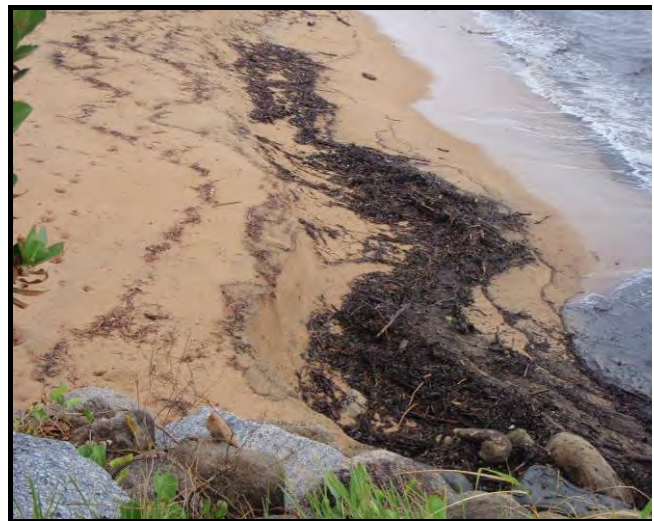
Photograph 6: Debris and minor beach scarping at Bramston Beach (Source: DSITIA)

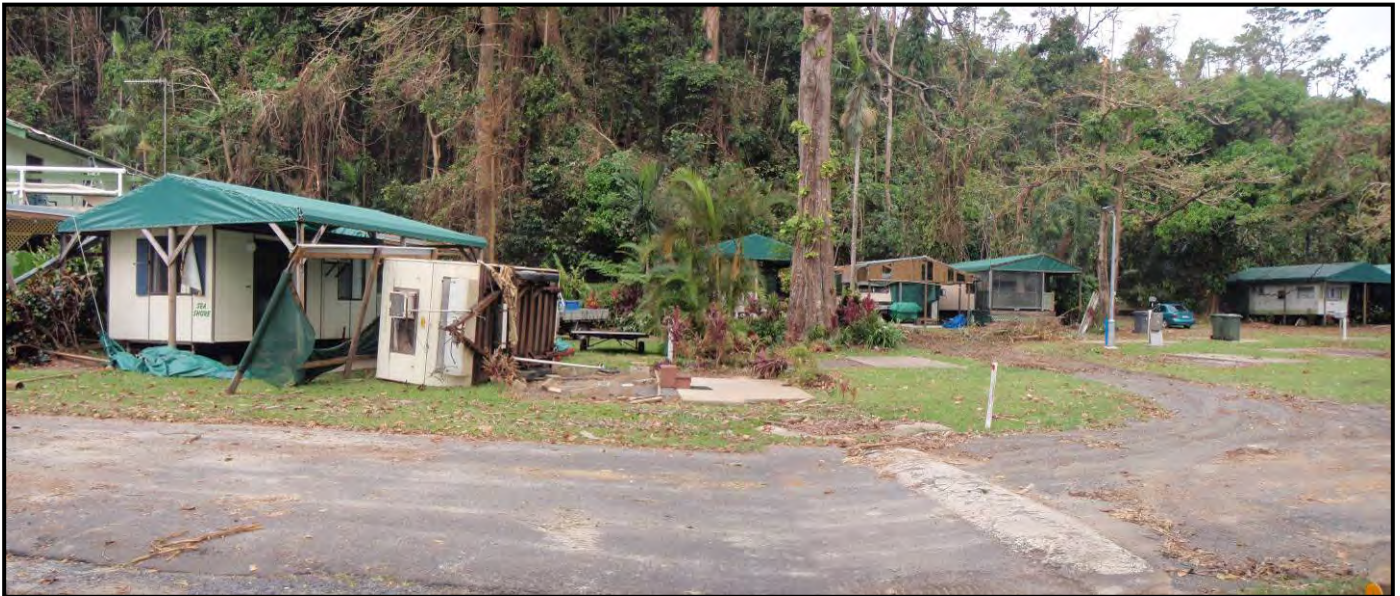
Cyclone impacts: Etty Bay is located 30 kilometres north of where the eye of TC Yasi crossed the coastline resulting in comparatively minimal damage to this region. In addition, Etty Bay was protected by the surrounding Moresby Range, buffering the full impact of westerly winds generated within the northern half of the cyclonic system. As a result, property and vegetation damage were minimal compared to other coastal locations to the south. The inspection found minimal beach erosion, with some sand having been washed over the foredune. The only road into Etty Bay suffered minor damage.

Photograph 7: Damage caused by TC Yasi at Etty Bay (Source: DSITIA)

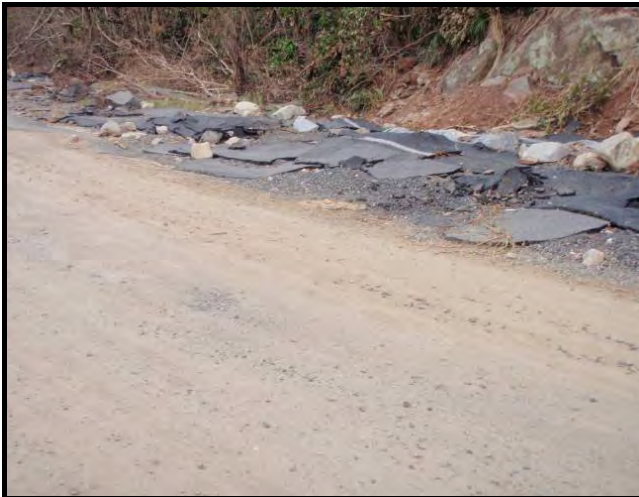
Cyclone impacts: Evidence of TC Yasi's impacts to the Bingil Bay region included vegetation damage and damage to the road connecting Bingil Bay and Clump Point. Evidence of the damaged road and debris lines located between Clump Point and Bingil Bay are an indication of the storm surge in this area. A peak surge of 2.97 metres above the predicted astronomical tide was recorded at Clump Point (3 kilometres to the south). The surveyed beach profile lines at Bingil Bay (Figure 20) did not extend to the debris line.

Photograph 8: Damage to road caused by TC Yasi between Clump Point and Bingil Bay (Source: DSITIA)

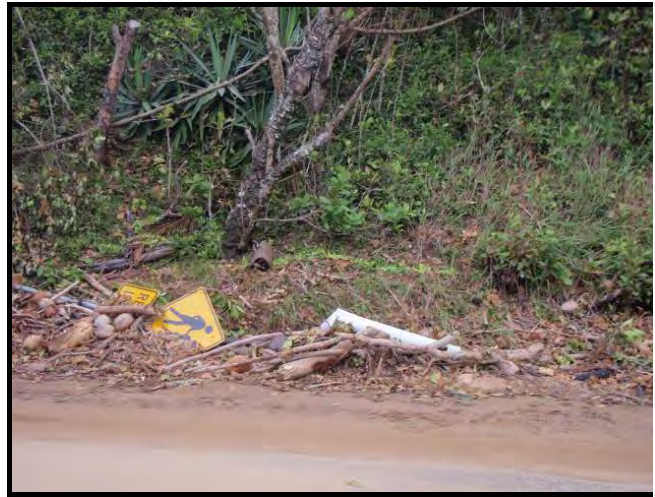
Photograph 9: Damage to road caused by TC Yasi between Clump Point and Bingil Bay (Source: DSITIA)

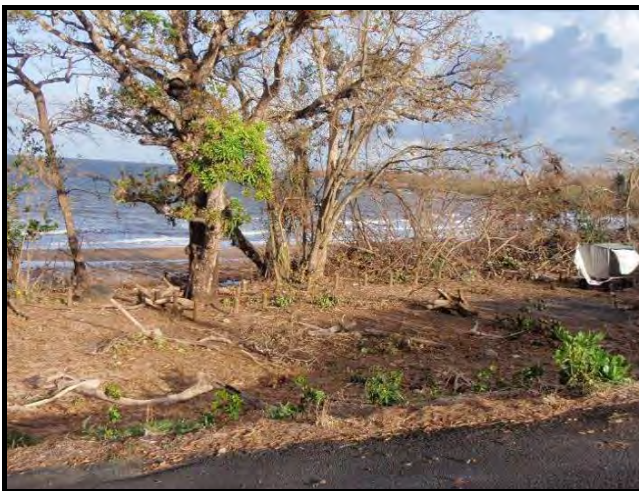
Photograph 10: Damage to coastal vegetation at Bingil Bay (Source: DSITIA)

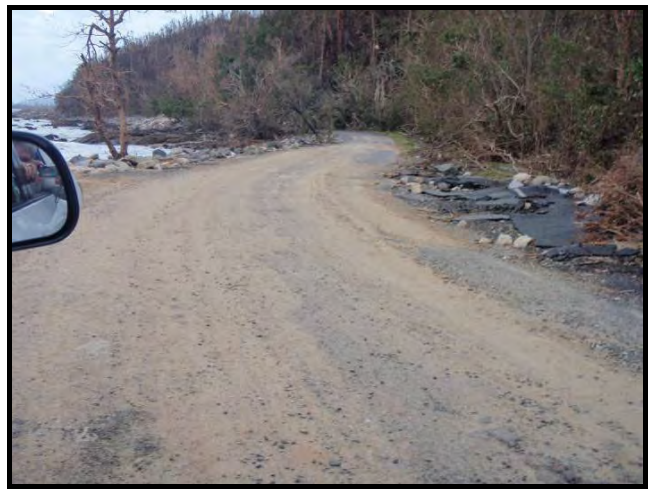
Photograph 11: Damage to road caused by TC Yasi between Clump Point and Bingil Bay (Source: DSITIA)

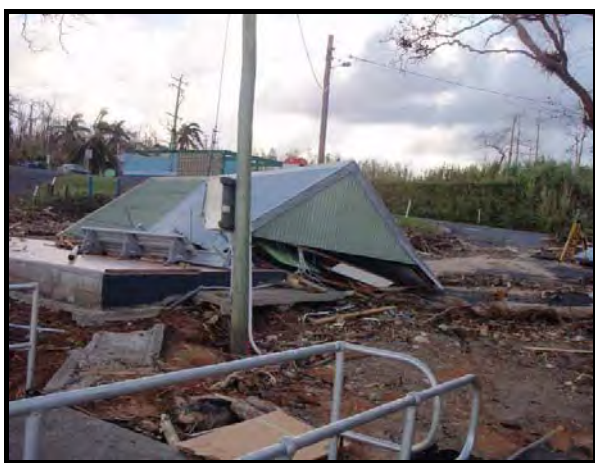
Cyclone impacts: The charter boat office adjacent to the jetty was extensively damaged with blown out roller doors and the walls completely destroyed, as well as holes and water damage to the lower sections of the internal cladding suggesting water depths of about 0.5 metres through the structure (about 3.5 metres AHD). The jetty had splintered decking and missing planks. It was evident that the repairs of the jetty carried out after TC Larry prevented more damage. The only evident damage to the storm tide gauge was the collapse of the anemometer. Although attempts are being made to retrieve some data from this device it appears the maximum wind speed was not captured. Clump Point storm tide gauge recorded peak water level at the 4.25 metres (LAT) compared to the jetty deck level of 4.27 metres (LAT). The water level recorded at the gauge does not include complete wave set-up or run-up and therefore the actual level may have been higher than the jetty itself, causing damage seen in the below photographs. The beach conditions do not appear to have been affected by TC Yasi. The approaches to the jetty had been undermined and electrical and water services had been severed to the jetty. Although generally a rocky beach, no apparent damage was evident.

Photograph 12: Building and infrastructure damage caused by TC Yasi at Clump Point (Source: DSITIA)

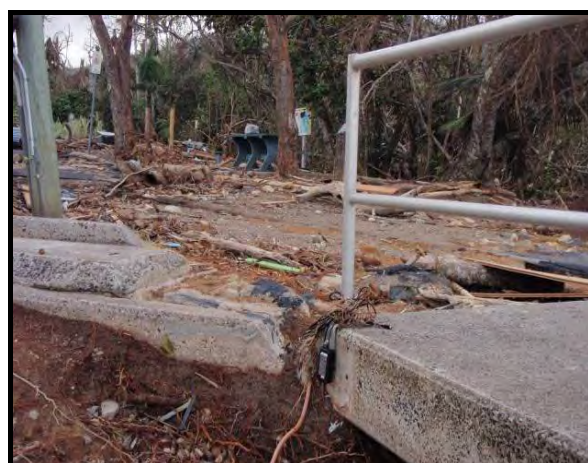
Photograph 13: Damage to Clump Point jetty (Source: DSITIA)

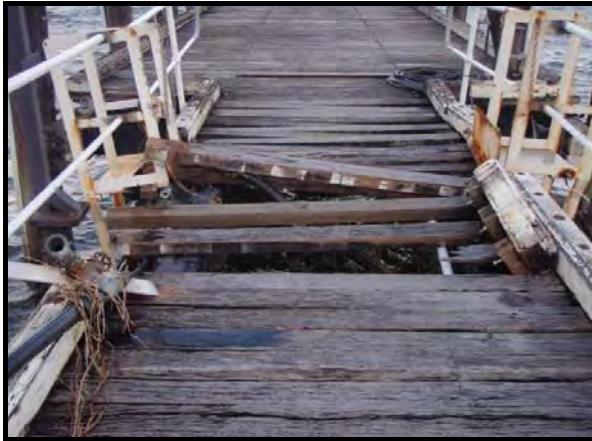
Photograph 14: Damage to Clump Point jetty during TC Yasi (Source: DSITIA)

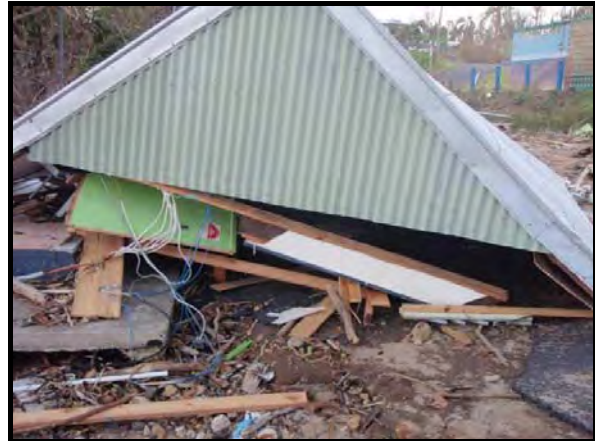
Photograph 15: Building damage caused by TC Yasi at Clump Point (Source: DSITIA)

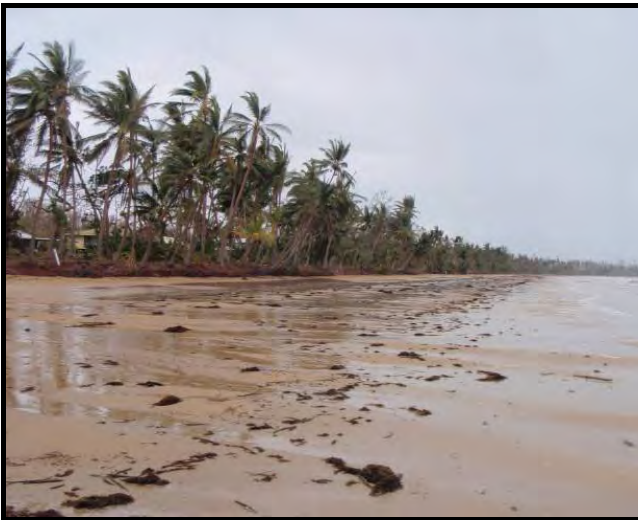
Photograph 16: Beach erosion caused by TC Yasi at Mission Beach (Source: DSITIA)

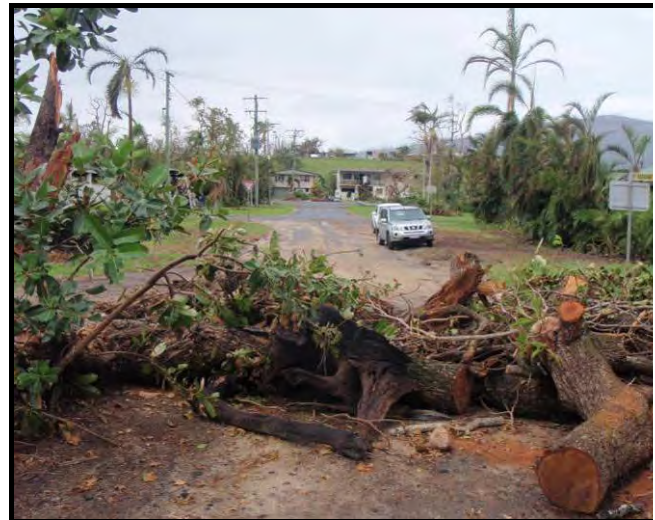
Photograph 17: Vegetation damage caused by TC Yasi (Source: DSITIA)

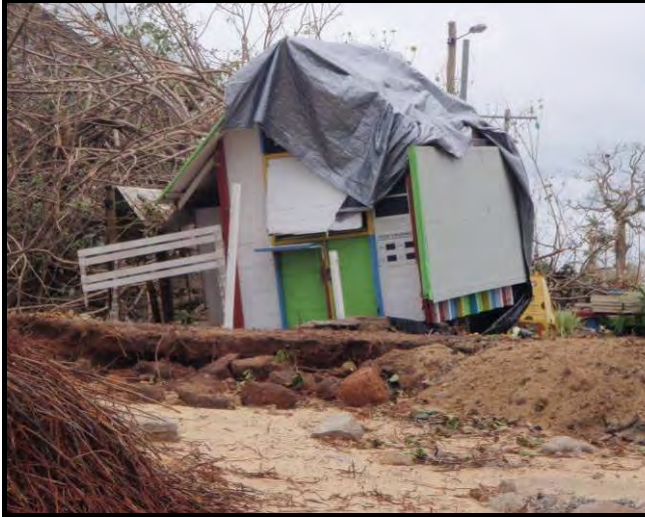
Photograph 18: Building damage caused by TC Yasi at Mission Beach (Source: DSITIA)

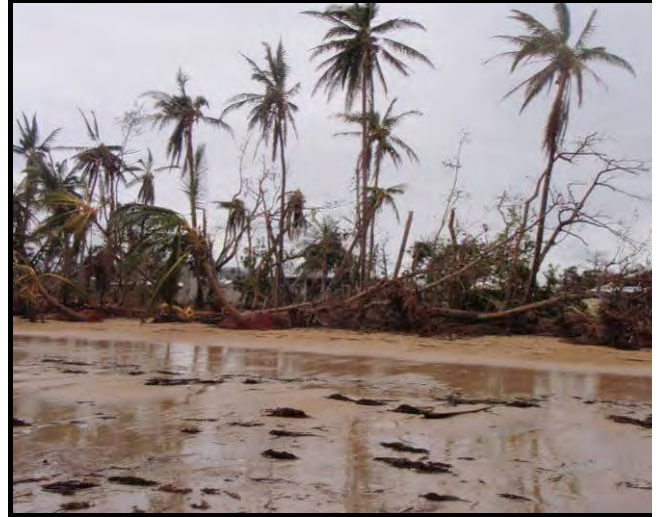
Photograph 19: Beach erosion and vegetation damage caused by TC Yasi at Mission Beach (Source: DSITIA)

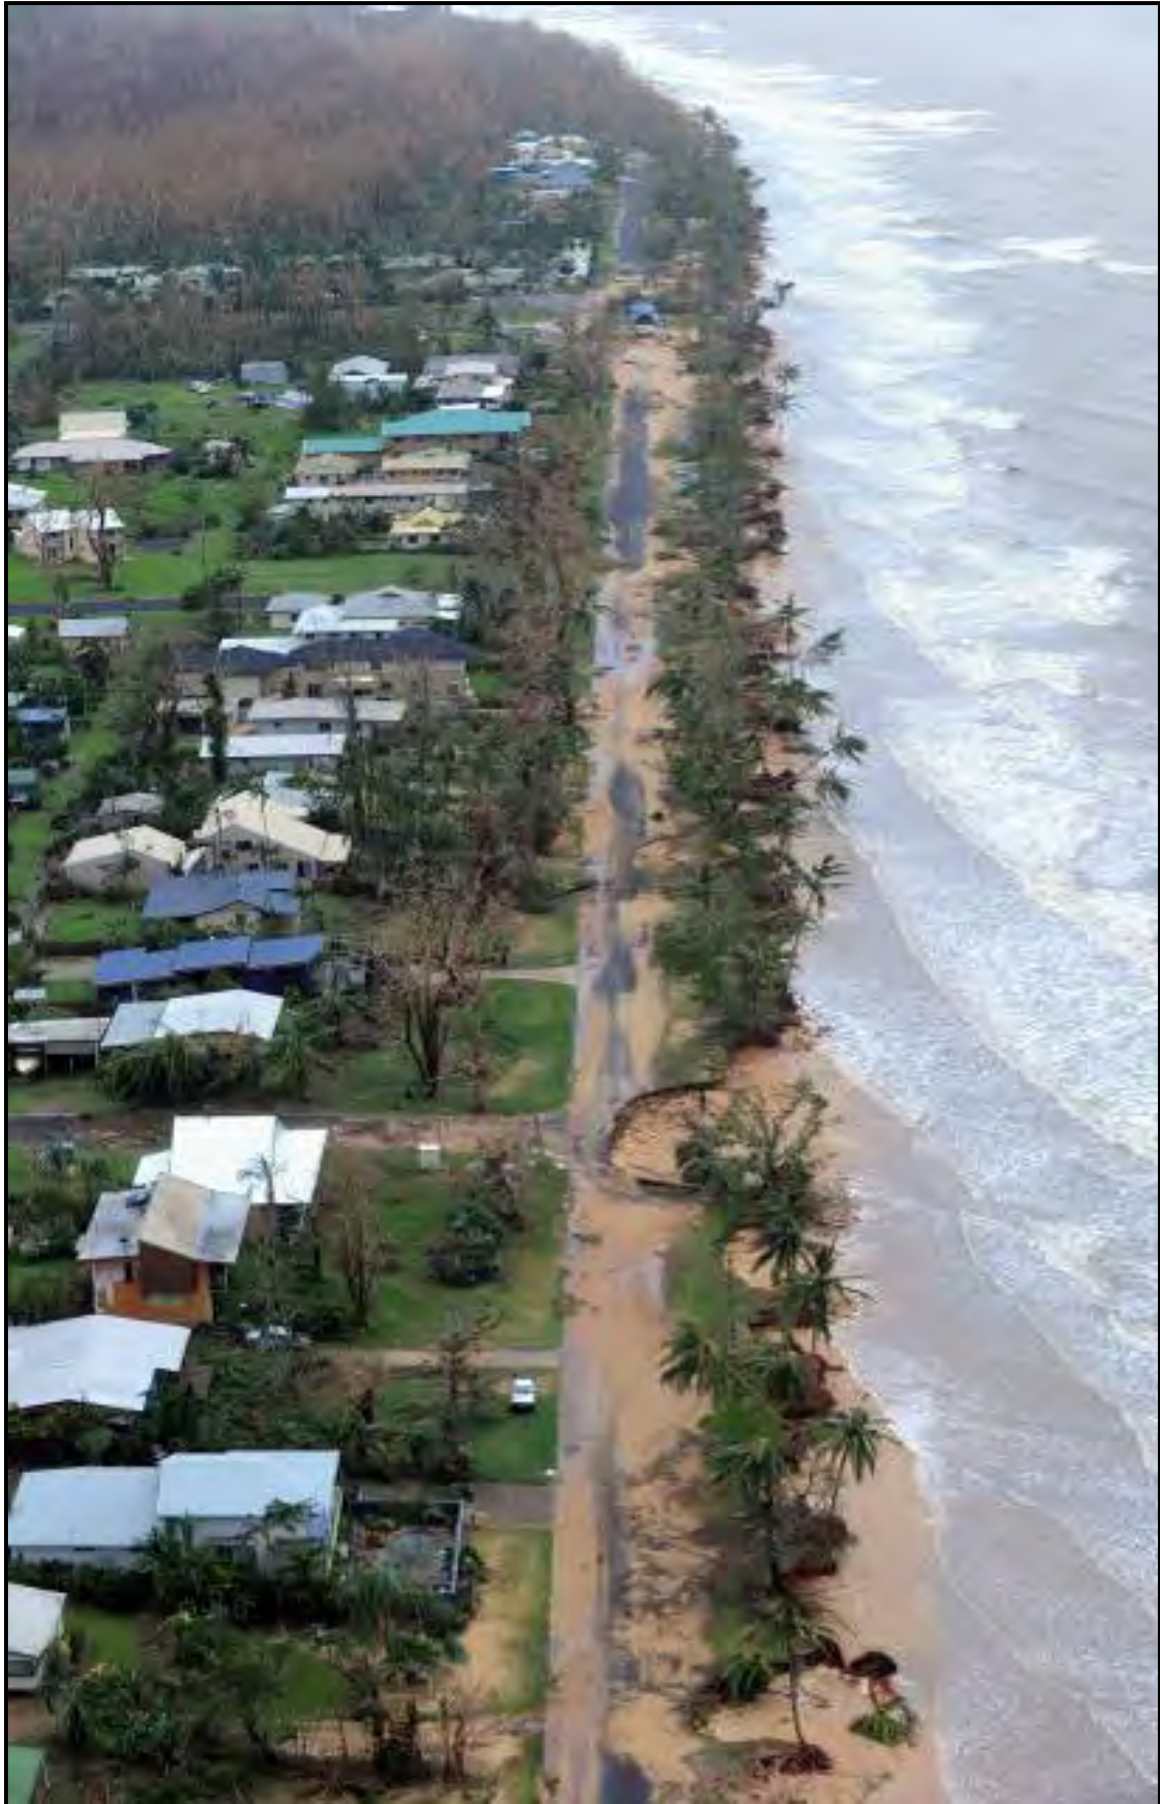
Photograph 20: Coastal erosion at South Mission Beach following TC Yasi (Source: News Limited)

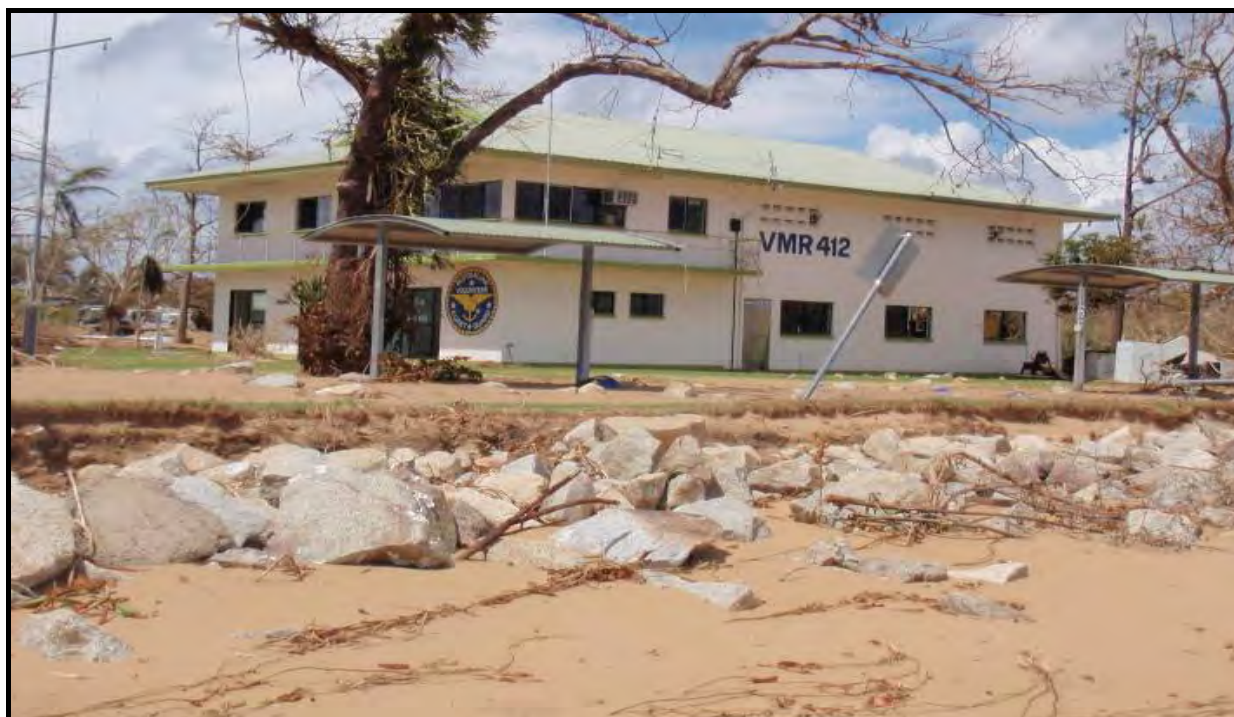
Photograph 21: Damage to Coast Guard building caused by TC Yasi at Hull Heads (Source: DSITIA)

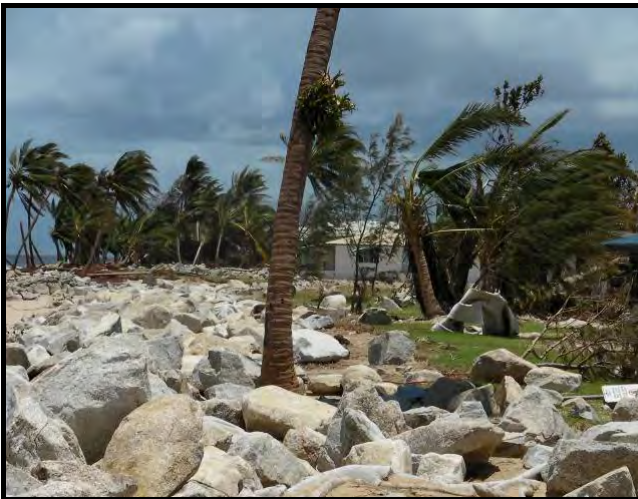
Severe damage was sustained to the existing rock wall at the southern end of Tully Heads. Soil erosion behind the crest of the rock wall as well as the inland movement of sand and rocks (up 0.5 metres diameter) indicated that there had been severe wave overtopping. Like Hull Heads, the storm surge at Tully Heads met the rising waters of the Tully River from the west. It was reported that more damage was done by the rising waters from the Tully River than by the storm surge over the fore dune. Containers at Tully Heads were also moved 300-400 metres (Photograph 23). Sand, pushed up by wind and the storm surge also inundated the properties as can be seen in Photograph 26. Erosion of the foreshore at Tully Heads has been an ongoing issue for many years. The continuous foreshore erosion was the primary reason the Bedarra View Caravan Park closed after TC Larry eroded the beach in 2006.

Photograph 22: Armour rocks from the seawall washed up by storm surge and increased wave energy during TC Yasi (Source: DSITIA)

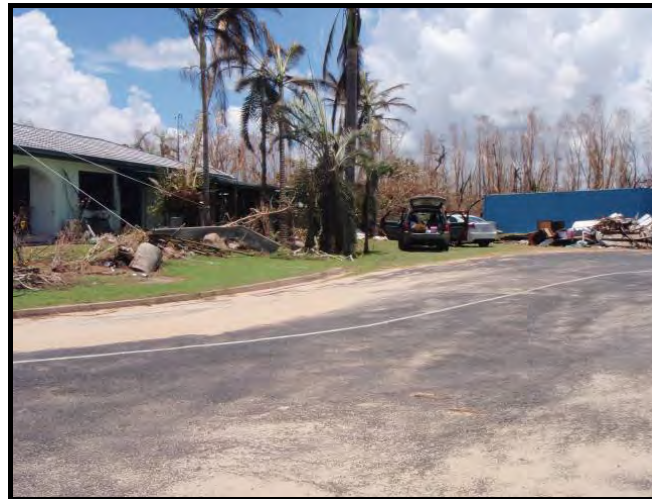
Photograph 23: Building damage and relocation of shipping container during TC Yasi (Source: DSITIA)

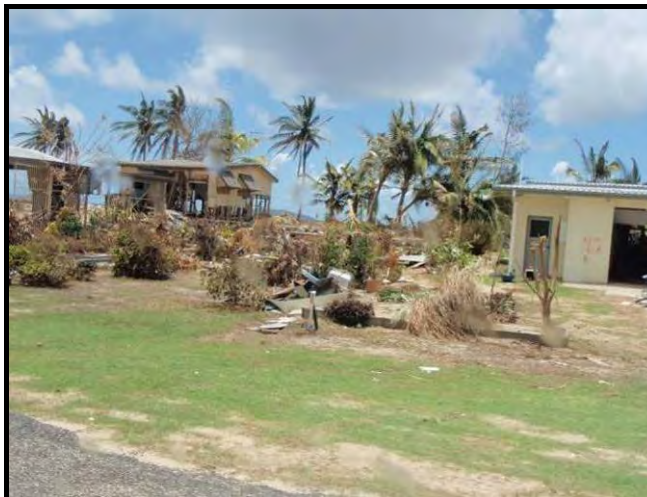
Photograph 24: Building and vegetation damage caused by TC Yasi at Tully Heads (Source: DSITIA)

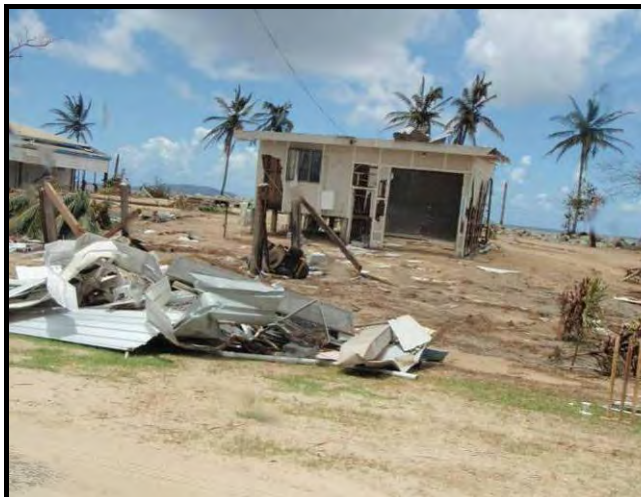
Photograph 25: Building and vegetation damage caused by TC Yasi at Tully Heads (Source: DSITIA)

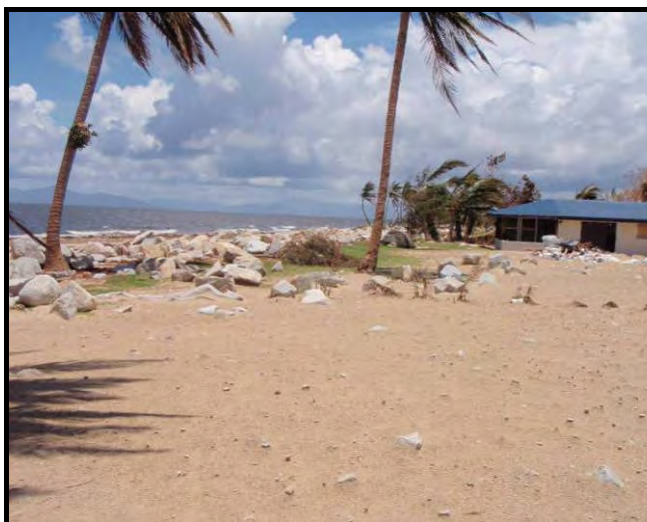
Photograph 26: Sand intrusion and rock retaining wall destroyed by TC Yasi at Tully Heads (Source: DSITIA)

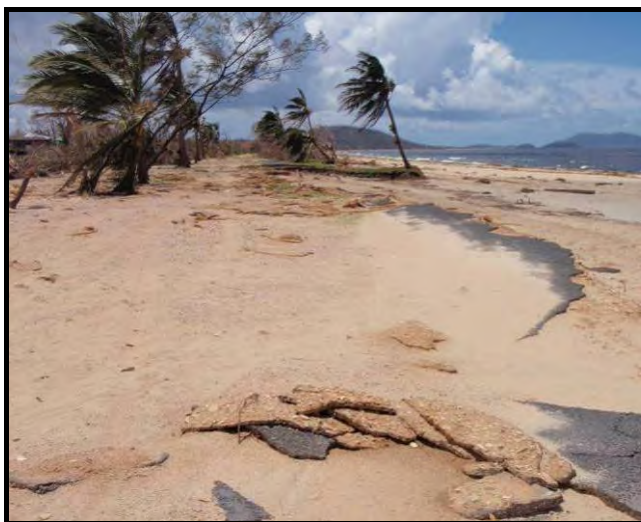
Photograph 27: Sand intrusion, vegetation damage and road destruction caused by TC Yasi at Tully Heads (Source: DSITIA)

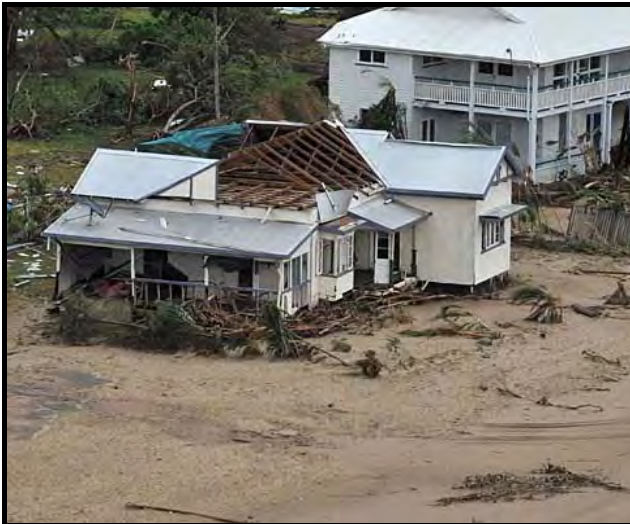
Photograph 28: Damage to houses at Cardwell caused by TC Yasi (Source: News Limited)

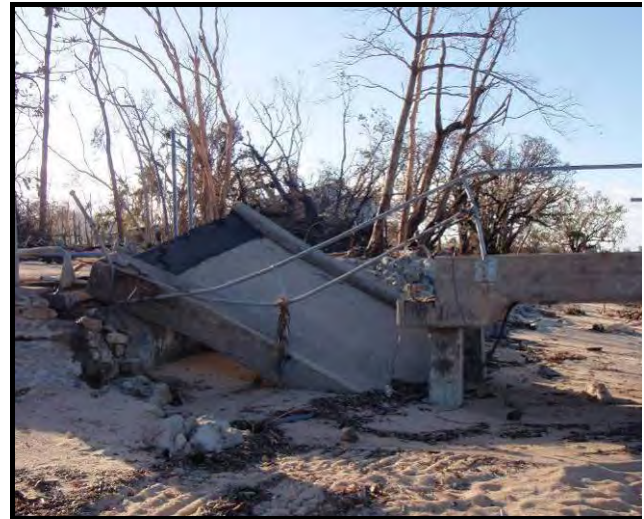
Photograph 29: Jetty damaged by TC Yasi at Cardwell (Source: DSITIA)

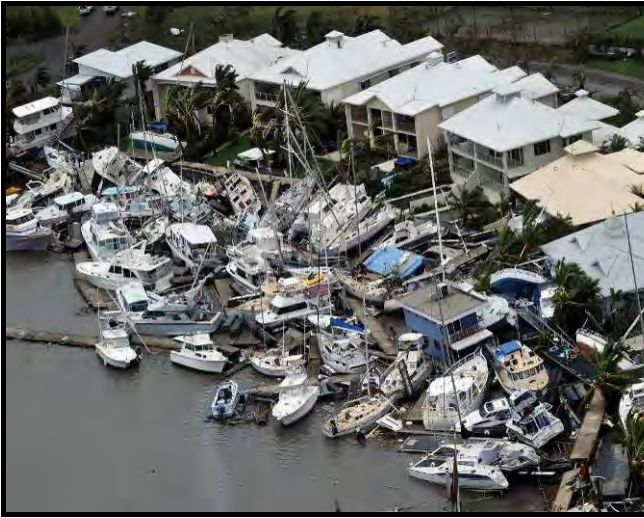
Photograph 30: Damage to Port Hinchinbrook Marina, Cardwell, caused by TC Yasi (Source: News Limited)

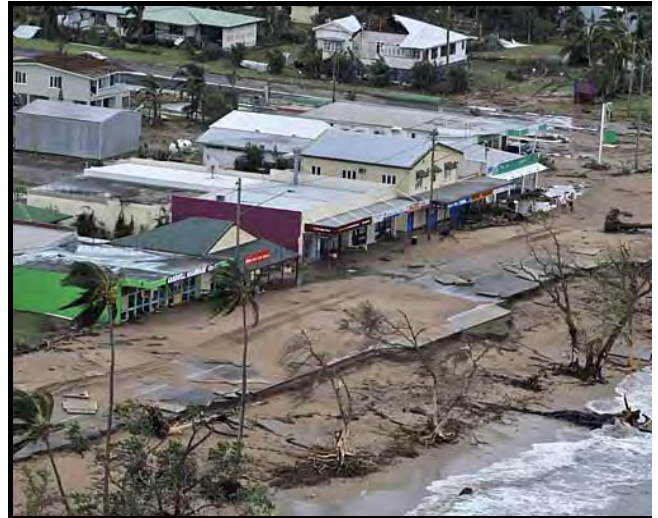
Photograph 31: Coastal erosion and damage to buildings and infrastructure at Cardwell following TC Yasi (Source: News Limited)

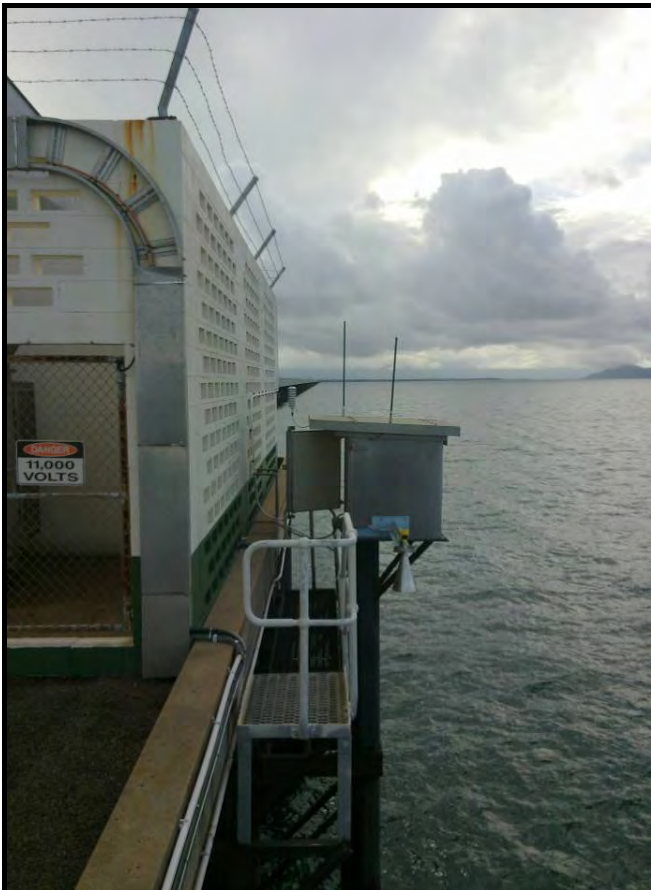
Cyclone impacts: Low lying areas of Lucinda were inundated and power was lost to the area for approximately 5 days. The beaches at Lucinda suffered only minimal damage. Several houses sustained damage; however the main damage caused by TC Yasi was to Lucinda's offshore sugar loading facility. Following TC Yasi, the regional harbour master declared an exclusion zone around the entire facility, including the 5–6 kilometres long trestle. During TC Yasi one of the department's storm tide gauges located offshore of Lucinda was completely destroyed (Photographs 32 and 33).

Photograph 33: DSITIA's offshore storm tide gauge at Lucinda - destroyed by TC Yasi (Source: DSITIA)

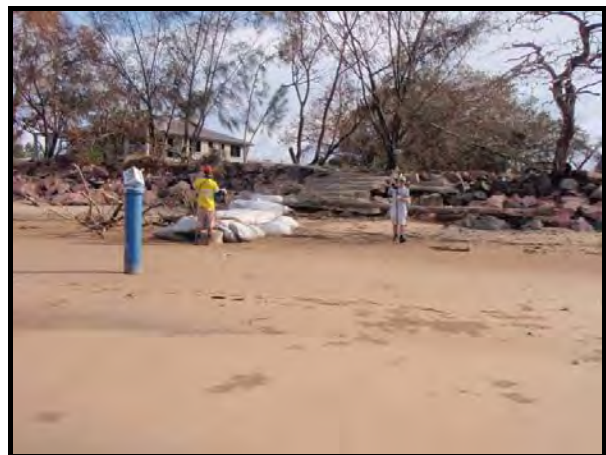
Photograph 34: Damage to Lucinda foreshore (Source: DSITIA)

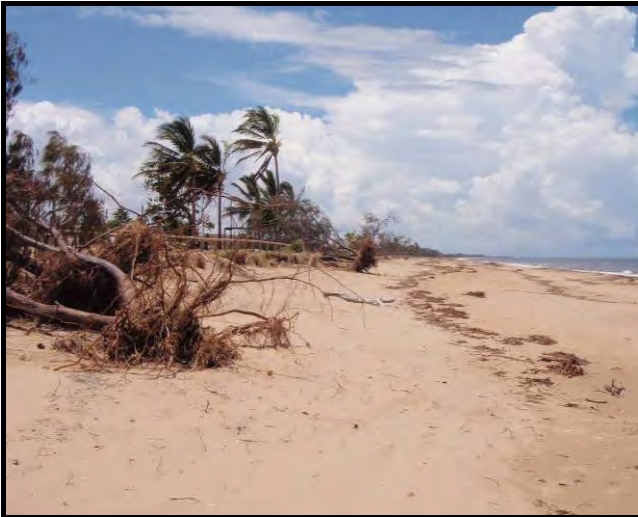
Cyclone impacts: Forrest Beach suffered only minor erosion effects due to TC Yasi, most of the damage in the settlement was caused by falling vegetation and airborne debris. Although the storm surge reclaimed a significant volume of the upper beach, the foreshore of the settlement remained relatively intact.

Photograph 35: Beach and dune erosion caused by increased wave action during TC Yasi at Forrest Beach (Source: DSITIA)

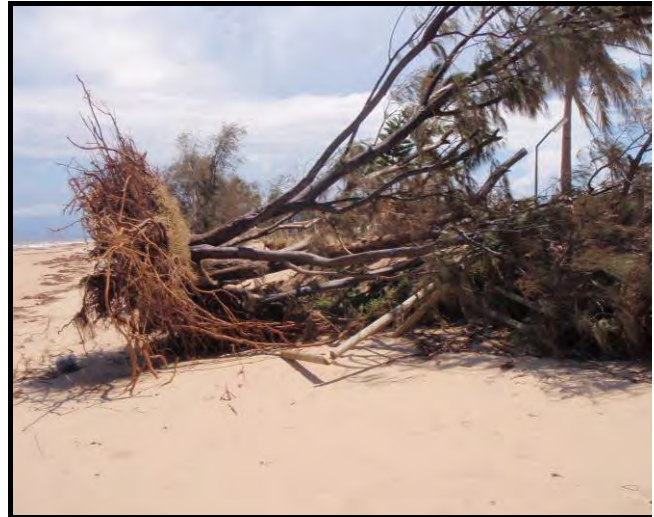
Photograph 36: Beach and dune erosion caused by increased wave action during TC Yasi at Forrest Beach (Source: DSITIA)

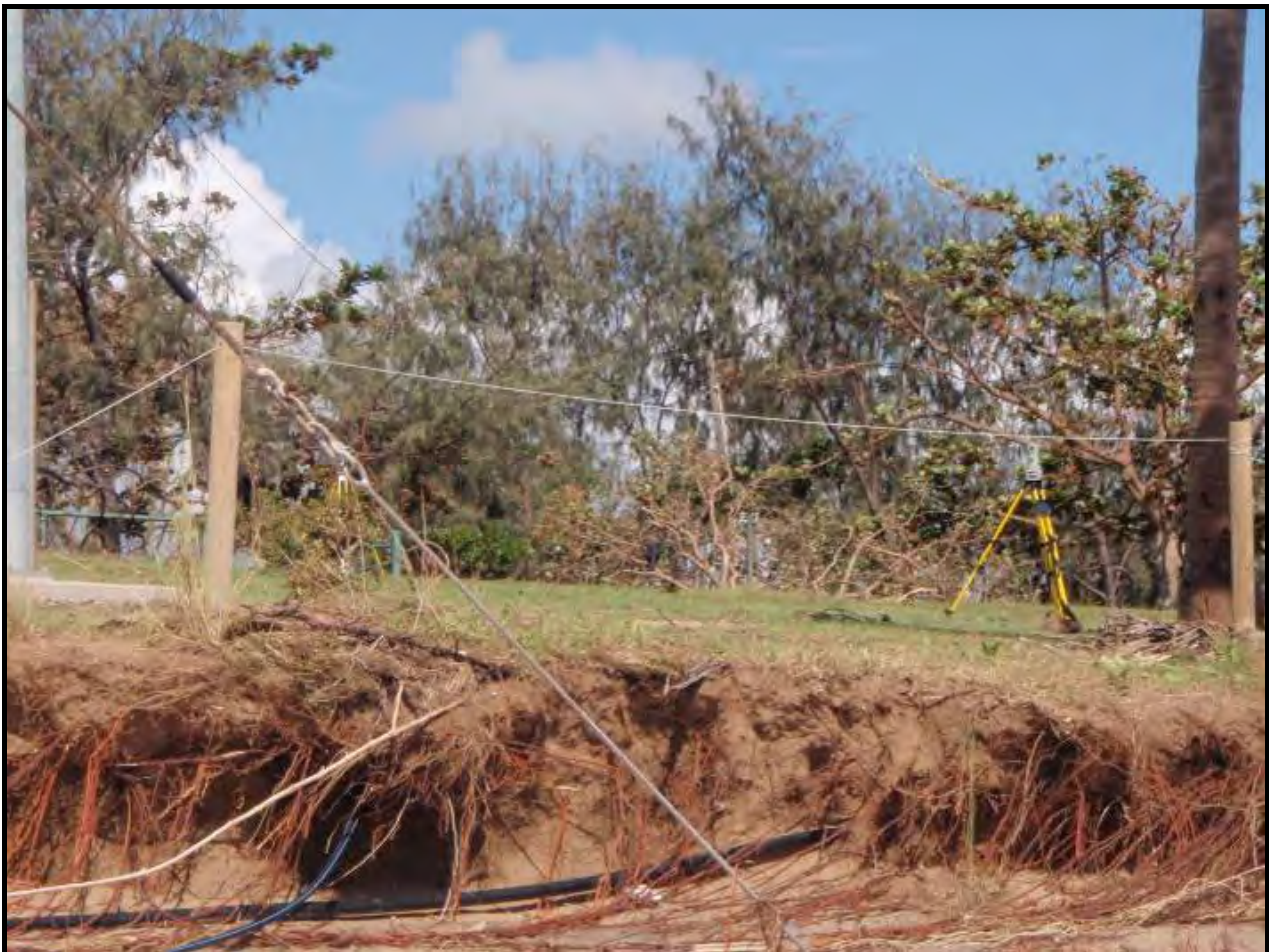
Cyclone impacts: TC Yasi had little effect on infrastructure or property at Balgal Beach, except for superficial damage to the playground near Tooth Street. A significant volume of sand was eroded from the dune system on the foreshore, leaving a scarp which varied vertically from 0.5–1 metre.

Photograph 37: Dune erosion caused by increased wave action during TC Yasi at Balgal Beach (Source: DSITIA)

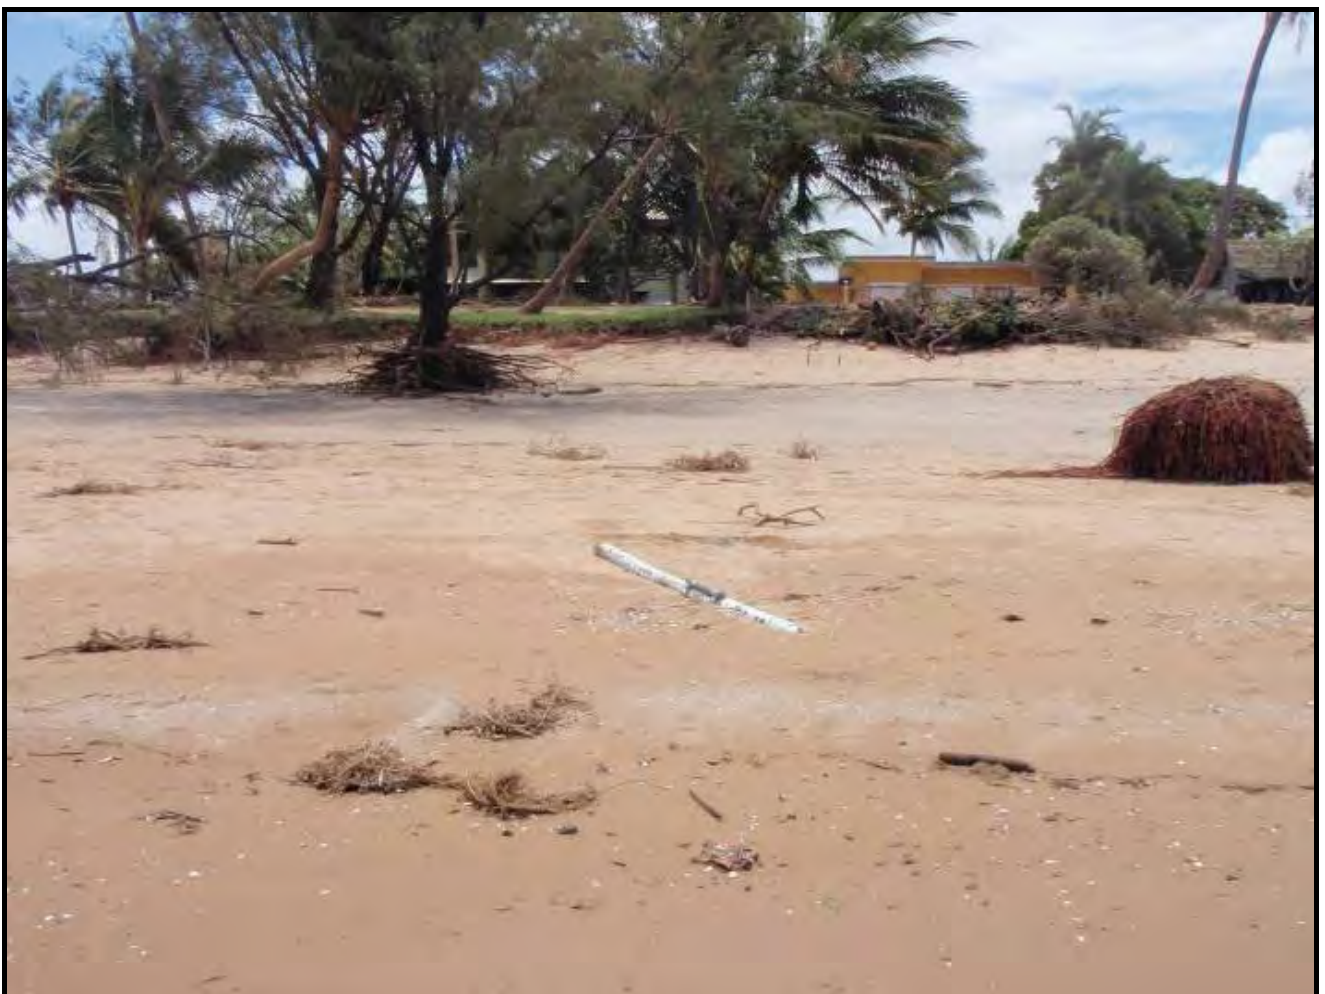
Cyclone impacts: The wind and storm surge associated with TC Yasi at Saunders Beach resulted in some sand infiltration across the foredune into the vegetated backdune, the foredune had also receded due to the storm activity between 2–10 metres. Approximately 50 per cent of the vegetation on the ocean-side of the foredune was undermined and ultimately collapsed due to the active sea state.

Photograph 38: Beach and Dune erosion caused by TC Yasi at Saunders Beach (Source: DSITIA)

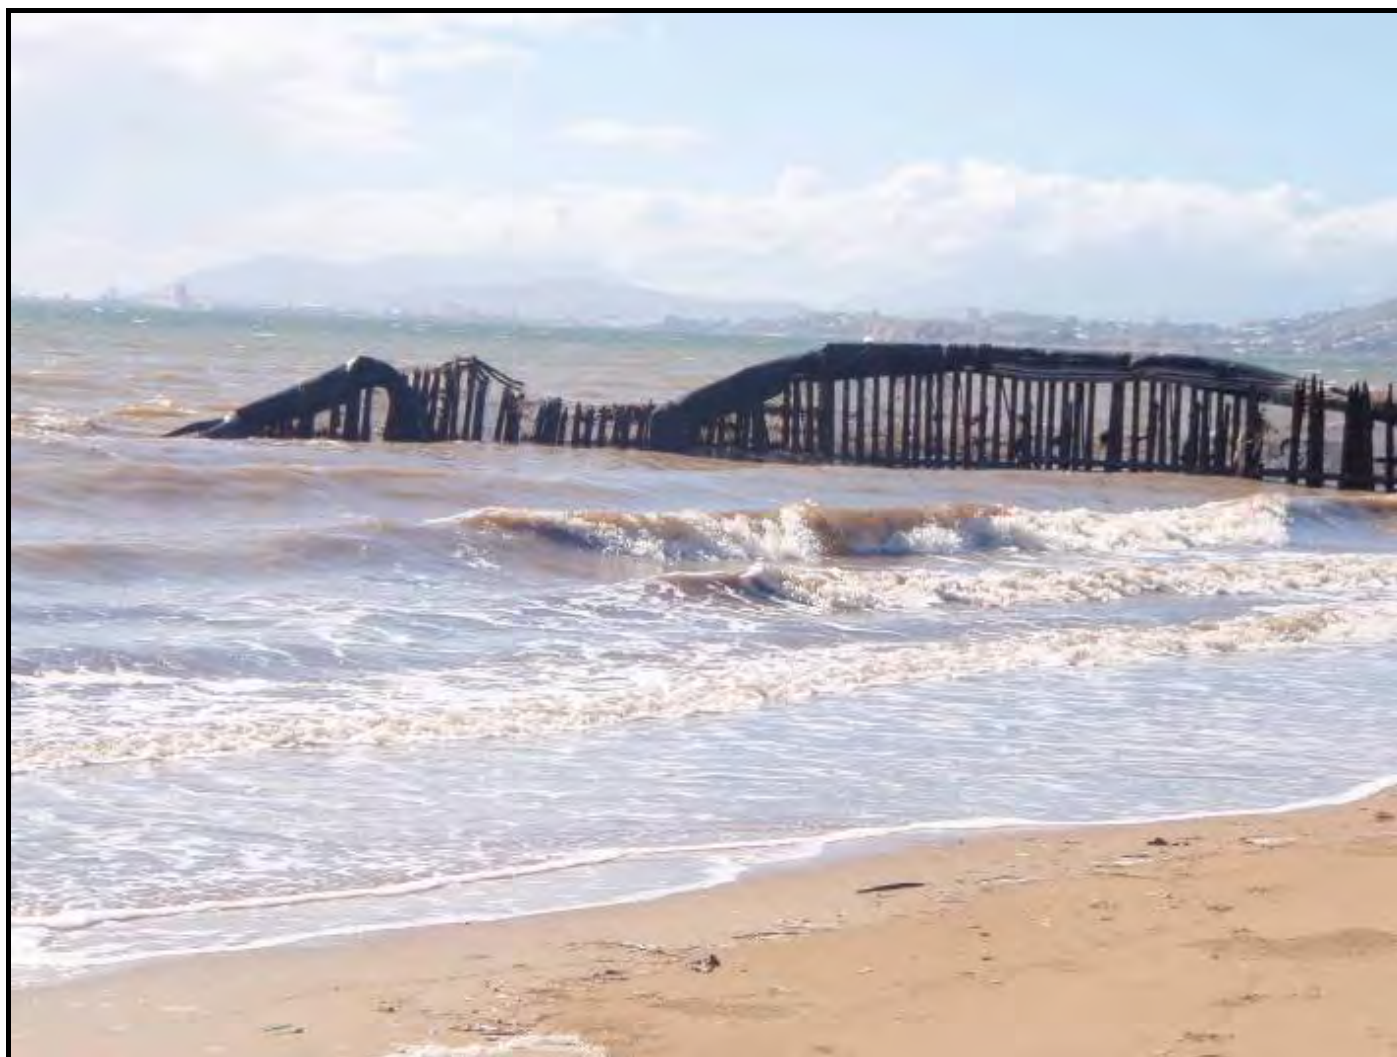
Photograph 39: Damage to swimming enclosure caused by TC Yasi at Pallarenda (Source: DSITIA)

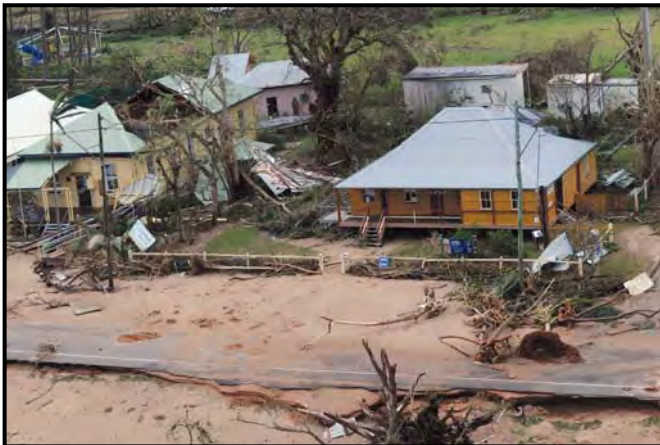
Photograph 40: The 5.33 metre storm surge during TC Yasi, 3 February 2011, damaged the Cardwell esplanade and deposited sand and debris above HAT (Source: News Limited).

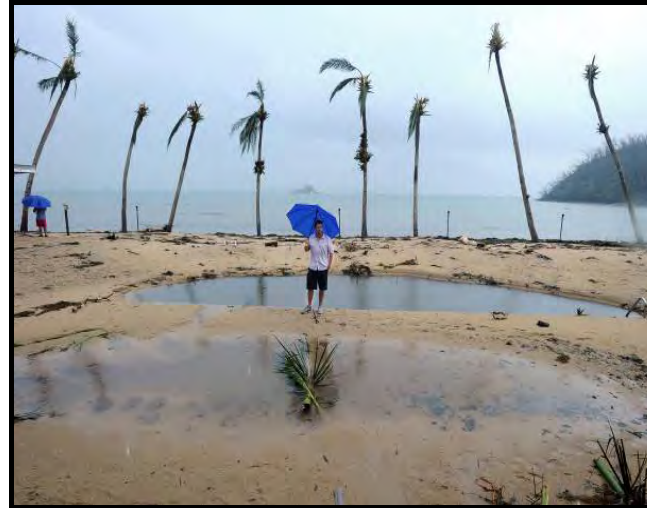
Photograph 44: Dunk Island Resort following the destructive waves, storm surge and winds caused by TC Yasi (Source: News Limited)

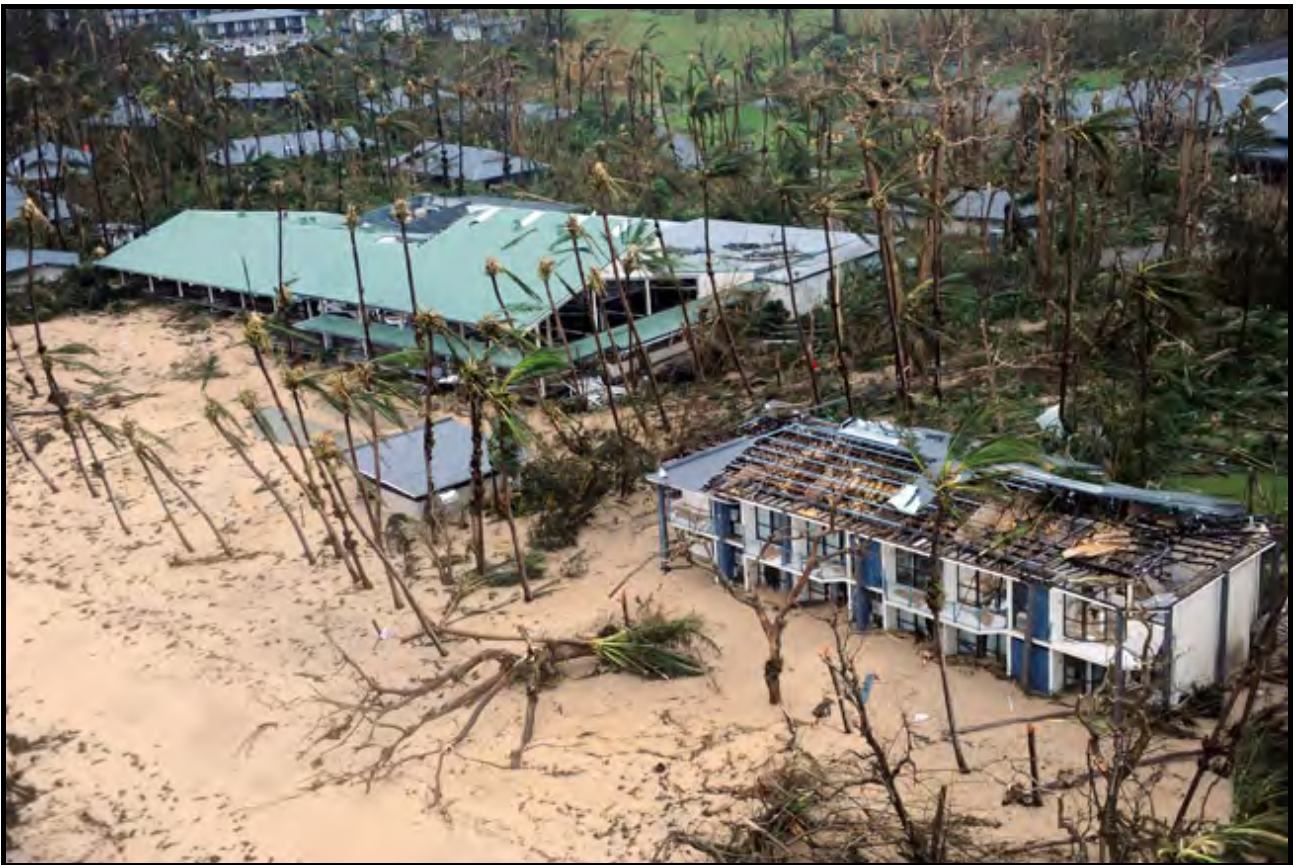
Photograph 45: Damage and mass sand deposition at Dunk Island Resort caused by the several metre storm surge during TC Yasi (Source: News Limited).
