Tropical Cyclone Larry

Supplementary Coastal Field Investigation

Coastal Sciences technical report

April 2007

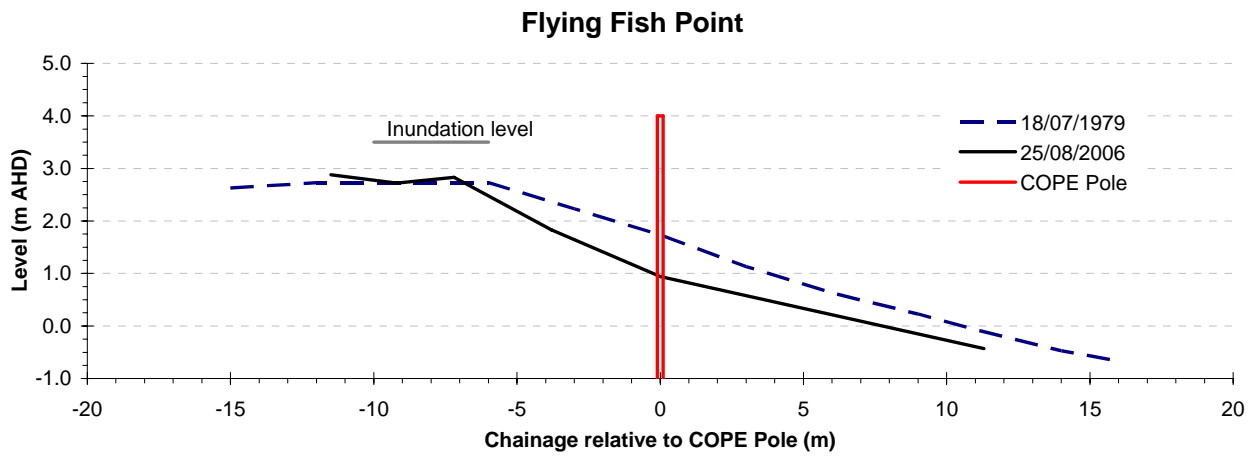
Figure 2. Beach Profile at Flying Fish Point COPE location.

The beach opposite the café – Edward Street, was in a good condition. The beach slope was relatively steep, in comparison to other beaches in the area. It appears that some sand may have been placed on the upper beach. No erosion scarp could be seen at the upper reach of the beach to the northern side of the toilet block, though there was still some erosion behind the rockwall that is in front of the toilet block. This erosion was up to 1m high in places, and was in a step formation. The pocket beach to the south of the toilet block had an erosion scarp of approximately 0.5m. An offshore bar was noticed to the northern end of these beaches, at a distance of about 100m out, and was causing the waves to break before the shoreline.

The beach at Beach Access 3 was again in a good condition, with a fairly steep slope from the mid beach to the intertidal zone. The upper beach was relatively flat. An erosion scarp was present and is approximately 0.5m high, and there was debris present at this location, and further down the beach as well. A shallow swale was evident to the south, just in front of the vegetation line. The offshore sand bars and near shore shoals were again present.

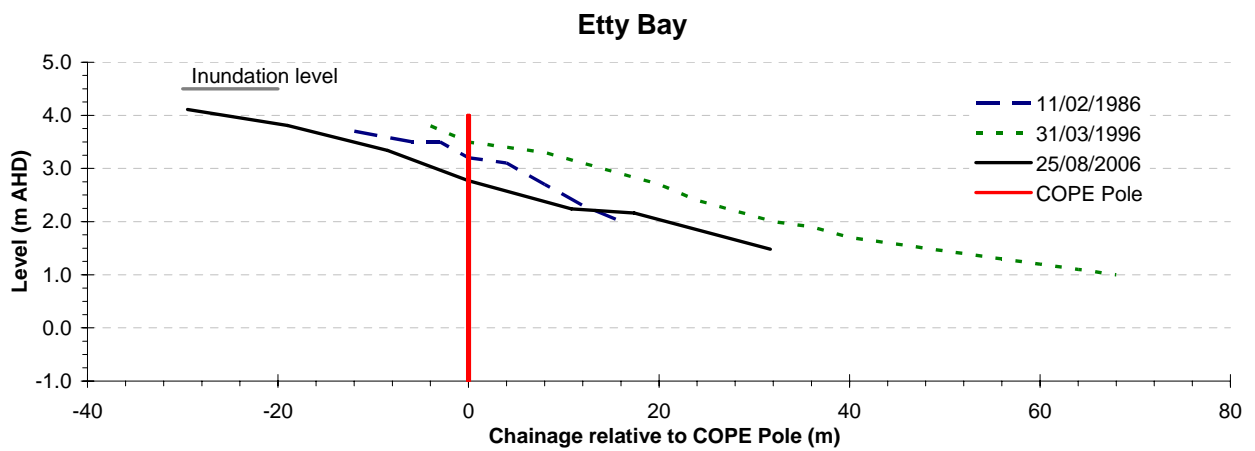
Figure 3. Beach Profile at Etty Bay COPE location.

Etty Bay is located just south of Innisfail and in close proximity to where TC Larry crossed the coast. The beach was in a good condition, with a gentle beach slope from the upper beach to the middle of the beach, it then flattens out into the intertidal zone. There was no erosion scarp present. There was a small amount of debris present around the palm tree line at the back of the beach. No sand shoals or bars were observed in the offshore or near shore area; however it was close to high tide at the time of the inspection.

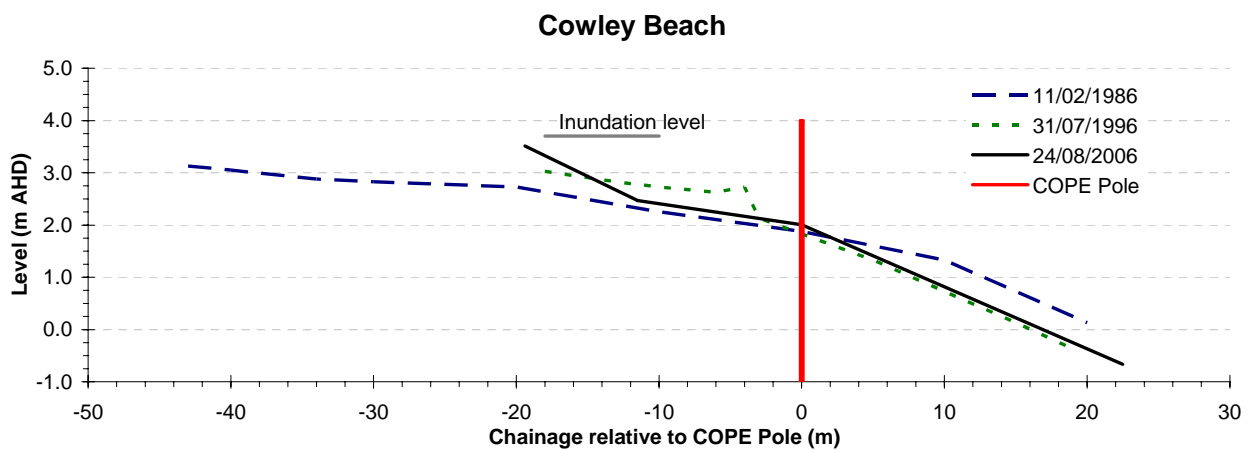
Figure 4. Beach Profile at Cowley beach COPE location.

Cowley beach is about 19km south of Innisfail and was getting towards the region of maximum winds to the south of the cyclone track. The beach profile survey was conducted approximately at the site of a COPE site. This is at the northern end of Cowley beach. The slope from the vegetation was steeper than other beaches in the region, and then it flattens out at the intertidal zone. Some sand shoals were present around the observed watermark, in the near shore area. The inspection took place about 2 hours prior to low tide.

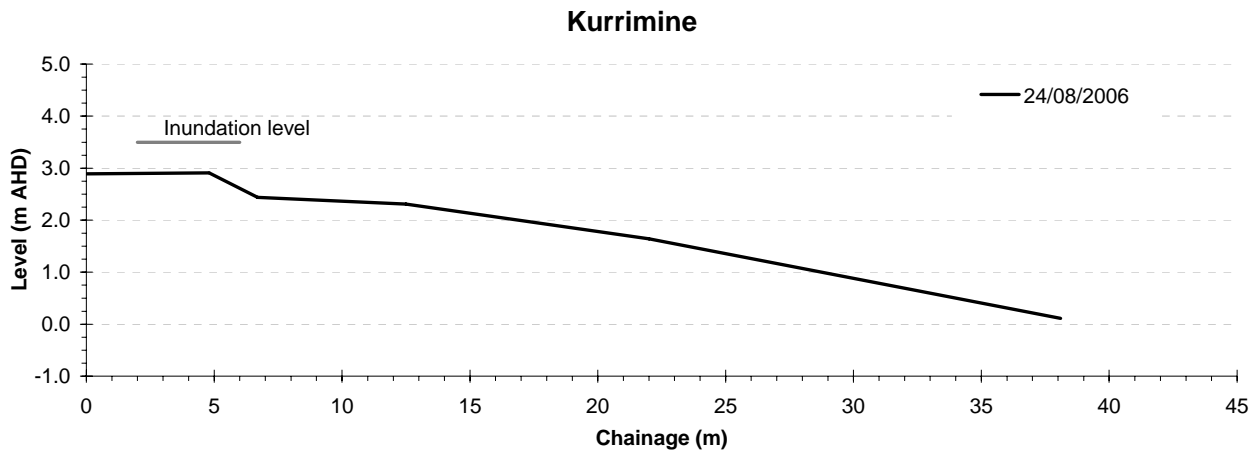
Figure 5. Beach Profile at Kurrimine beach.

The beach on the southern side of the boat ramp was in good condition, with a gentle slope from the vegetation line to mid way down the beach where the gradient increases and then flattens out in the intertidal zone. The erosion on this side of the boat ramp varies from about 0.5m to 1m high around the bases of the palm trees.

The beach on the northern side of the boat ramp, in front of the caravan park, was in a worse condition. The slope of the beach was still gentle, though the level of the beach was much lower, than the beach on the southern side of the boat ramp. A large amount of sand had been dumped in front of the caravan park, along the vegetation line, likely for beach nourishment, though no work had started. Due to the deposition of this sand, it was hard to determine the size of the scarp that is threatening the caravan park, however a 2m scarp was evident just on the northern end of the rock adjacent to the boat ramp.

The profile at the King Reef caravan park was similar to that on the southern side of the boat ramp, at the northern end of Kurrimine Beach. The beach slope was gentle to a flat intertidal zone. Offshore shallow sand bars were evident out from this profile.

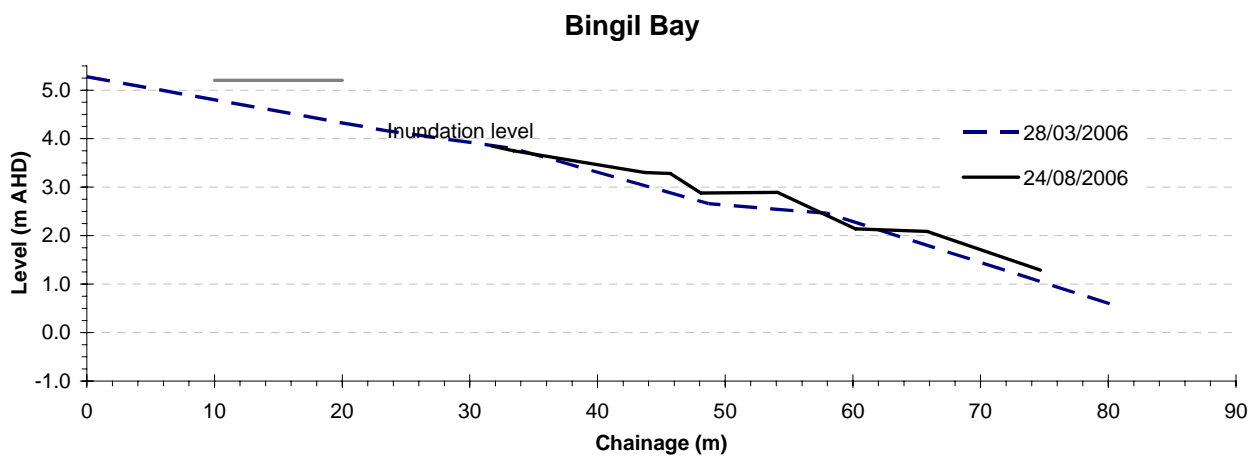
Figure 6. Beach Profile at Bingil Bay.

Bingil Bay is approximately 33km south of Innisfail, facing east. The beach at low tide consists of moderately steep intertidal crest and trough system, with a slightly steeper narrow upper section that meets the flat foredune. The upper beach showed a number of undulations in the post Cyclone Larry profile, with a definite depression in the middle of the beach. The slope of the beach on either side of the depression was steeper than other beaches in the region. An erosion scarp of approximately 0.5m high was present and was particularly noticeable around the base of the palm trees.

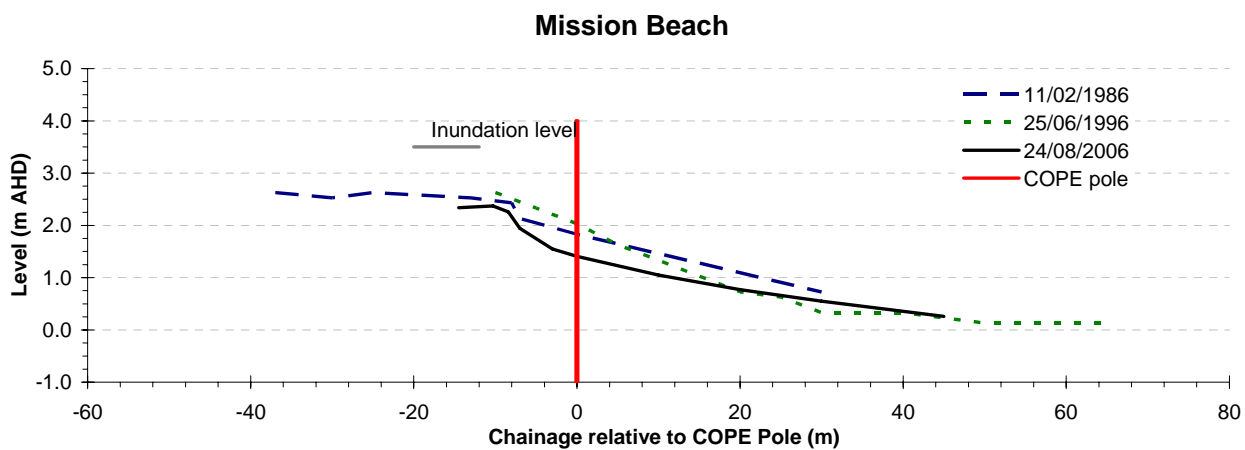
Figure 7. Beach Profile at Mission Beach COPE location.

Mission beach is positioned 2km south of the Clump Point jetty, and 35 km south of Innisfail. The beach has a gentle slope from the vegetation down to the intertidal zone. An erosion scarp of approximately 0.5m high to 1m high existed at the edge of the vegetation, and was noticeable around the base of the palm trees along the front of the vegetation. The 1m scarp was only evident in a few locations, with a lower scarp between them. A line of debris was still present on the beach, at the base of the palm trees. An inundation line was surveyed on the grounds of the Castaways Resort, approximately 2m seaward of the pool. See Appendix A for a photo showing this location.

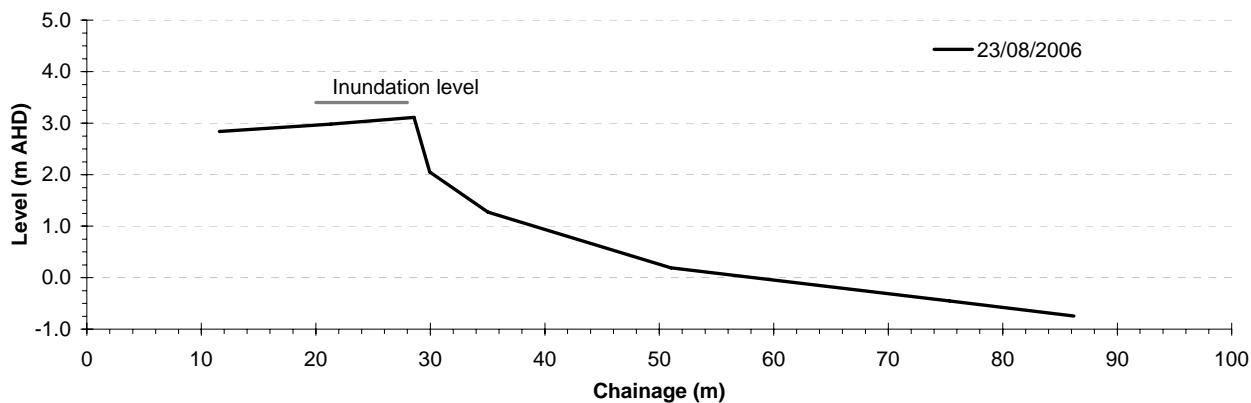
Figure 8. Beach Profile at Wongaling Beach.

Wongaling beach is sited 40km south of Innisfail and faces east. The beach exhibits a more concave profile with a steeper upper beach and gently sloping low tide beach. The inspection was at the southern end of Wongaling beach. A small sand bar was evident just offshore from the beach; this can be seen in the photographs in Appendix A. An erosion scarp of approximately 0.5m high still existed at the upper reach of the beach, and debris was still present on the upper beach.

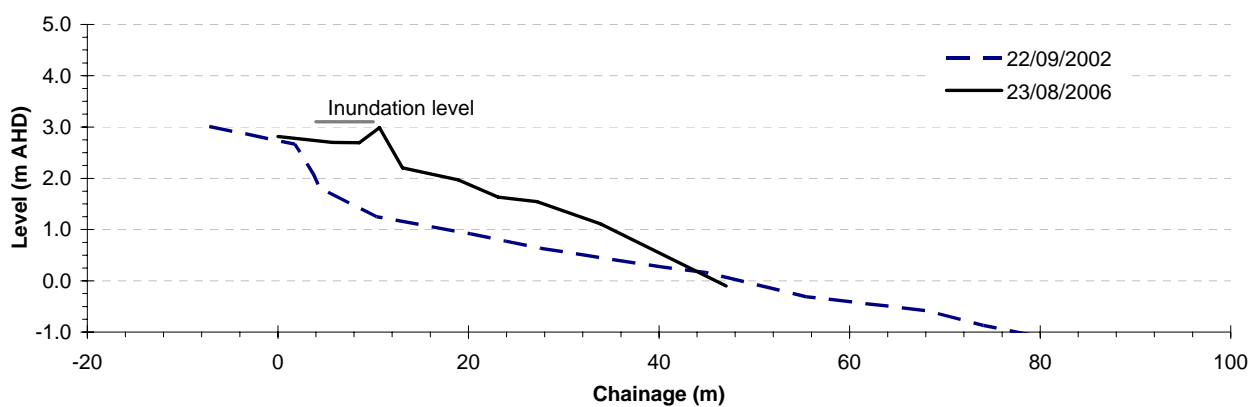
Figure 9. Beach Profile at South Mission Beach.

The site opposite Jacky Jacky Street is close to the location of a toilet block, which has now been removed, where an inundation level was taken in March 2006. The beach at this location was in fairly good condition, with a gentle slope to the water from the base of the rockwall. There appeared to be a new section of rockwall at this location, and the area behind was filled and levelled, with coarse grain sand. The height of this rockwall is approximately 1m high.

The beach profile at the site known as beach profile 9 contained a small crest and swale approximately half way up the beach from the high water level. Sand has been dumped at the back of the beach around the

base of the trees. The beach slope from the small crest and swale to the water was gentle. There was little erosion visible in the area, though the sand dumped around the trees suggests that there may have been some erosion. See Figure 12 for the location of beach profile 9.

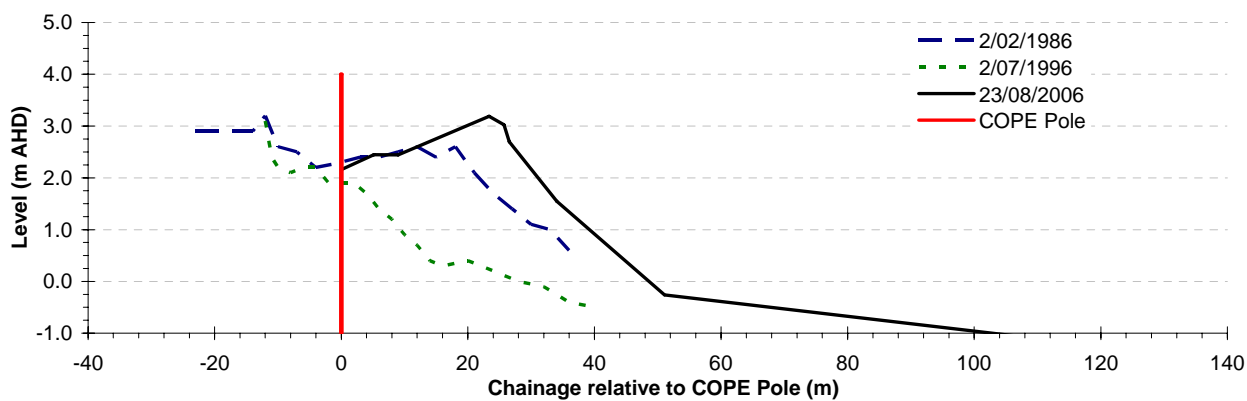
Figure 10. Beach Profile at Hull Heads COPE location.

Hull Heads is located 50km south of Innisfail and faces southeast. A beach profile was taken from the corner of Luff Street, and the undeveloped Goddard Street, which was close to the location of the COPE surveys. During the survey the original COPE pole was located. The site of the COPE pole showed that this beach had been accreting for many years since as the COPE pole was completely within the foredune vegetation, and completely behind the current beach, as can be seen in the photographs in Appendix A.

The beach has a steeper slope than other beaches in the area, which flattens out in the intertidal zone. An erosion scarp of approximately 0.5m high was evident. A number of small sand shoals were present around the Hull River mouth, and there were also some shallow sand bars offshore from the beach at Hull Heads.

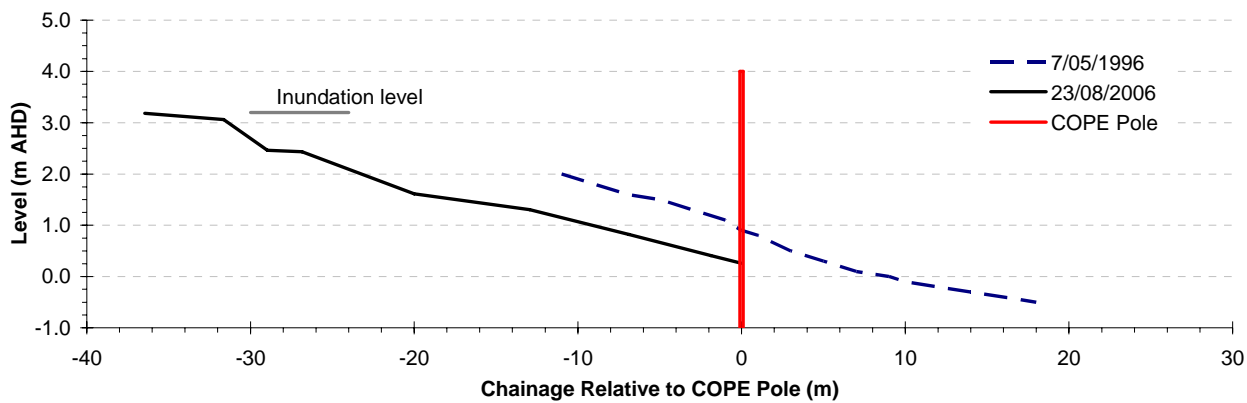
Figure 11. Beach Profile at Tully Heads COPE location.

Tully Heads is located 55km south of Innisfail and faces southeast. The foreshore of the Bedarra View caravan park has retreated approximately 10m inshore of the foredune vegetation. The erosion of this beach has been an ongoing issue for many years. At the time of the inspection it was high tide. The beach exhibited erosion at the vegetation line, to a height of approximately 0.5m. The beach was still littered with debris, mainly vegetation, and there were some large displaced rocks sited inland from the vegetation line.

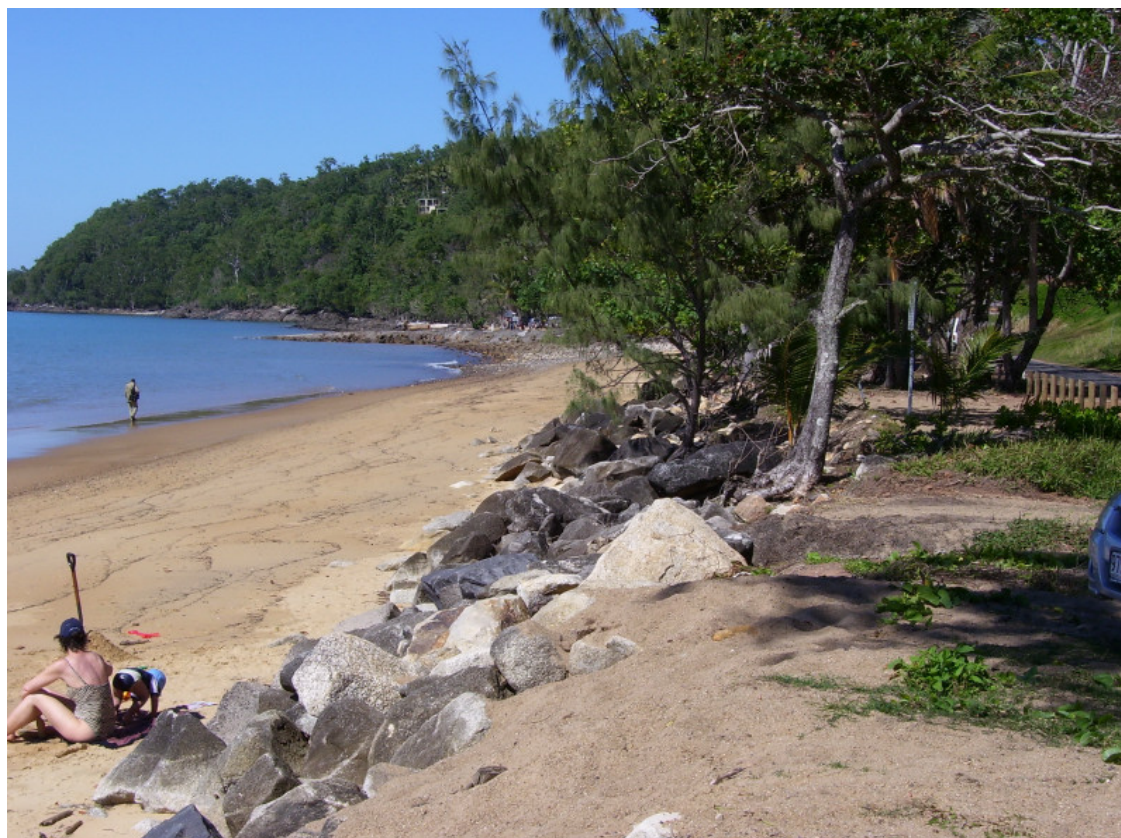
Looking south from the intersection of Kennedy Esplanade and Jacky Jacky Street. Graded area on the right side middle of the photo, is the probable location of a removed toilet block.

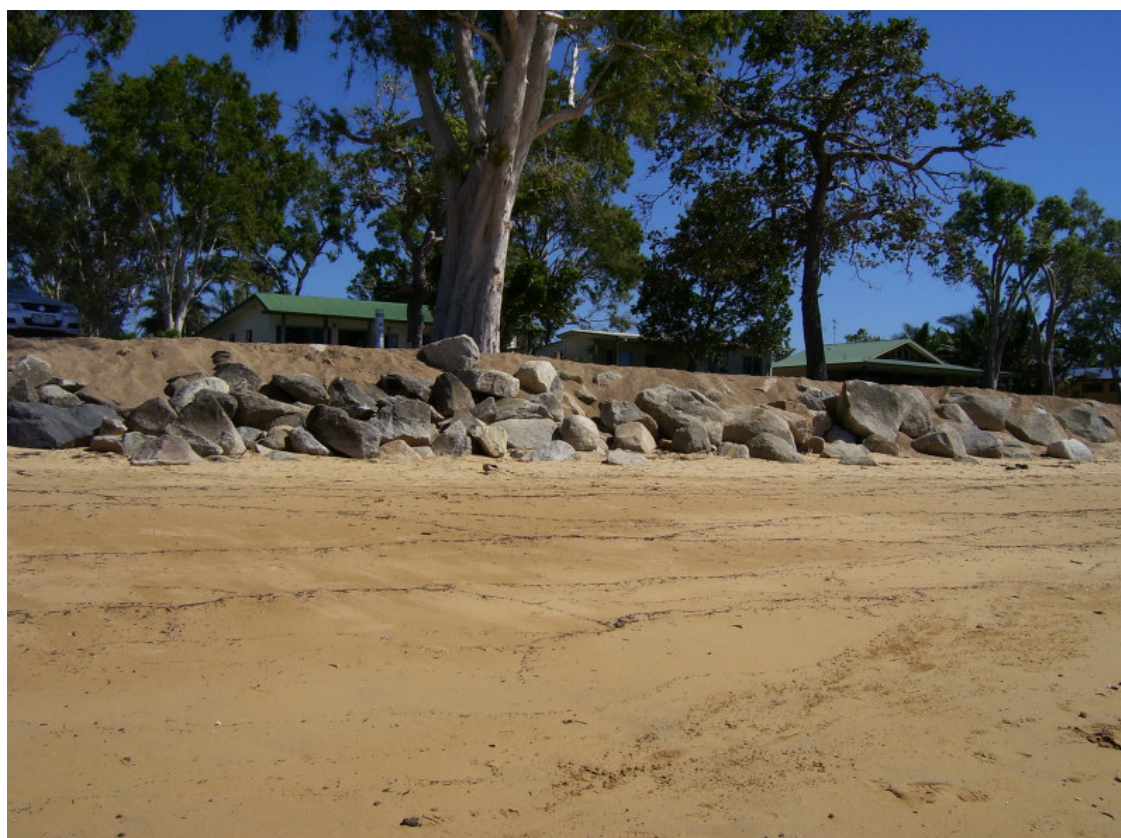
Rockwall constructed along Kennedy Esplanade opposite Jacky Jacky Street. The area behind this rockwall has been filled and graded.

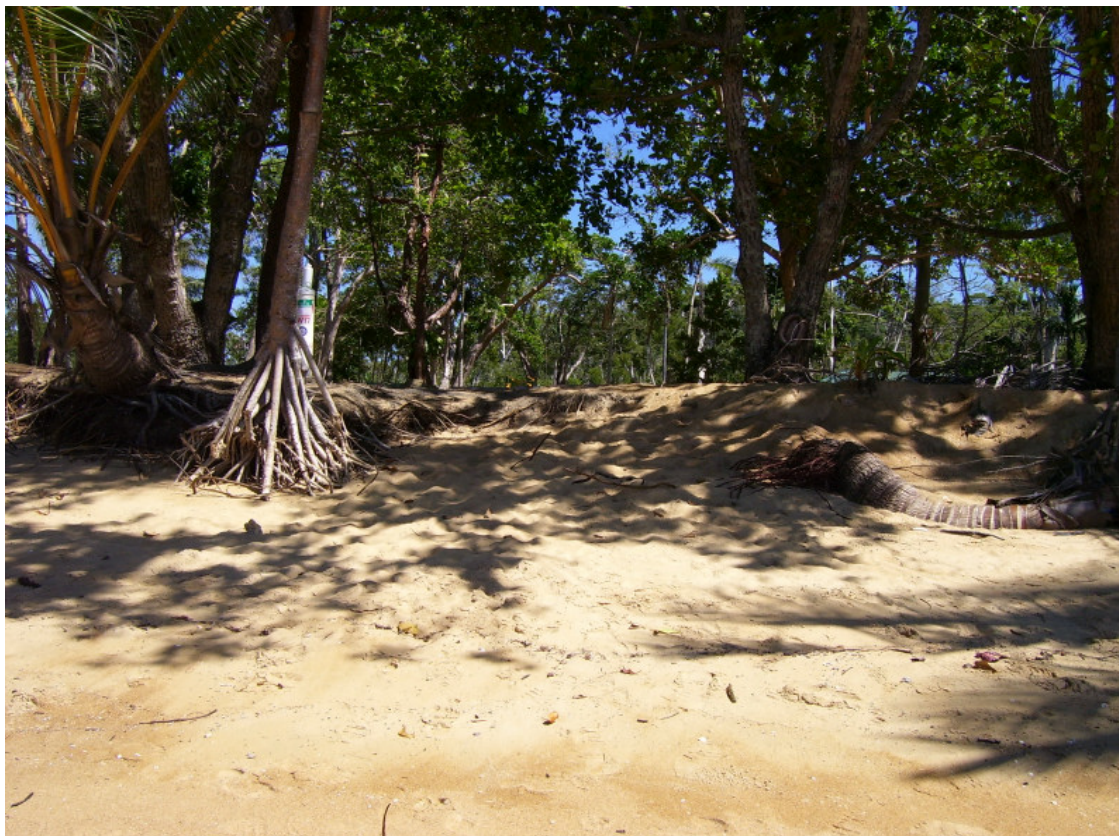
The erosion scarp present at Wongaling Beach – southern end

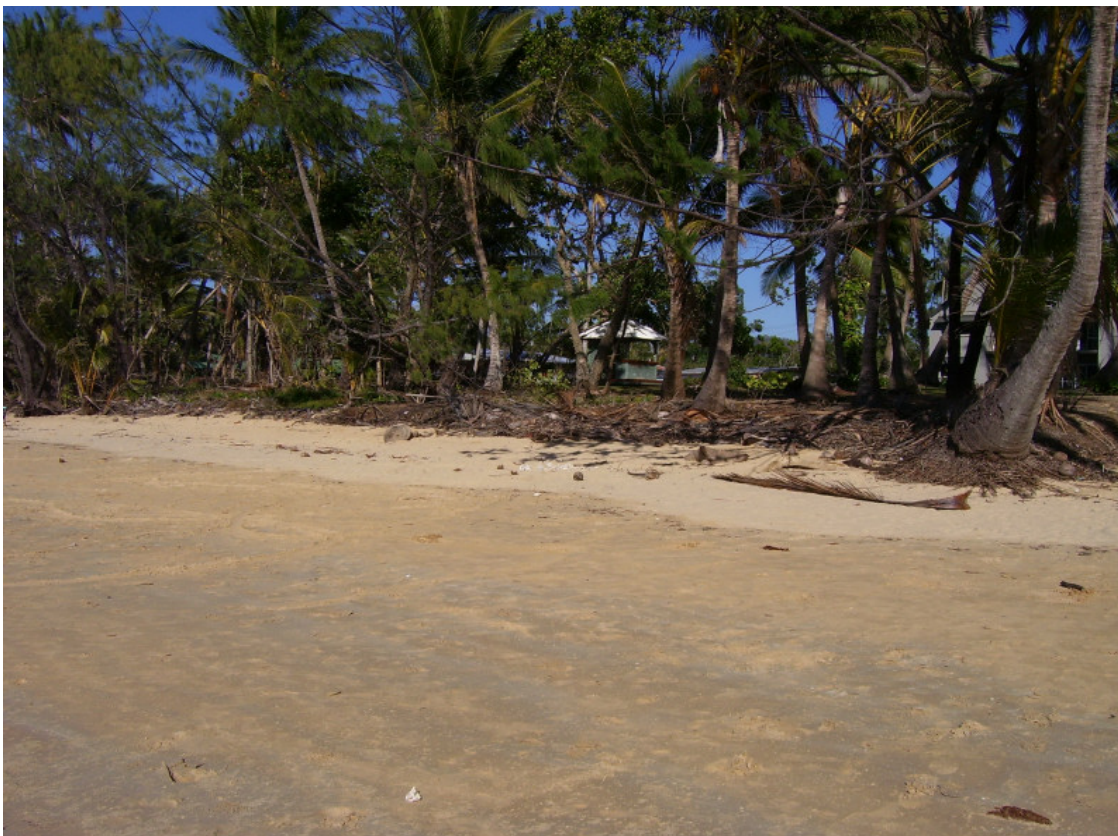
Looking at the debris and erosion in front of Castaways

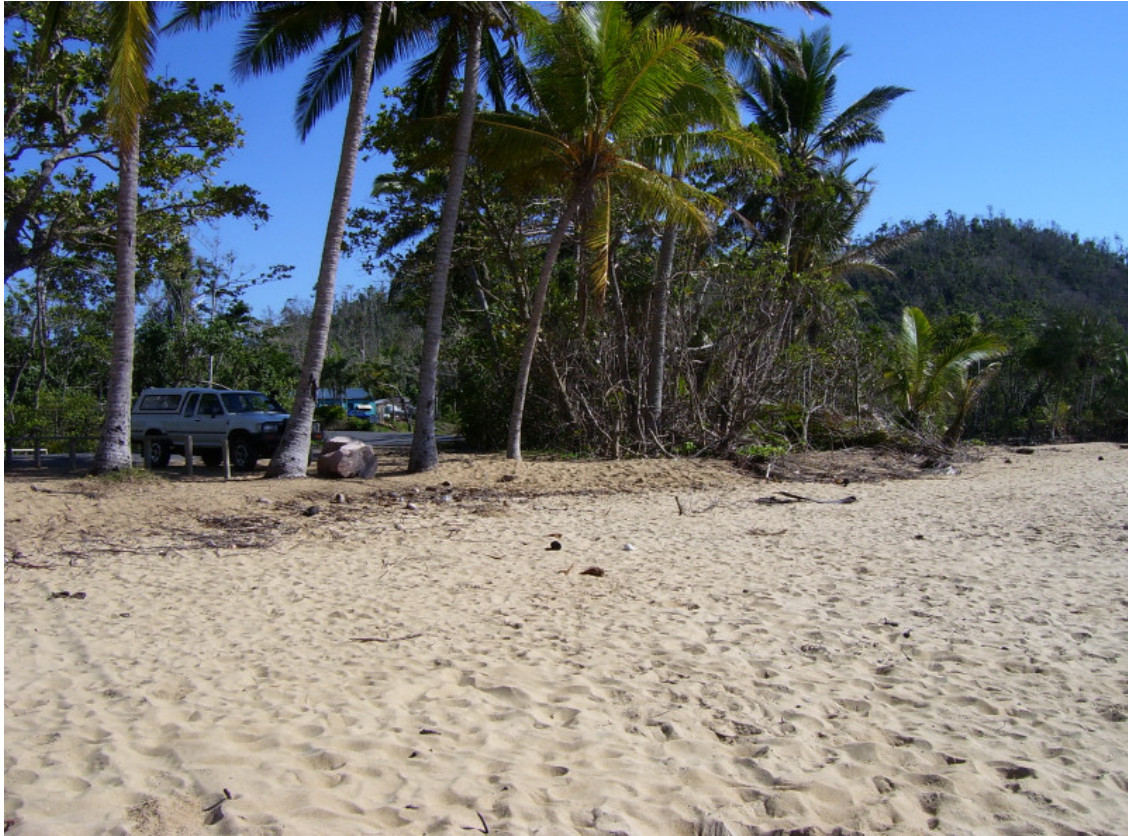
Looking north and the erosion and debris

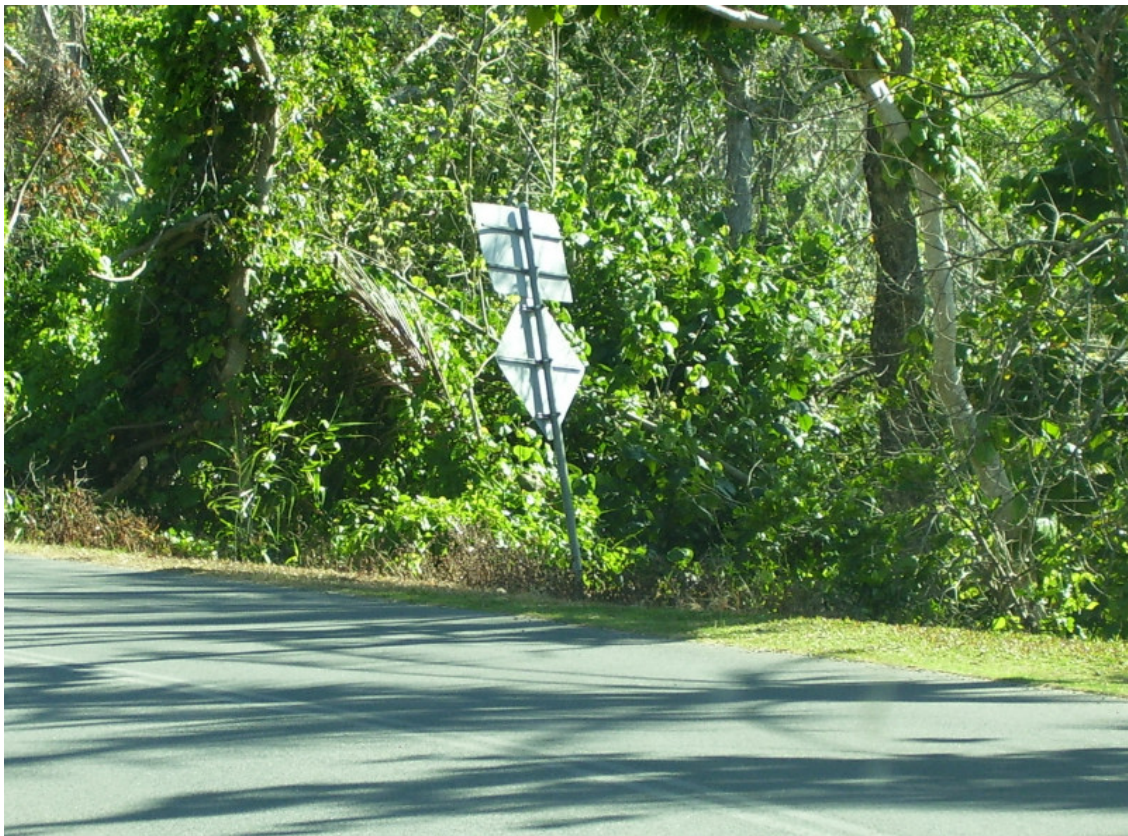
Signpost damaged from the winds, on the northern side of Bingil Bay on the road back to the Bruce Highway

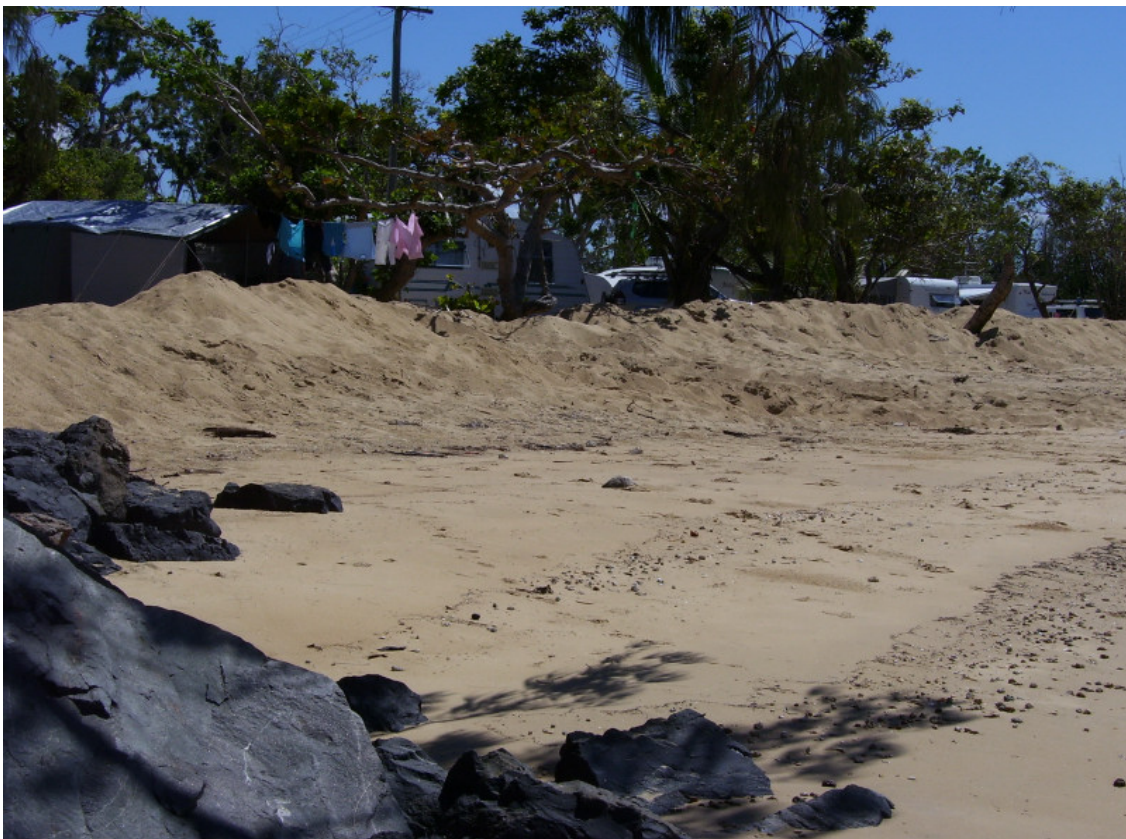
Sand dumped along the vegetation line in front of the caravan park

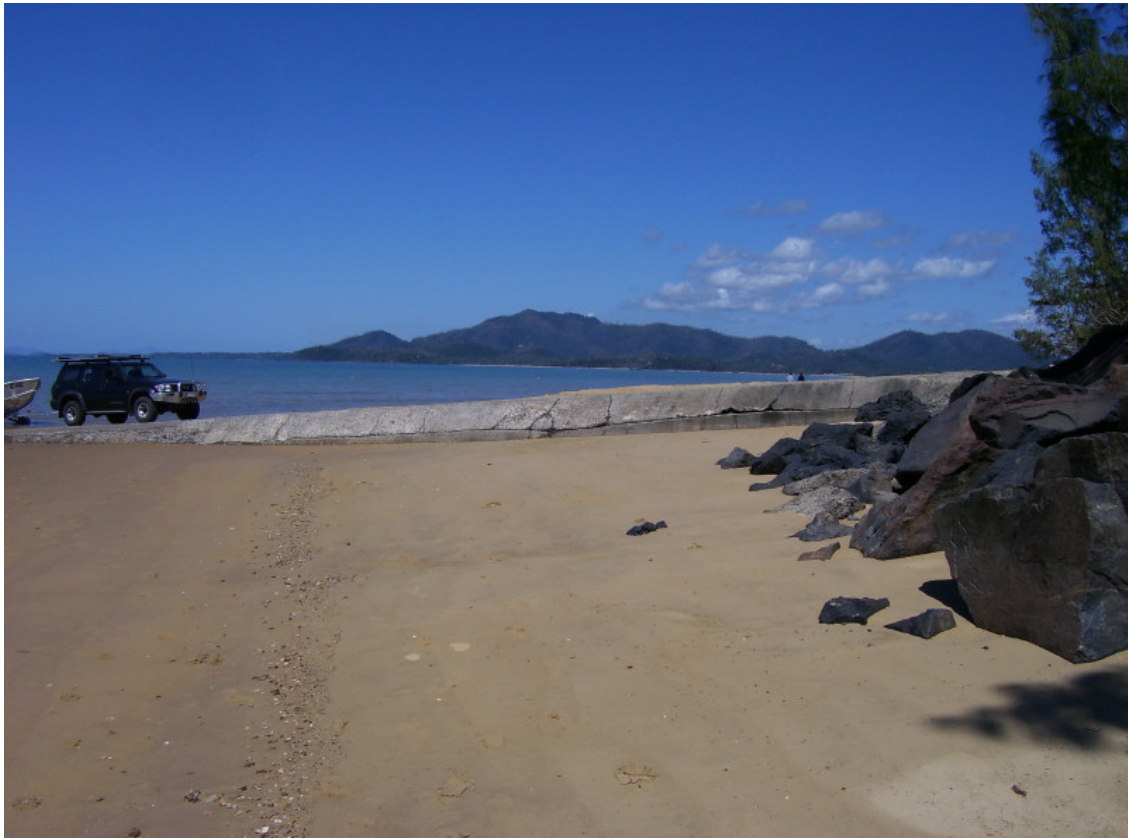
Looking south at the boat ramp, the beach is lower on this the northern side, than it is on the southern side of the boat ramp

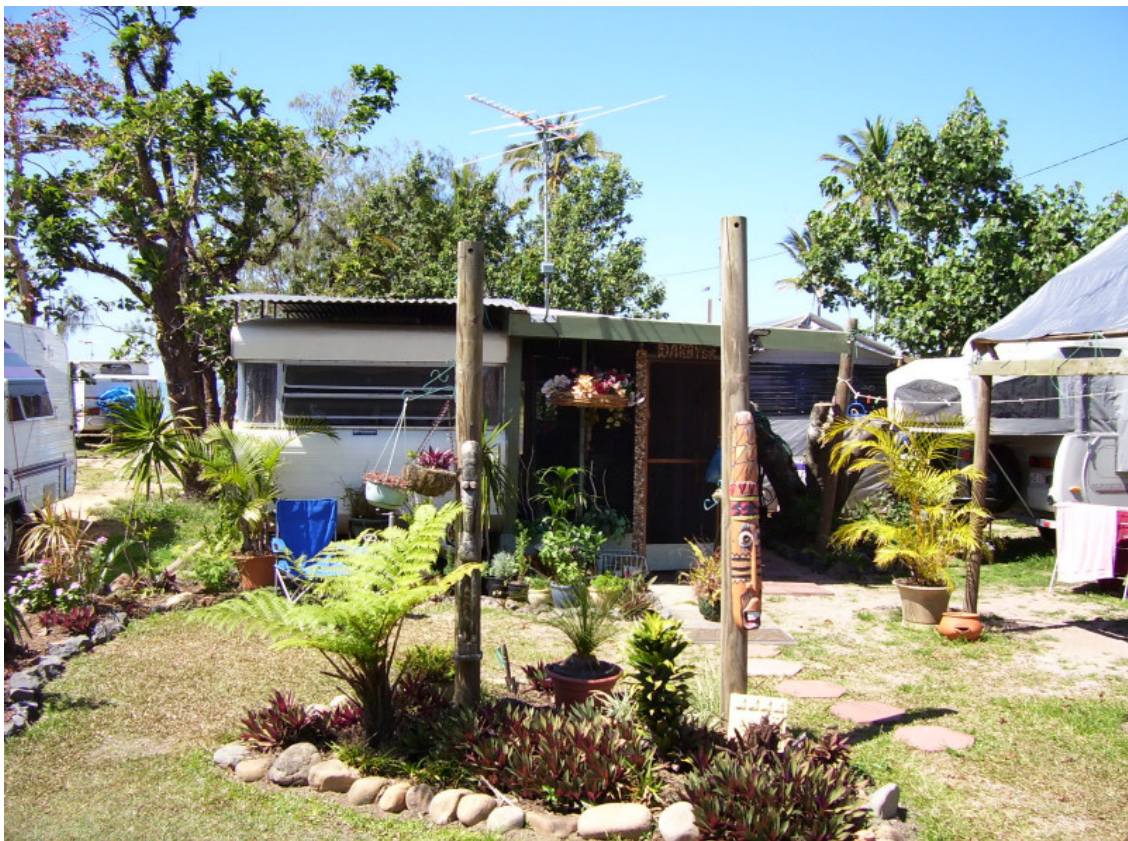
Caravan that survived the cyclone, while one next to it was completely destroyed

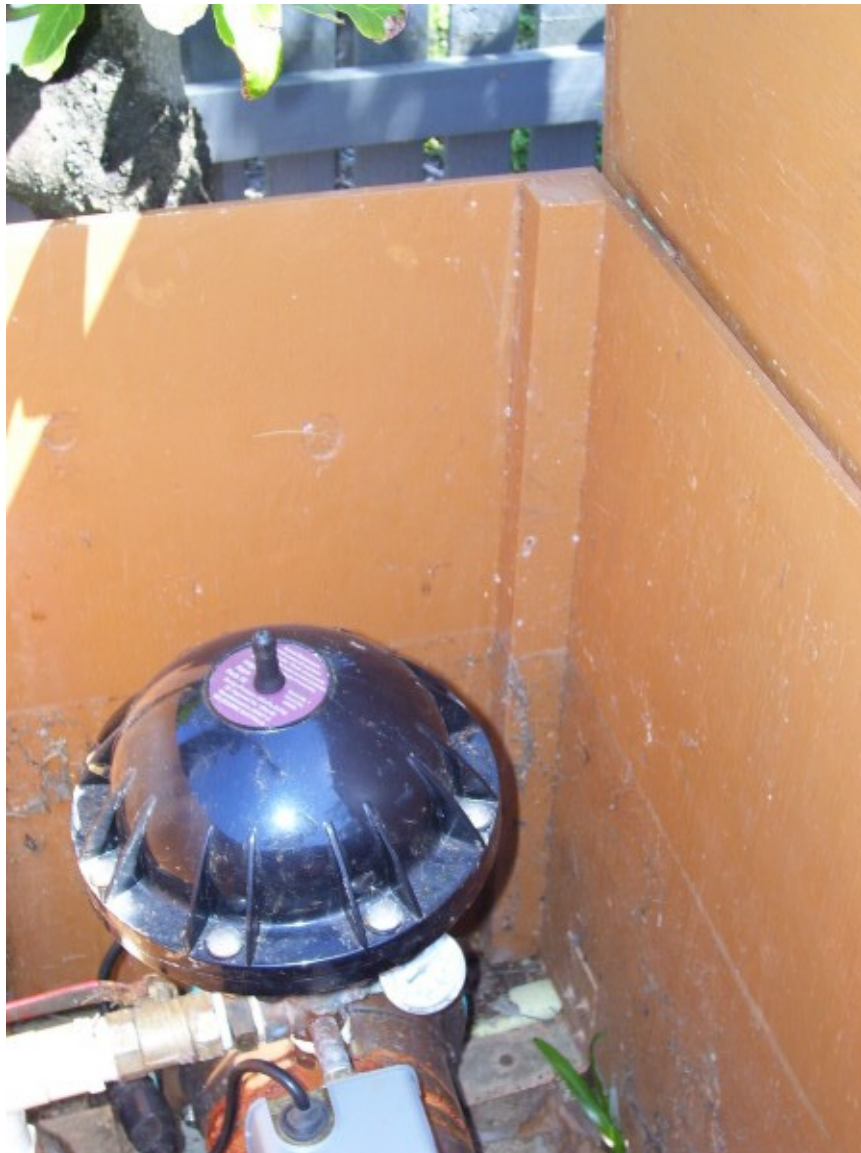
Water line in pump box in back yard, opposite the caravan park on Bambrook Avenue

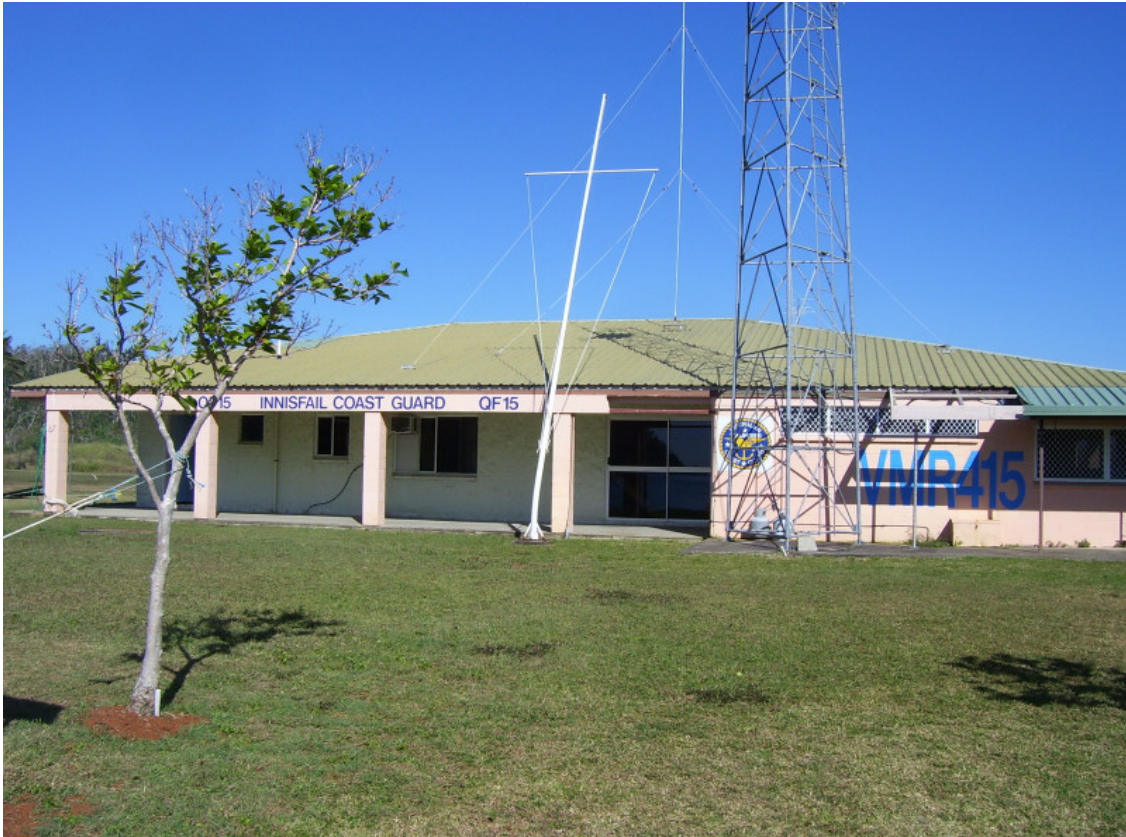
Mourilyan Harbour is sited just south of Innisfail and in close proximity to where TC Larry crossed the coast. Mourilyan Harbour is the site of one of Queensland's storm tide gauges. The site visit discovered that the flagpole outside the new Mourilyan Coast Guard building was bent close to the base. Photographs of this flagpole are shown in Appendix A.

Coast Guard building at Mourilyan Harbour, the flagpole has been structurally damaged by the cyclone, notice the tree in the foreground has also been damaged and is at a similar angle to the flagpole

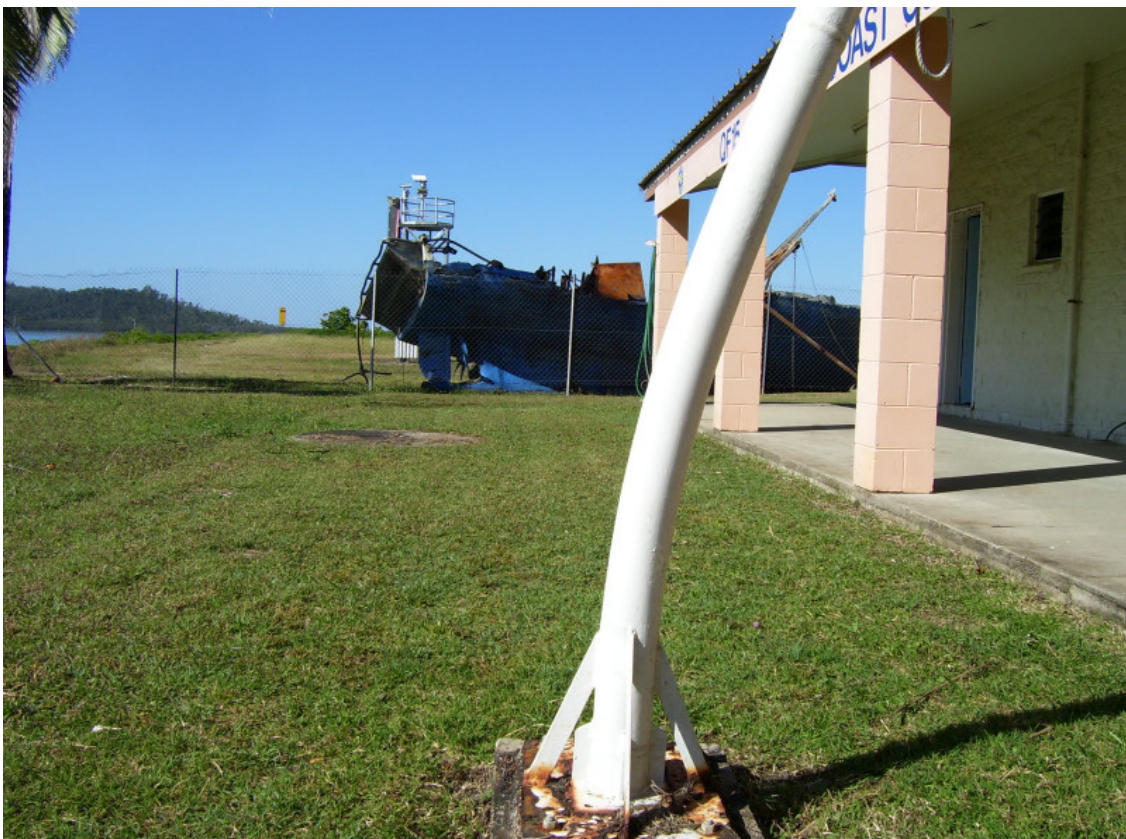
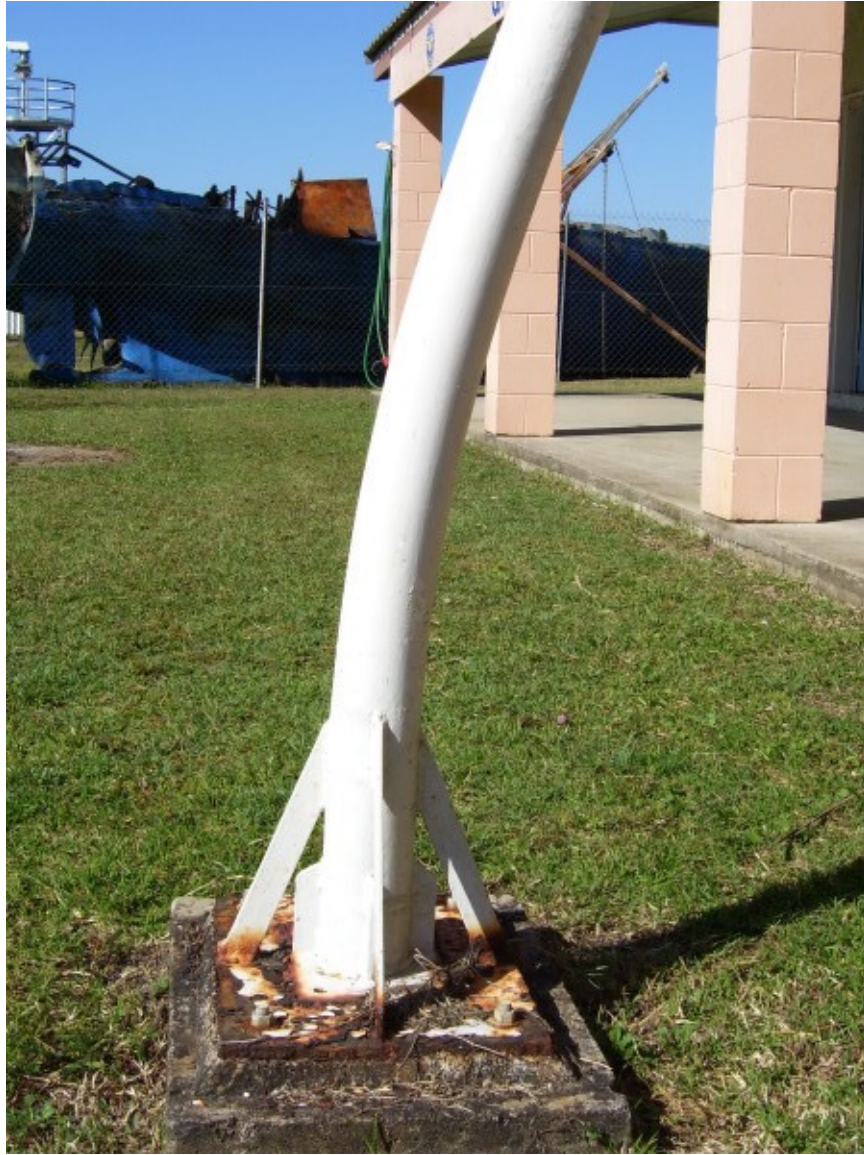
A close up on the flagpole outside the Coast Guard building at Mourilyan Harbour

Close up of the flagpole, outside the Coast Guard building at Mourilyan Harbour

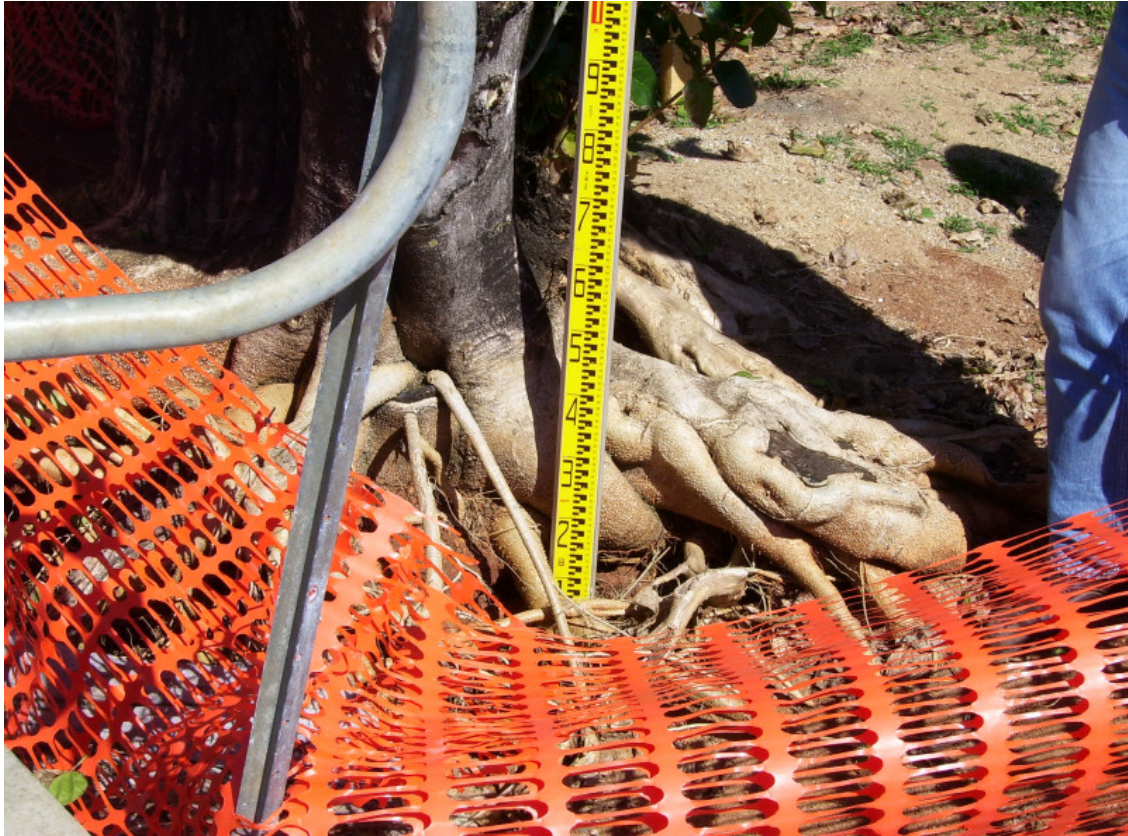
Tree outside the toilet block, where a scour mark was surveyed in March, it is evident that erosion has occurred around the roots of the tree

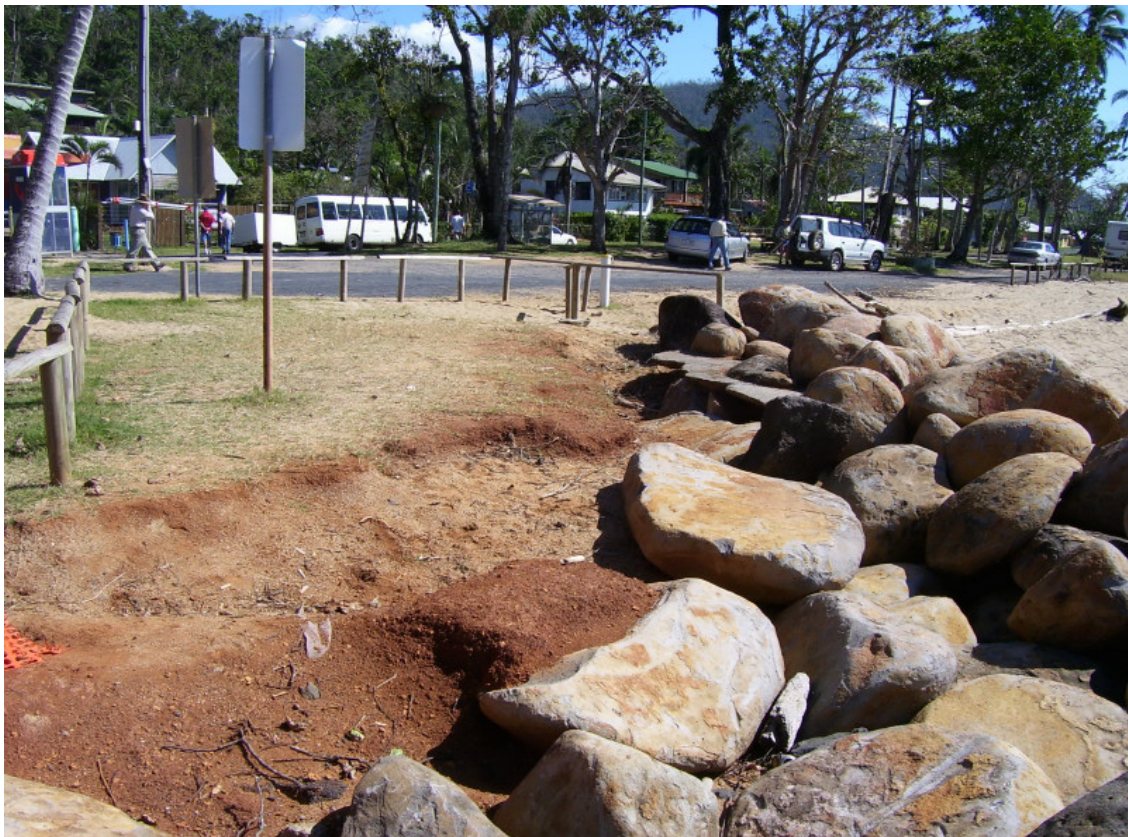
The rockwall at the northern end of Flying Fish Point was in good condition. There was erosion behind the rock, though this was not as significant as the erosion behind the wall at the toilet block to the south. The erosion behind the wall is about 0.2m to 0.3m in depth, and is a narrow strip of erosion. The beach here was in a good condition, with a gentle slope into the intertidal zone. No sand bars or shoals were evident at this location.

Erosion behind the rockwall outside the toilet block and the southern end of Flying Fish Point
