Tropical Cyclone Larry

Supplementary Coastal Field Investigation

Coastal Sciences technical report

April 2007

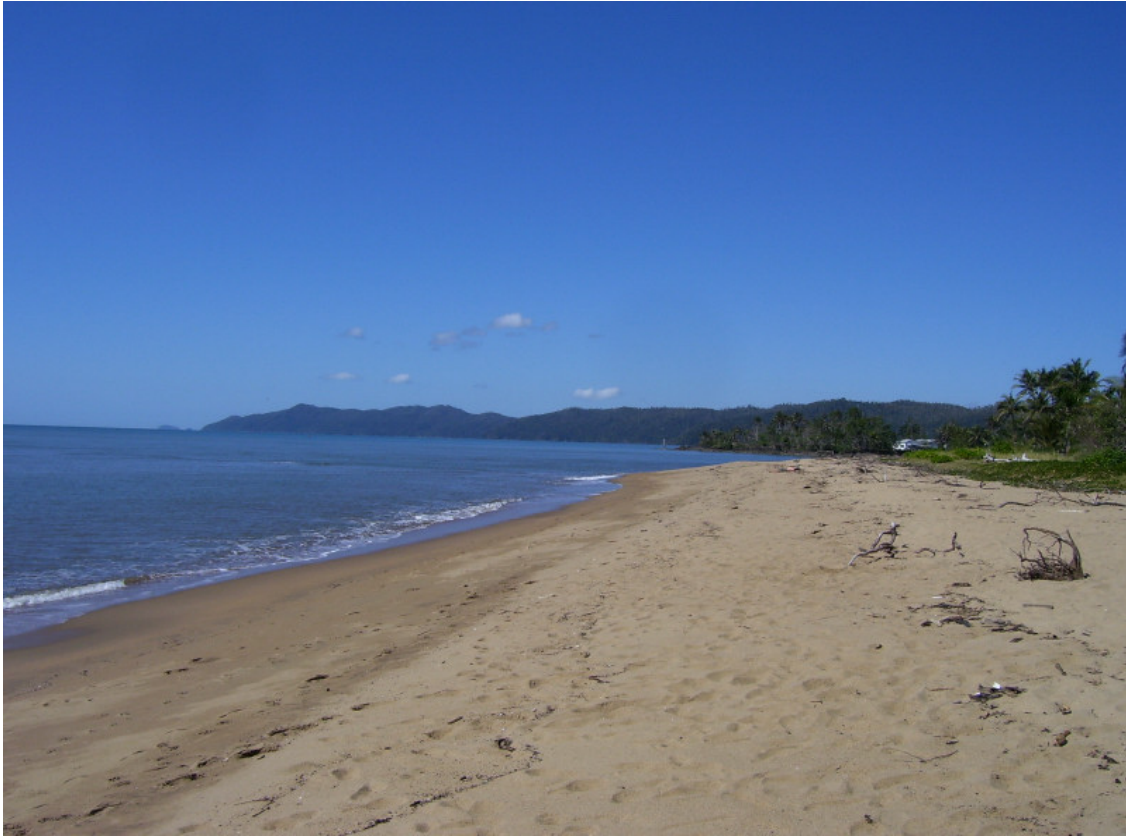
Looking south from Beach Access 3, a sand bar is noticeable in the middle of the photo, by the change in the wave patterns

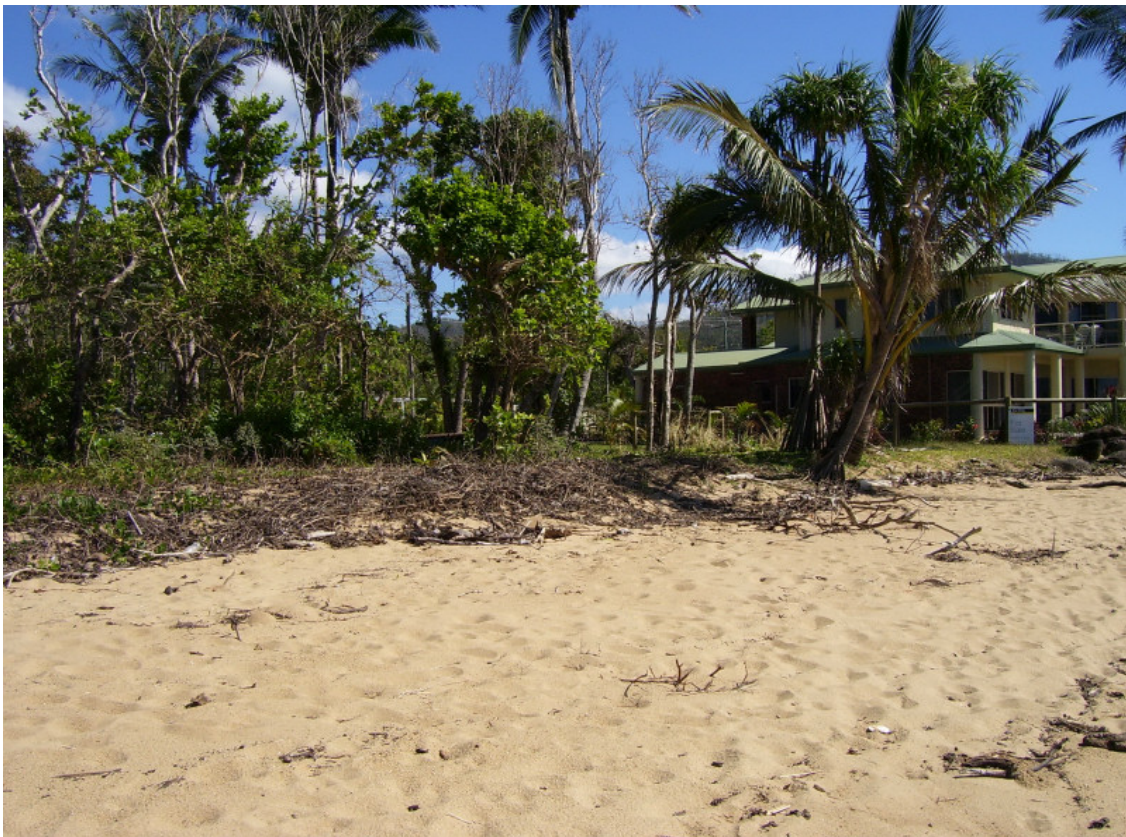
The beach at Beach Access 3 was again in a good condition, with a fairly steep slope from the mid beach to the intertidal zone. The upper beach was relatively flat. An erosion scarp was present and is approximately 0.5m high, and there was debris present at this location, and further down the beach as well. A shallow swale was evident to the south, just in front of the vegetation line. The offshore sand bars and near shore shoals were again present.

Looking towards the northwest from Beach Access 3, an erosion scarp of approximately 0.5m is evident, as is the debris
