# Report: Level 1 emergency exercise

**Exercise location:** Anglo American Aquila Coal Mine

**QMRS-focused event exercise date:** Wednesday, 13 September 2023

**Mine-focused event exercise date:** Tuesday, 7 November 2023

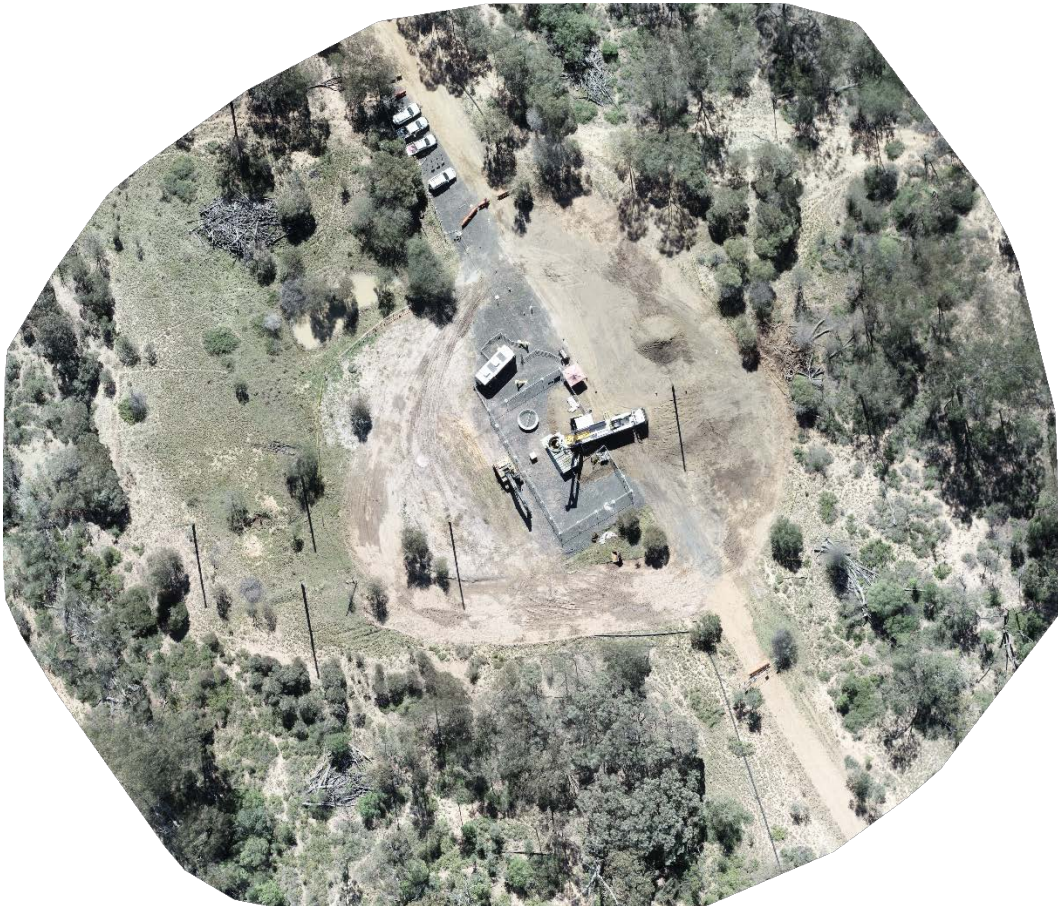
**Figure 6: Initial trials were held at Aquila Mine and risk management controls were in place**

- Continue to resolve SRS1200 (Shaft Rescue System) operational and certification requirements as a matter of urgency. AngloAmerican invested heavily in this system and has the infrastructure on the surface and underground. Unfortunately, the system could not be used for the Level 1. However,

when writing this final report, QMRS has resolved the certification issues, and Aquila Mine has the infrastructure to support training for this critical system for the industry.

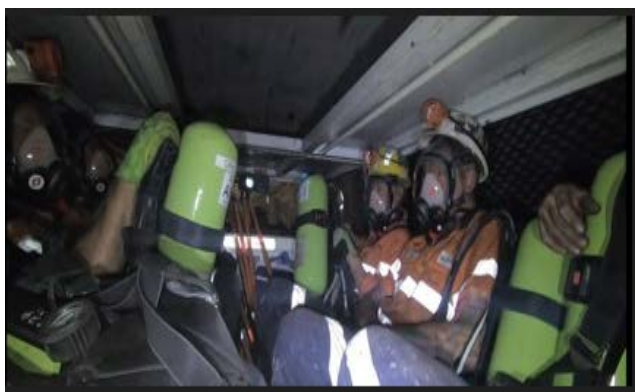
Time	Location	Action/activity / Key Decision/comments
11:56	I got to COB at 56c/t NEM; AMT871 was in the roadway	<p>All CMW left vehicles and entered NEM's 56 ct COB. Stoneworks Crew was in there with the injured person. An ERZC advised the crew they were in fresh air, take off self-rescuer and don CABA. It was congested, I couldn't hear instructions, and there was no room for anyone to work with the casualty on a stretcher.</p> <p>Mine rescue personnel and our crew assisted and helped with the casualty. Personnel were gathering around and a little confused about the next steps. The 801 crew vehicle driver in AMT904 was getting impatient and was beeping the horn.</p> <p>Casualty CMW carried to AMT871, where 801 mine rescuer crew assisted in loading the patient into Driftrunner. Stretcher brackets were taken from AMT904. I'm unsure if it was because there was none in CM871 or because CMW didn't know their location.</p>

Figure 17: CMWs self-escaping in personnel transport

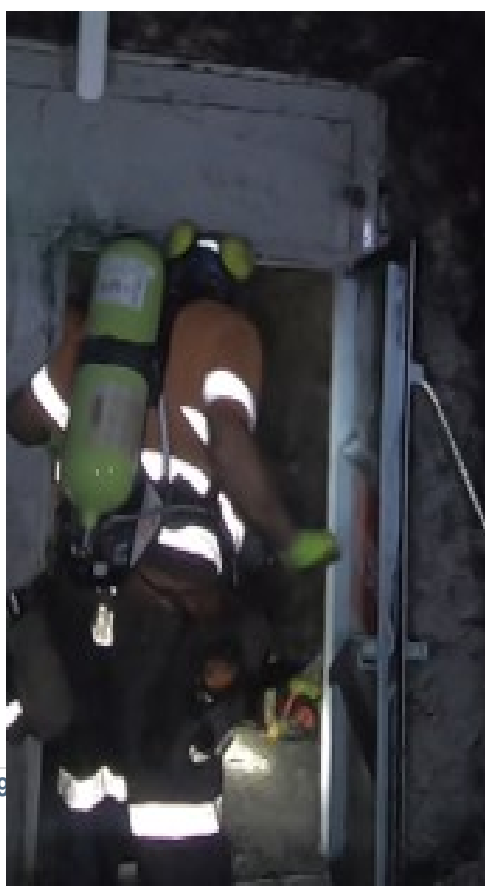
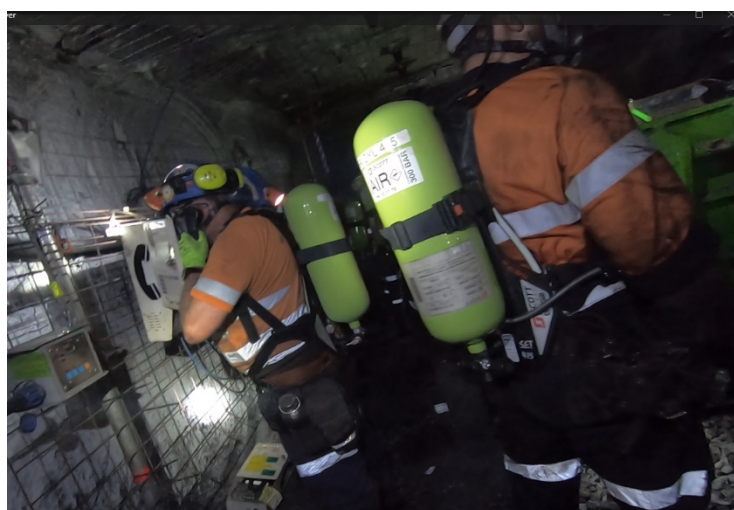
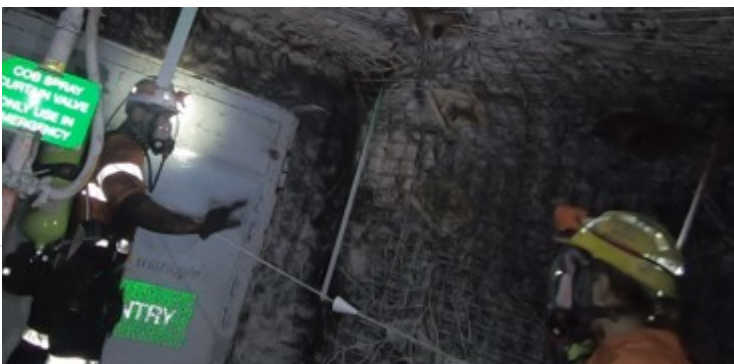
Time	Location	Action/Activity	Key decisions/comments
12.20	58ct COB	Top-up air for CABA Contact CRO	The air top-up was done well and in an orderly manner. ERZC, knowing the difficulty of hearing on the phone, decided to turn the ventilation air off inside the COB, which made a big difference. ERZC contacted CRO, discussed who, status, injured person, location, and fire, and established a plan. CMW's collected a spare CABA for the injured CMW who remained in the Drifty Patient status checked regularly - good.

**Figure 18: Better control and discipline were shown with this crew at 57 ct COB.**

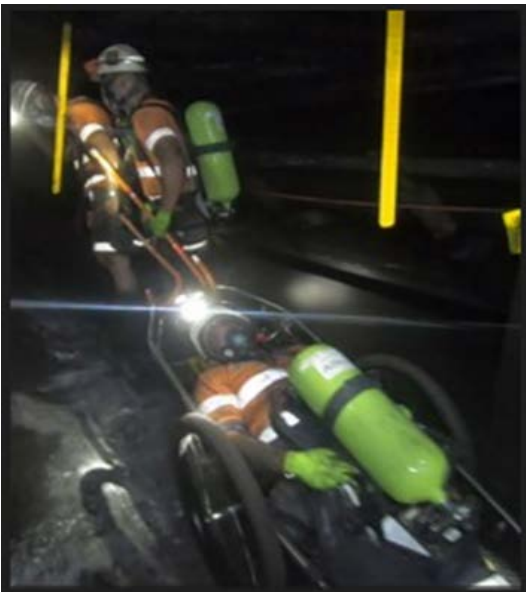
From NEMs 26ct COB, the exercise scenario required the escape to continue on foot on the belt road. The CMW with the sprained ankle was placed in the wheeled stretcher and the escape continued on foot. Negotiating the narrow walkway in the belt heading proved challenging but not impossible. When the crew arrived at the next outbye COB at Aquila Mains 23 ct, some CABA suit whistles had sounded. Additionally, the crew were showing signs of fatigue.

**Figure 19 Wheeled stretcher patient.**

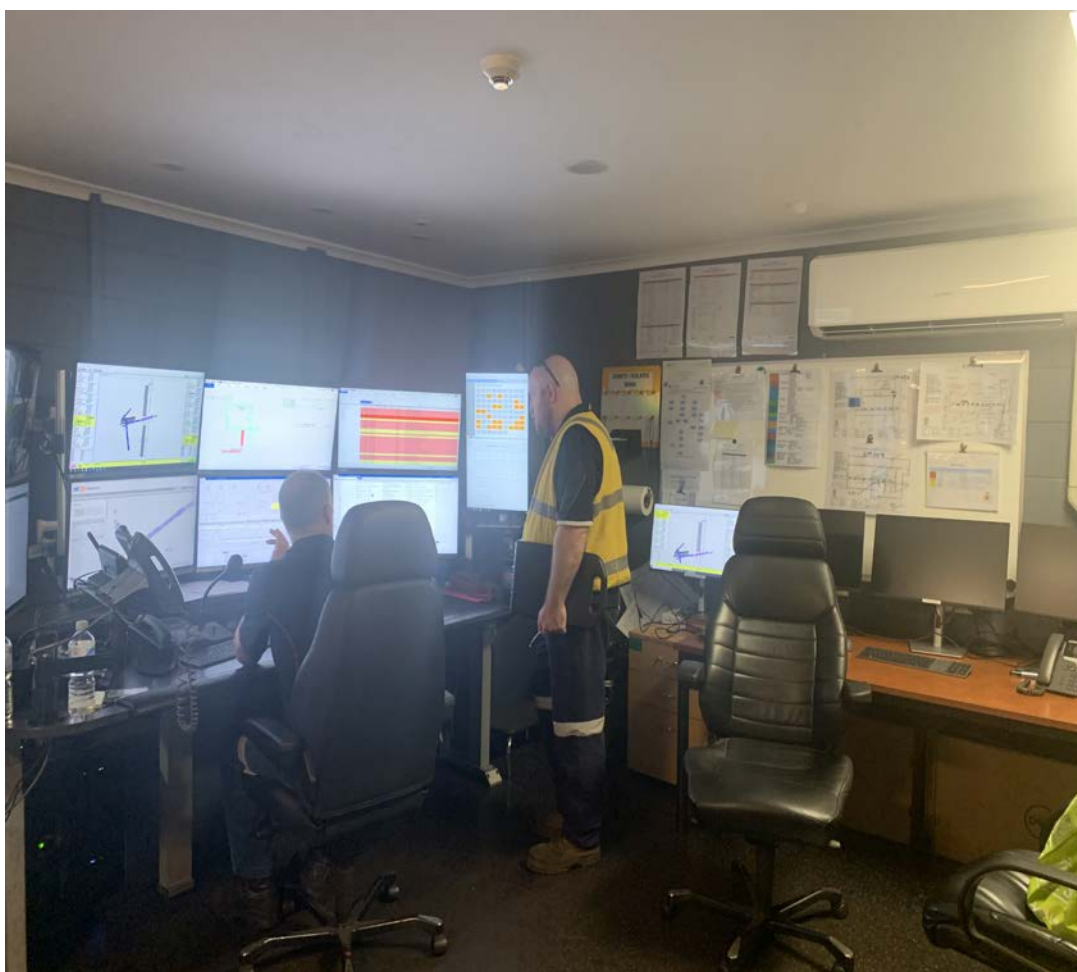
Figure 24: CROs and assessor reviewing information and data in the control room

- Consider creating a Citect page with all the UG belts Dupline lockouts so the CRO can easily visualise people activating lockouts whilst escaping.
- Depending on the particular scenario, when Tube Bundle CO readings go over range, another person with gas chromatograph (GC) training could start testing bag samples from those locations to get accurate readings, which happened after the fire was out and near the end of the exercise. CROs might be too busy to do bags.

- Display of helicopter landing pad coordinates somewhere in the control room for when escalating to Queensland emergency services.
- Mine should do more mock exercises with IMT groups and control room practising using EMQNET to become proficient in the system.
- CCTV of the muster area showed that many persons waiting in this area were on their mobile phones. That should be policed to prevent information from being spread across social media.

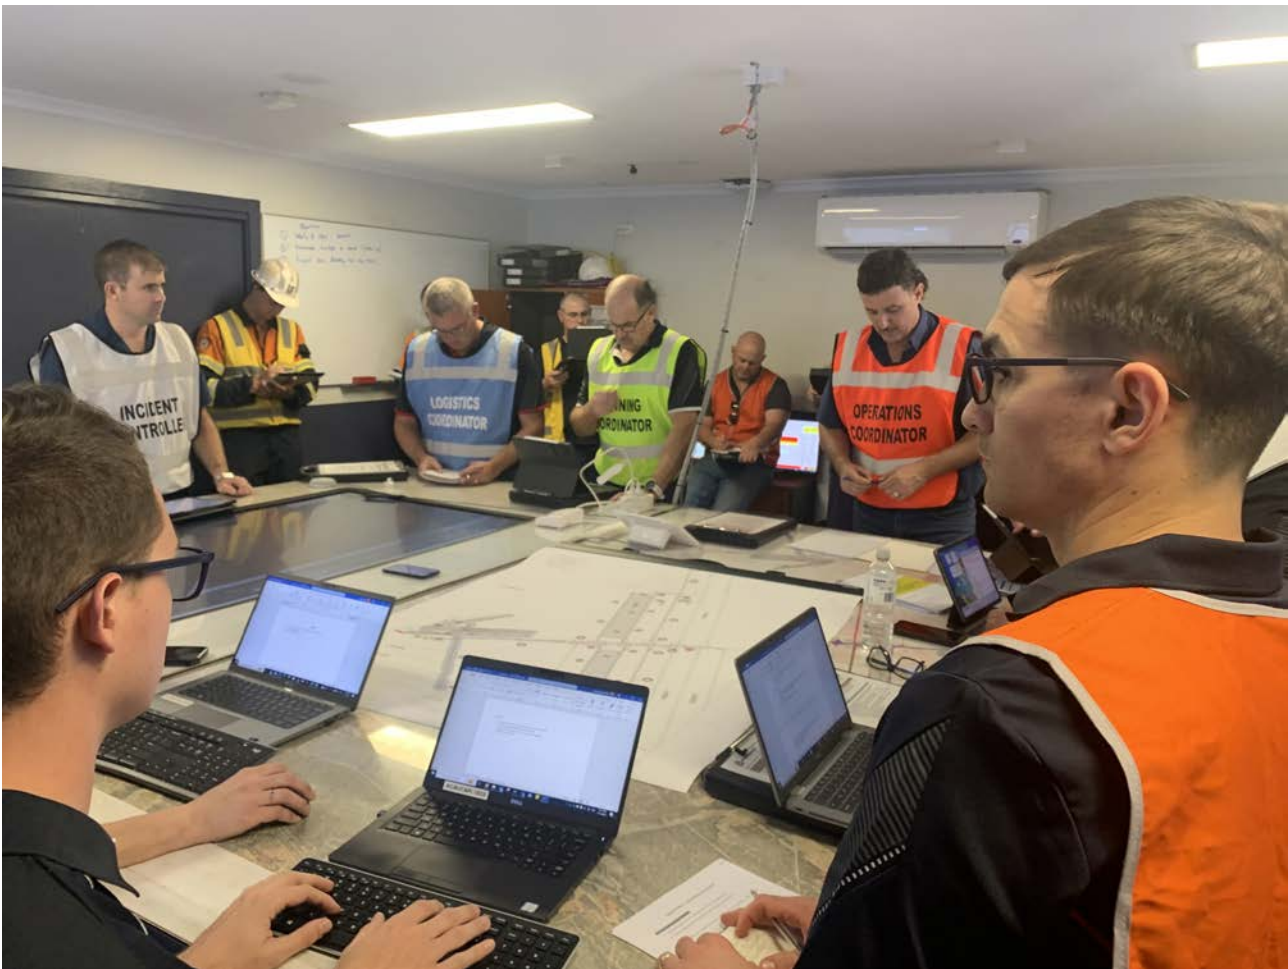
Figure 25: Incident Management Team (IMT) Meeting
