# Metalliferous level 1 mine emergency exercise 2016

## George Fisher Mine

This report is for the 2016 metalliferous level 1 mine emergency exercise held at the George Fisher underground mine between 10.00 am and 2.00 pm on Tuesday 30 August 2016.

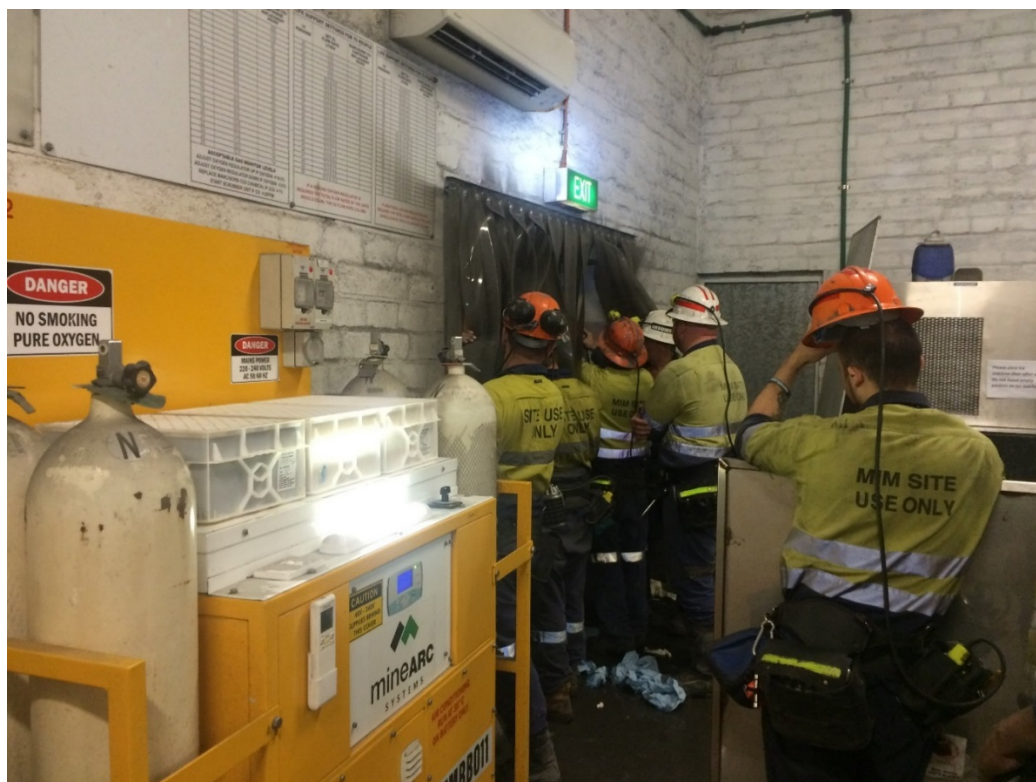
**Figure 4: The 18 level crib room being sealed**

Crib room personnel were advised at 10.56 am that the atmosphere outside was contaminated and smoke was coming into the crib room. The crib room was successfully sealed and the MineARC systems activated so as to form an FAB. There were some difficulties following the process; however, the team persevered and succeeded. Issues were identified about where the charger for the gas monitor in the crib room had been relocated. This interfered with the activation of the MineARC system. Foam expansion canisters could not be activated to seal the crib room door. Paper towel was used instead,

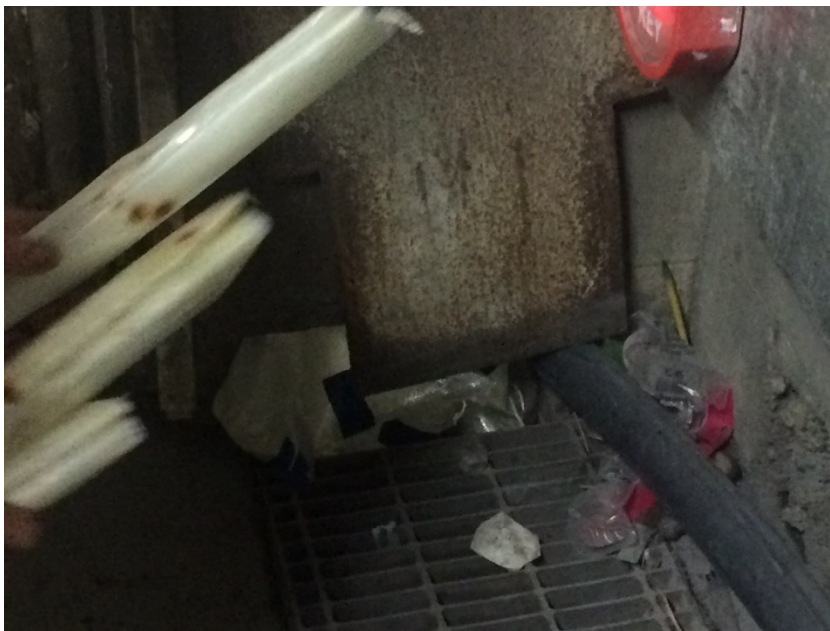
**Figure 5: The 12 level crib room wash basin drainpipe**

This first workers entered the crib room at 10.12 am and started to prepare the room for sealing. It was noted that a drain from a wash basin had been installed in the crib room box drain and this interfered with the installation of the bottom sealing rail. The crew used their innovation and successfully sealed the area using self-expanding gas bags (see Figure 5).

- Installation of a washbasin drain line through the box drain prevented fitting a designed steel plate to seal the box drain.
- When personnel enter a crib room, the common practice is to take off their cap lamps and SCSRs and leave them outside. In an emergency, this separates personnel from their critical safety equipment.

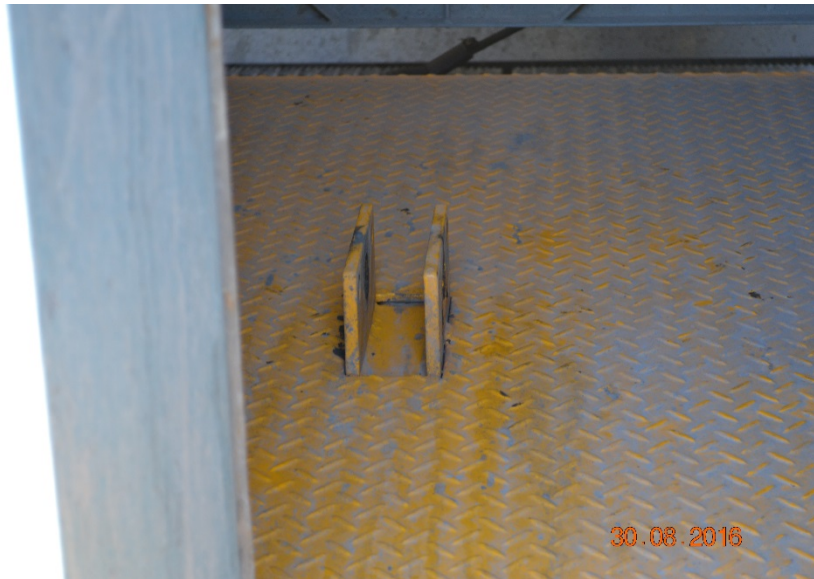
**Figure 7: Floor of man riding in the skip**

During the conversion of the skip and after the floor was lowered, the linkages were detected from the anchor point in the floor. These plates are a trip hazard and if a worker was required to lie on the floor, these plates may impact on them (see Figure 7).

- Review the design of the linkage and attachment points for lowering the floor so that:
  - there is no trip hazards or protrusions on the floor
  - the linkage can be removed for the skip

- the design of the linkage and attachment points for lowering the floor so that
    - there are no trip hazards or protrusions on the floor
    - the linkage can be removed for the skip

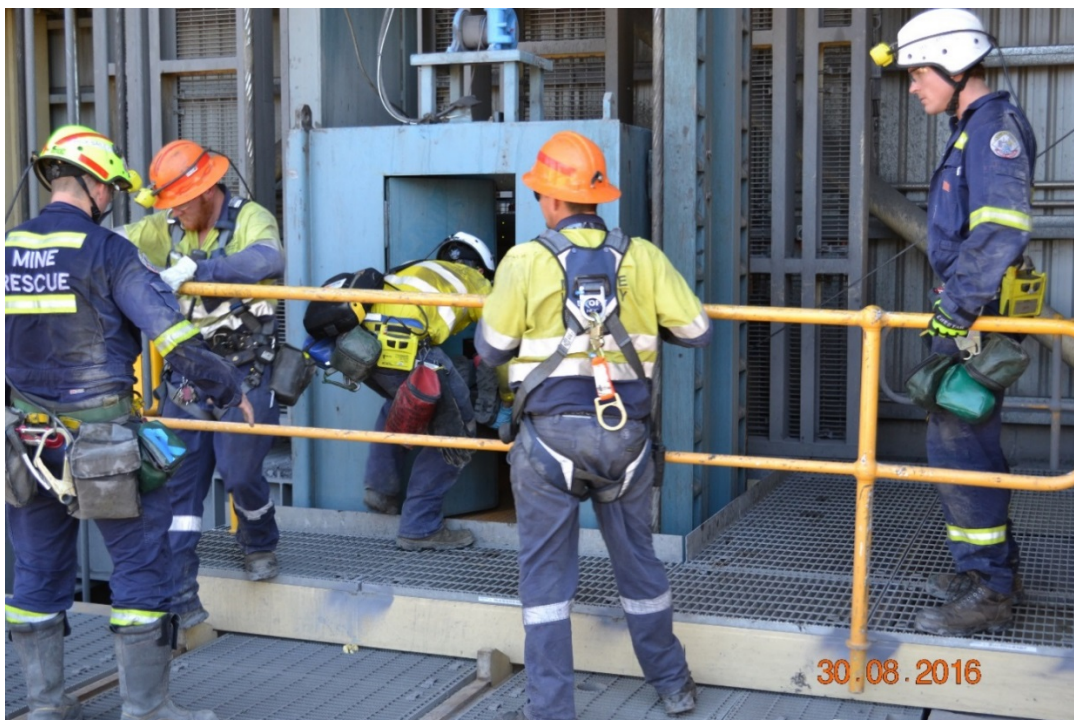
**Figure 8: Skip door issue**

The linkage was then placed behind the door, which impacted on the door opening. As a result, the door only opened approximately halfway, which also impeded people accessing and leaving the skip. This was particularly evident when the ERT tried to get the injured worker out of the skip, to the point where the injured worker (who was supposed to be unconscious) was asked to stand up and get himself out of the skip (see Figure 8).

- Make a section of the kick rail in front of the door removable to allow personnel to access and egress the skip without considering the trip hazard.
- Install a hood over the open area to prevent any potential falling objects from striking personnel in the skip.

- Ensure that access to a skip for emergency egress has doors that are large enough for a stretcher to fit through.
- Have all access doors designed so they do not reduce the floor space, thereby reducing the number of personnel that can be conveyed in a skip.
- If a materials winder is to be used for personnel, have a simple quantifiable way to calculate or measure the load that is on the skip to ensure the overload rating in all drive modes is not compromised.
- Ensure that access and egress from a skip is not impeded by a trip hazard.
