Level 1 Mine Emergency Exercise 2017

Broadmeadow coal mine

November 2017

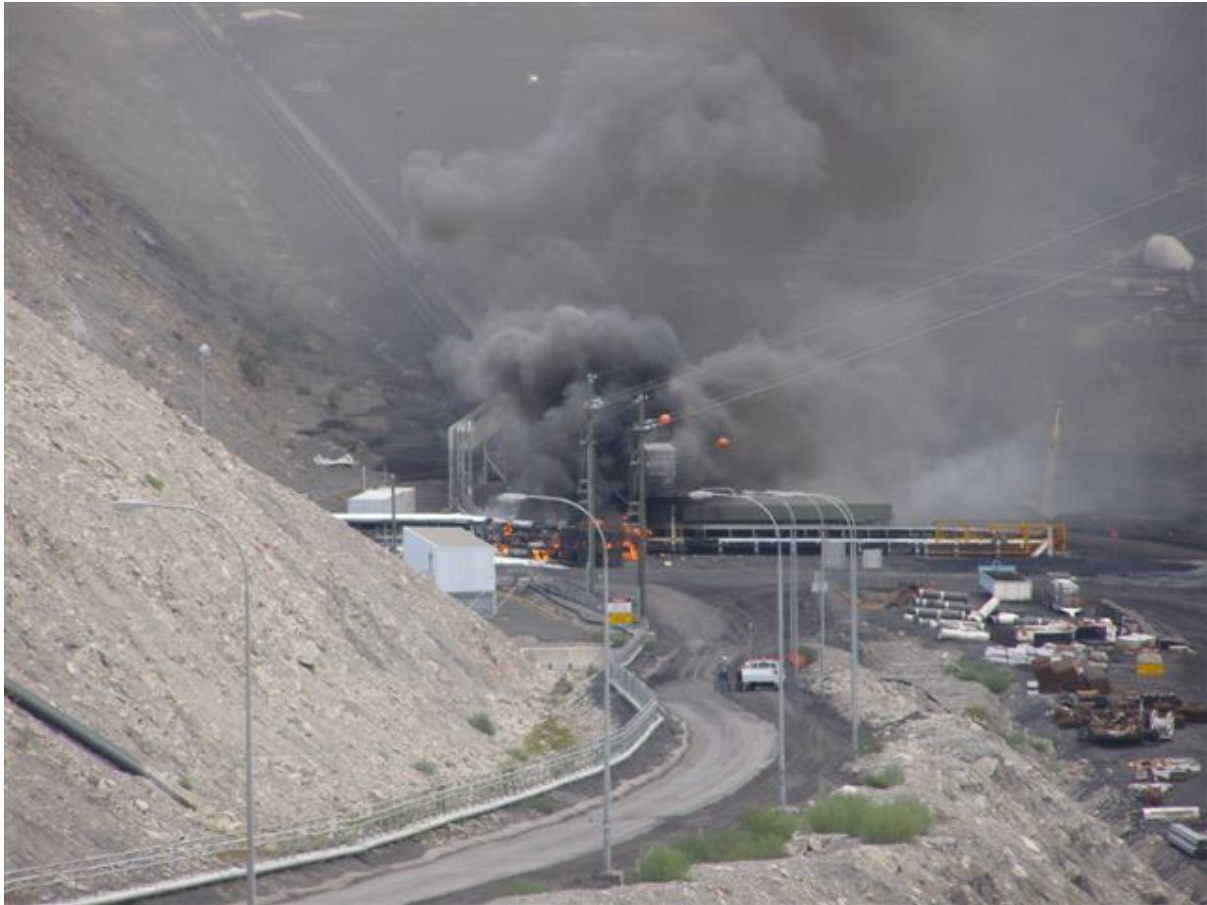
Figure 3 Water truck incident April 2006

The scenario for the exercise was based on an incident that happened in 2006 where a water truck ran away down a ramp collided with the conveyor structure and caught fire. A considerable amount of smoke was created in the bench as a result of that incident. See Figure 3.

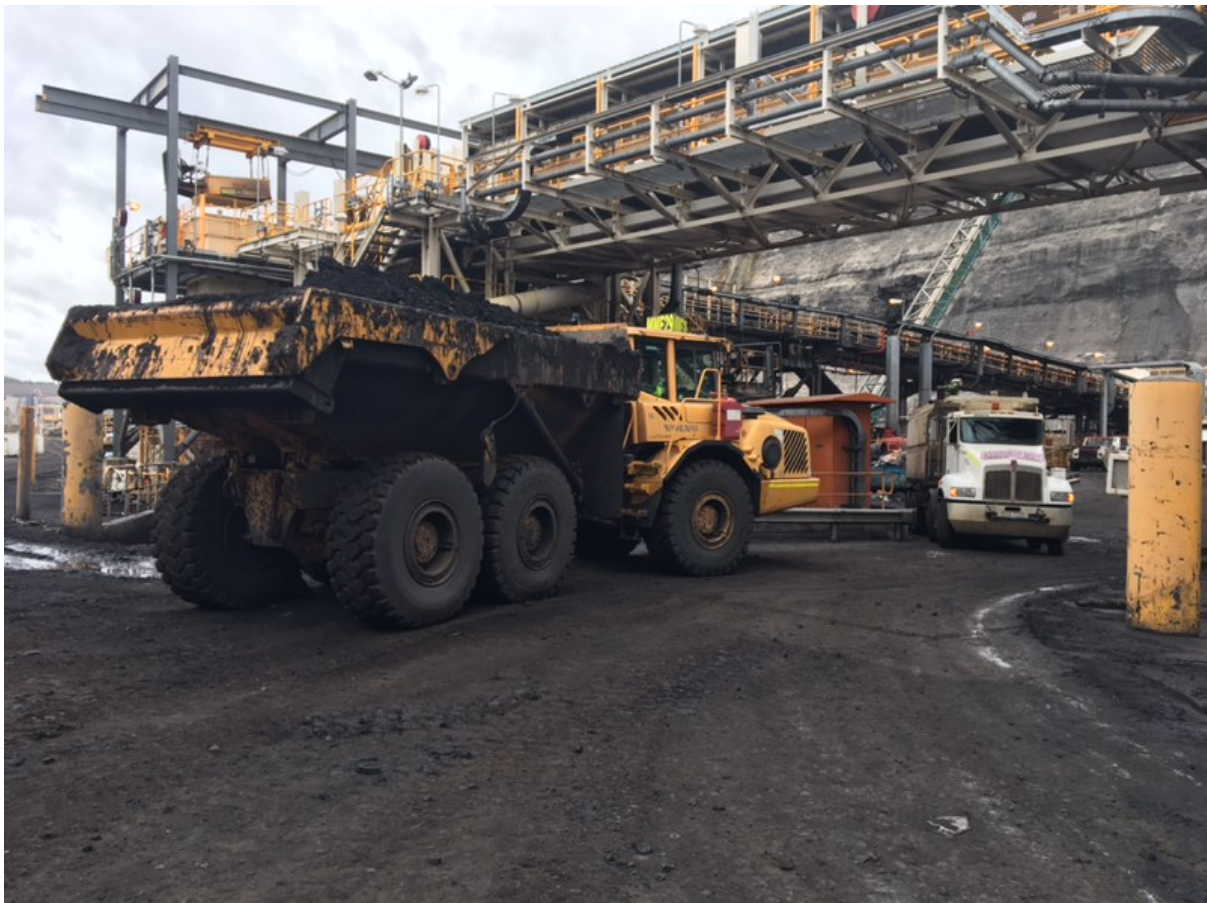
Figure 5 Fire site with Moxy and water truck

A water truck and Moxy truck full of coal were positioned at the required location to add to the reality of the situation. See Figure 5.

Incident commenced at 10am with a collision between a water truck and Moxy truck under the 103 belt underpass adjacent to South Mains portals. Despite initial firefighting efforts by mine personnel the fire escalated and required the deployment of the Goonyella Riverside ERT members to bring it under control. High volumes of irrespirable atmosphere entered the mine and remained within the in-pit area of the mine surface.

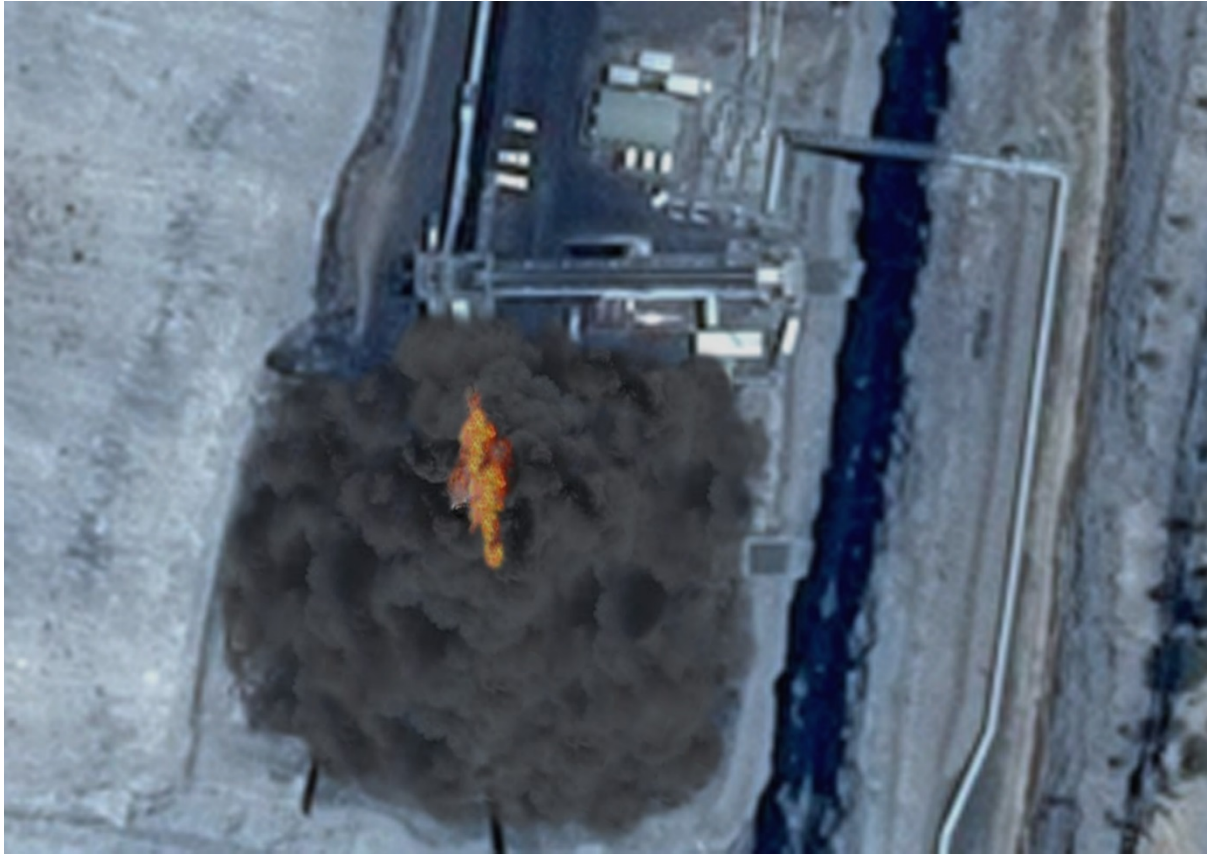
Figure 7 fire and smoke at the peak of the fire

Aerial photographs were also prepared and Figure 7 shows the extent of the smoke for the purpose of the exercise.

All of the underground entries other than the conveyor portal to longwall 12 are engulfed by smoke in this figure.

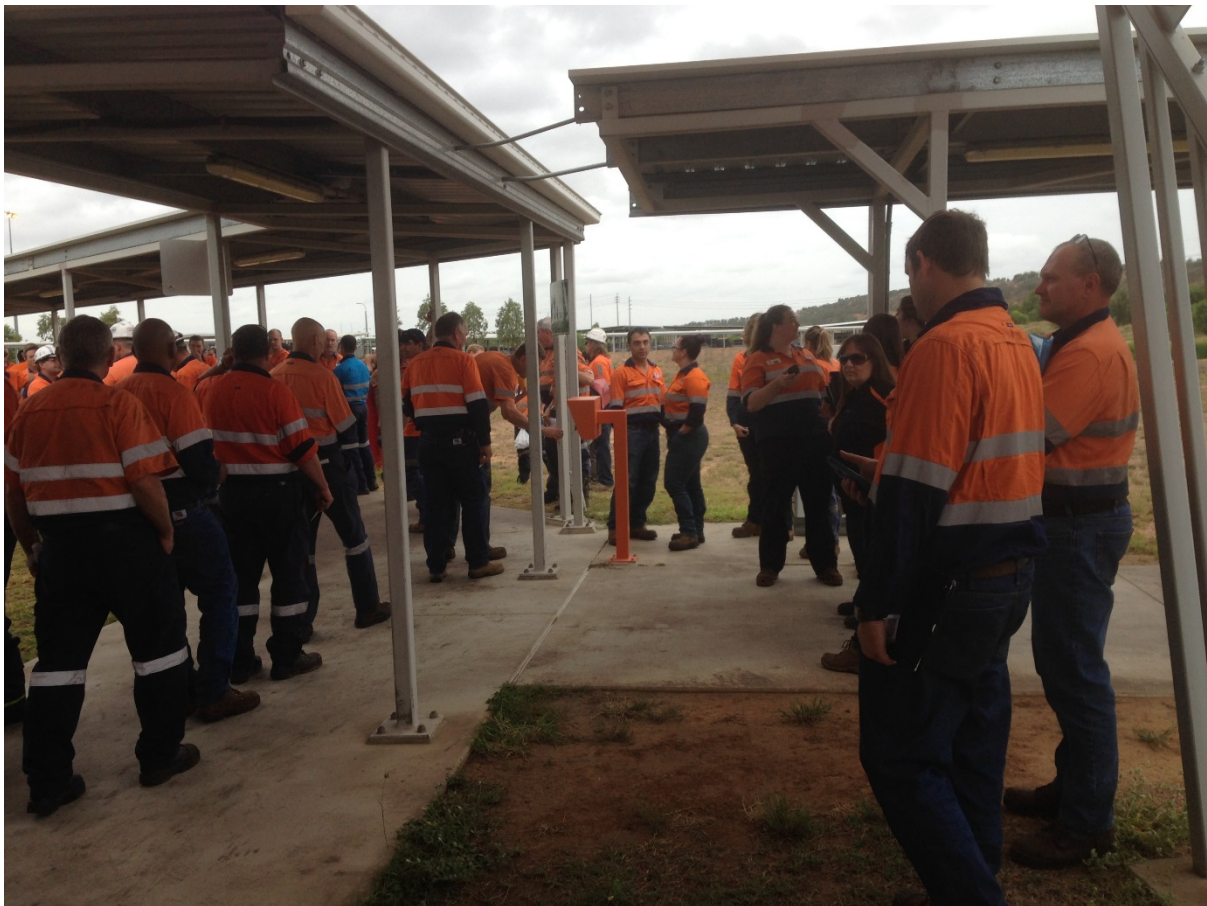
Figure 10 Personnel at the surface tag off location

The IMT formed very quickly after the incident started and personnel were quickly allocated duties as part of the incident management team. When the siren was activated all extra personnel on the surface had to tag off at a location outside the main offices. Various CMWs were selected from this group to assist the different teams in the incident response team. These personnel were left for approximately 40 minutes and were then moved to training room 344B/3B where they were briefed. CMWs were seen on their mobile telephones at several times during this exercise. This would have stimulated the input from social media. The site tagging system is called TAMS and there was an issue with the system account for personnel on site. At one stage the whole of the group in the holding area had to come back and tag on/off on the system to assist in the process of identifying who was where on the surface. See Figure 10.

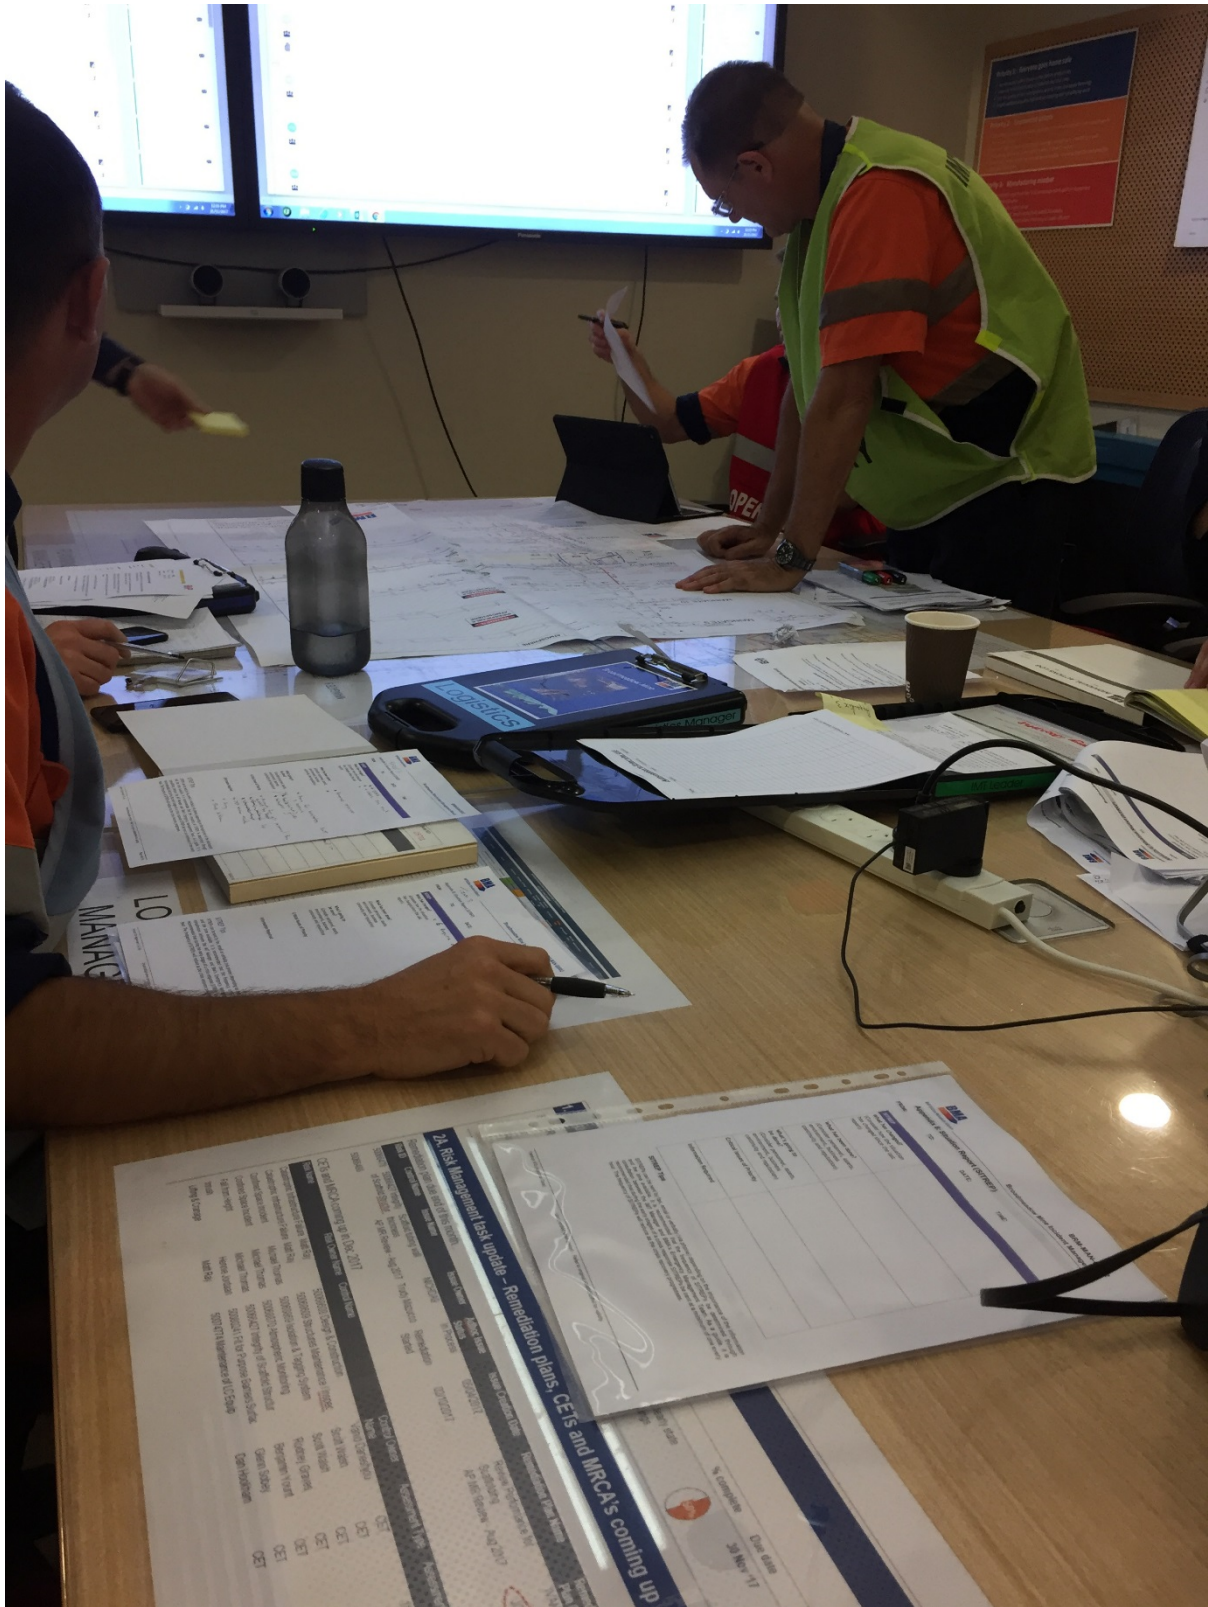
Figure 11 IMT room

There are five rooms allocated to the IMT process - see Figure 8. The larger room is the IMT room which has a large desk with mine plans covered in perspex along with two large computer screens. These are not the touch screen /smart screen type. See Figure 11.
