Cyclone technical report no. 2

Tropical cyclone Joy December 1990

Report No. BPA 29
Coastal Management Branch
Cyclone technical report no. 2

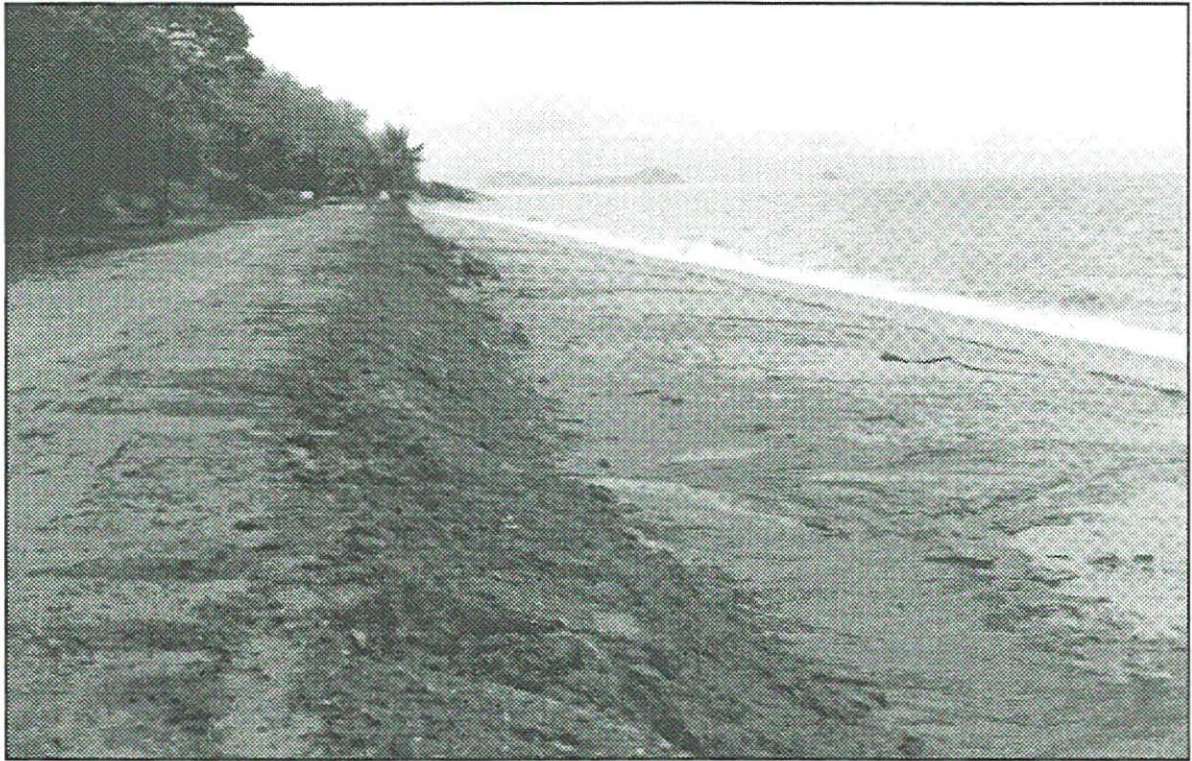
Very little erosion was apparent in this region with most beaches in good condition. Some minor erosion was observed at the northern end of Trinity Beach and at Bramston Beach. See photographs in Figure 43.

Trinity Beach (northern end).
Erosion along this section of beach was caused by wave action and water run-off.

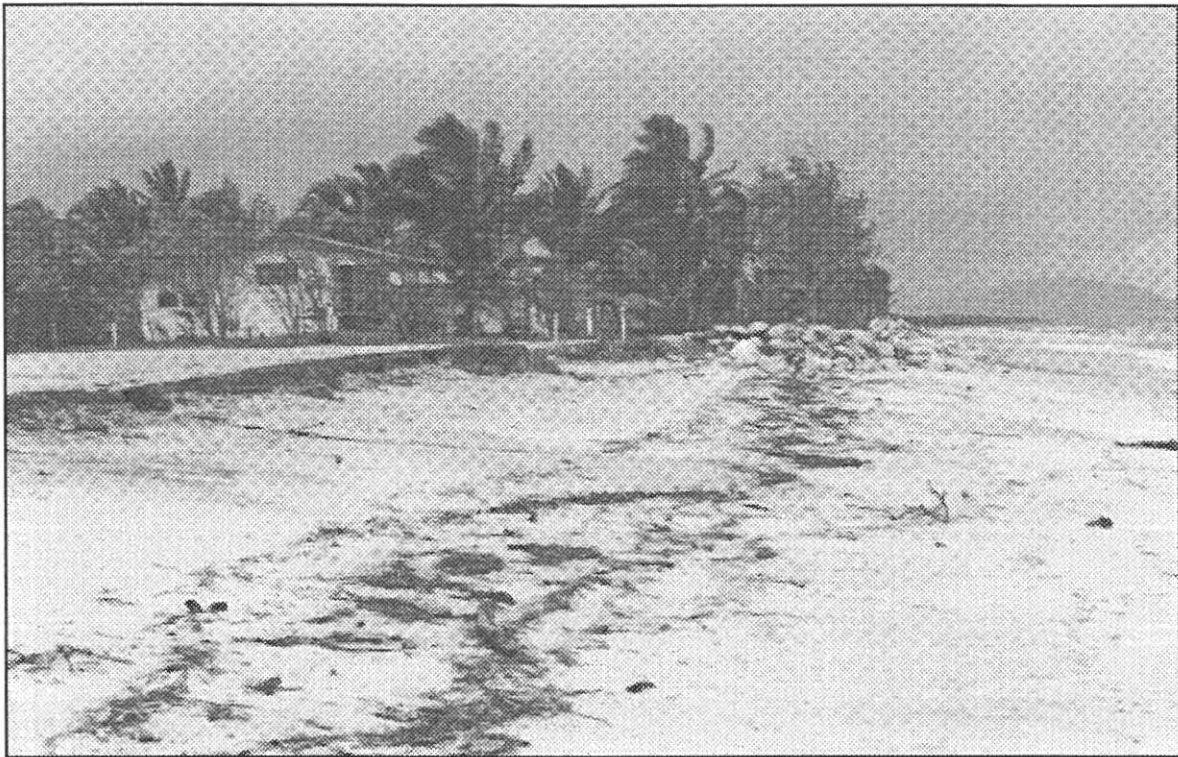
A small number of cases of beach erosion were reported including some minor slumping of a rock wall at Tully Heads and some re-shaping of a re-nourished beach at Cardwell. See photographs in Figure 44.

Tully Heads.
Minor slumping of the rock wall was evident.

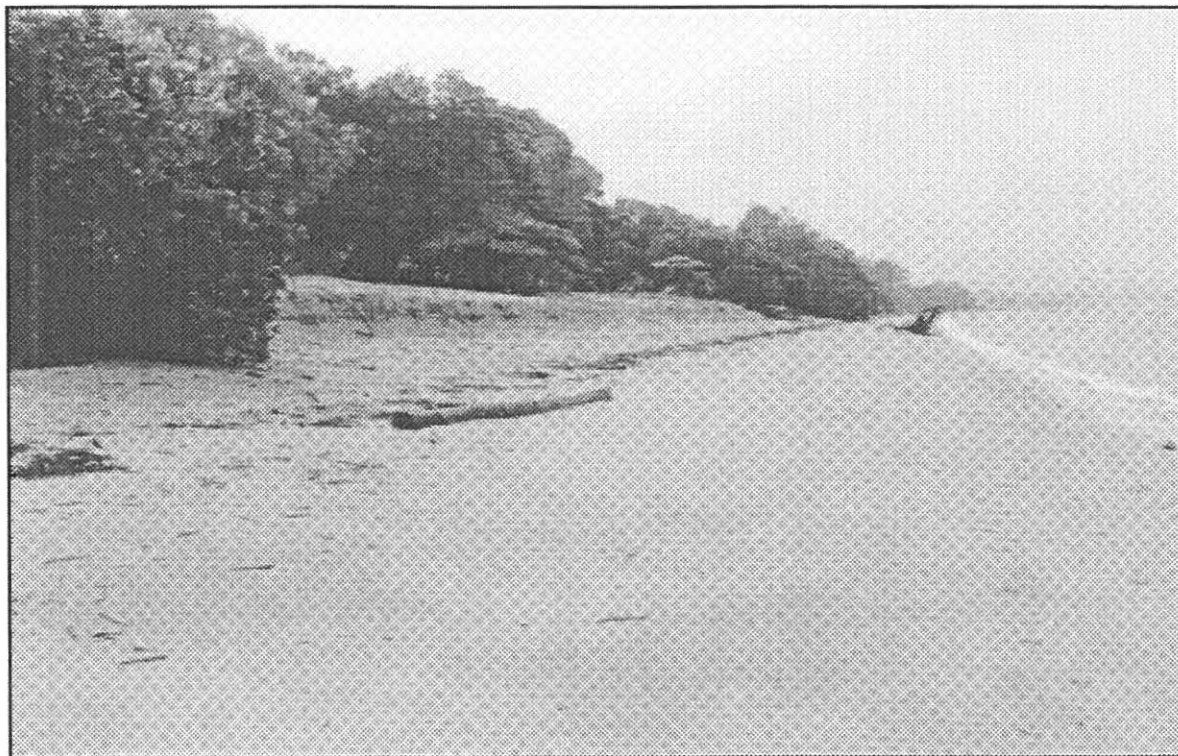
Cardwell Beach.
Area where sand replenishment took place.

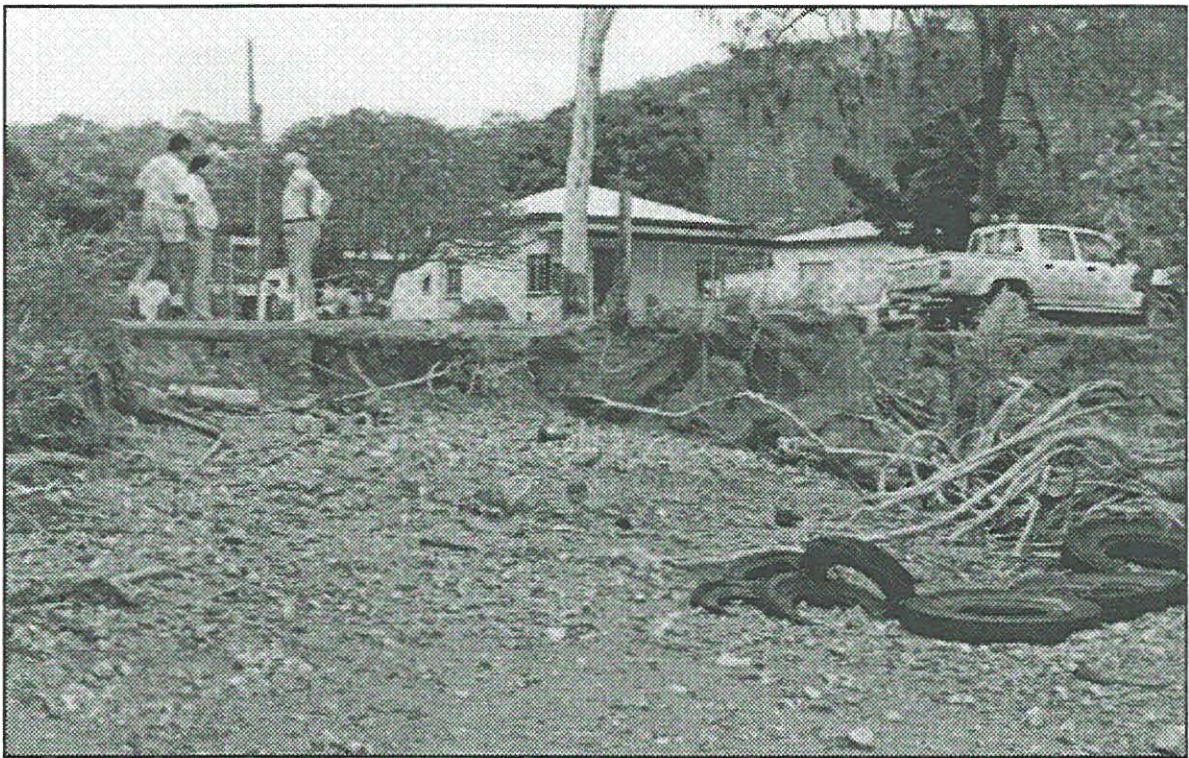
Figure 45

Substantial beach erosion was reported in this region; some is shown in Figures 45 and 46. Moderate erosion and tree losses were reported at Midge Point, Halliday Bay, Seaforth, St Helens Beach and Ball Bay. Due to coastline recession, the erosion scarp at Ball Bay was reported to be approximately two metres from the road in one location. At Shoal Point, erosion scarps of three metres and extensive destruction of fencing and walkways were reported. Lesser erosion occurred at Eimeo and scarps of two to three metres were observed at Bucasia and Lamberts Beach.

Midge Point.

Ball Bay.

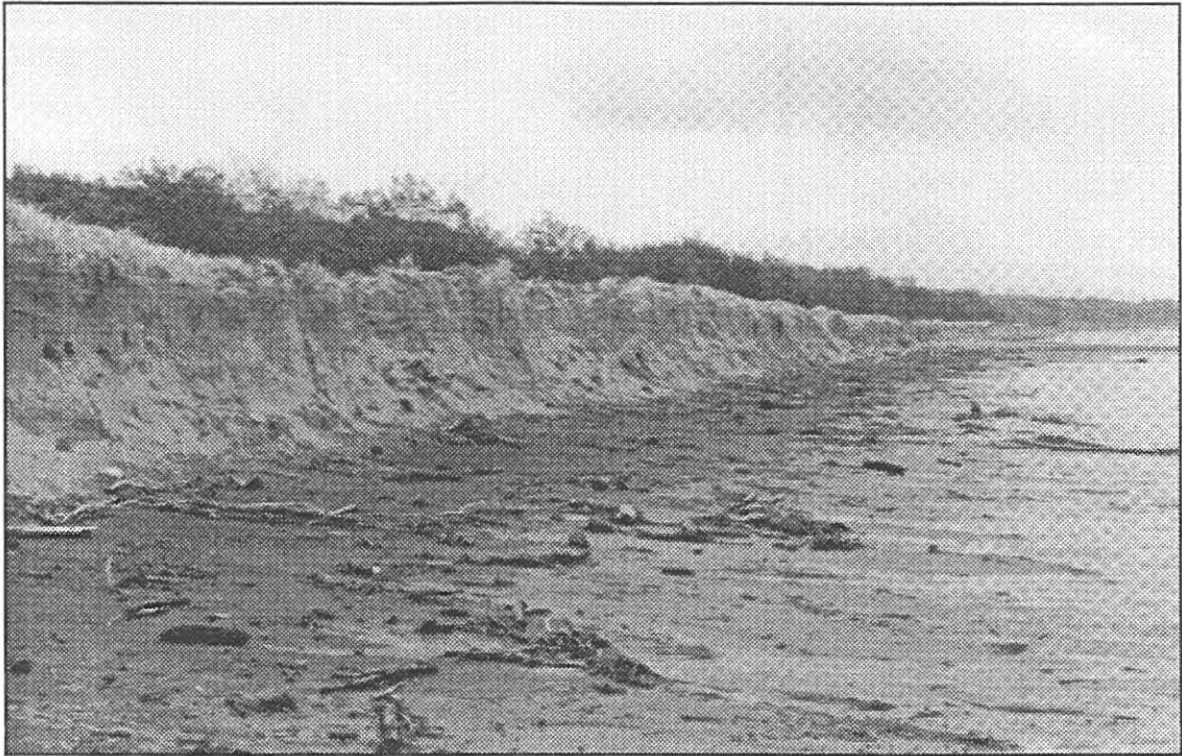
Figure 46

Bucasia.

Shoal Point.

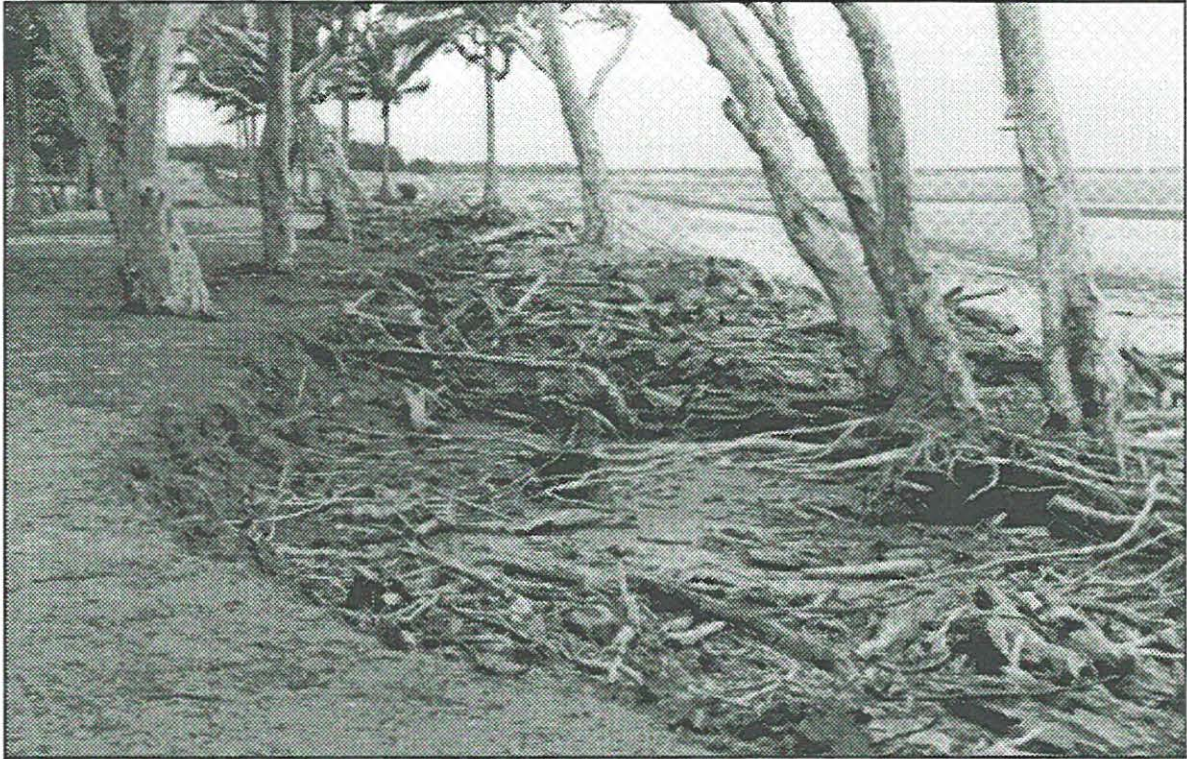
Far Beach. Rock wall.

Along the dune system of Town Beach a number of breakthroughs were reported and damage occurred to the rock wall fronting the park. At Far Beach the storm wave conditions overtopped and damaged the rock wall. See photographs in Figure 47.

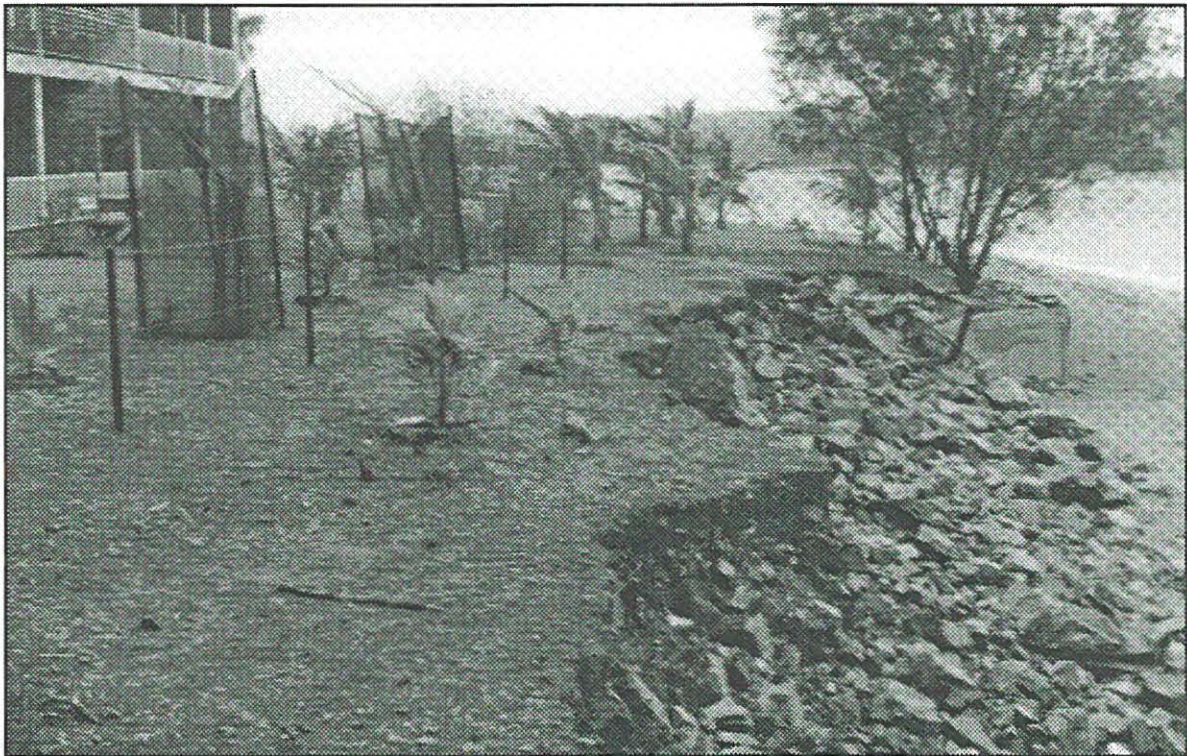
Louisa Creek.

Some moderate erosion was reported in this region along with a number of problems associated with stormwater run-off at Louisa Creek, Grasstree, Salonika, Sarina and Armstrong Beaches. See photographs in Figure 47.

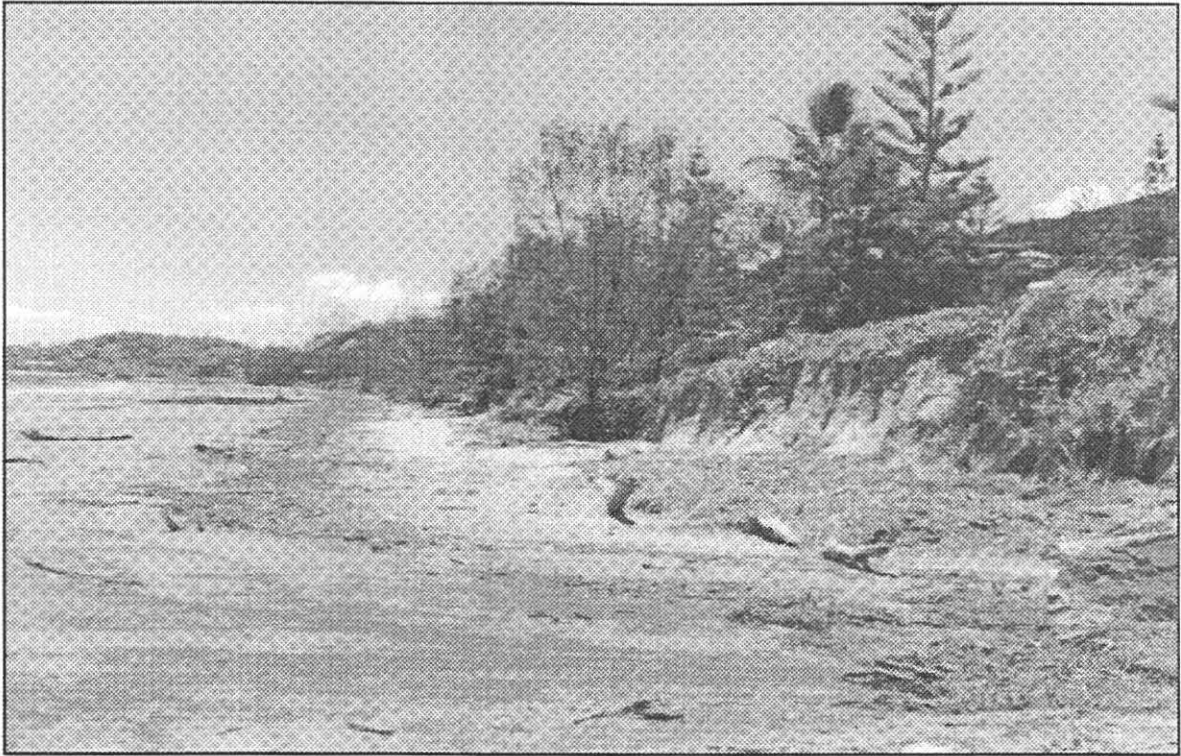
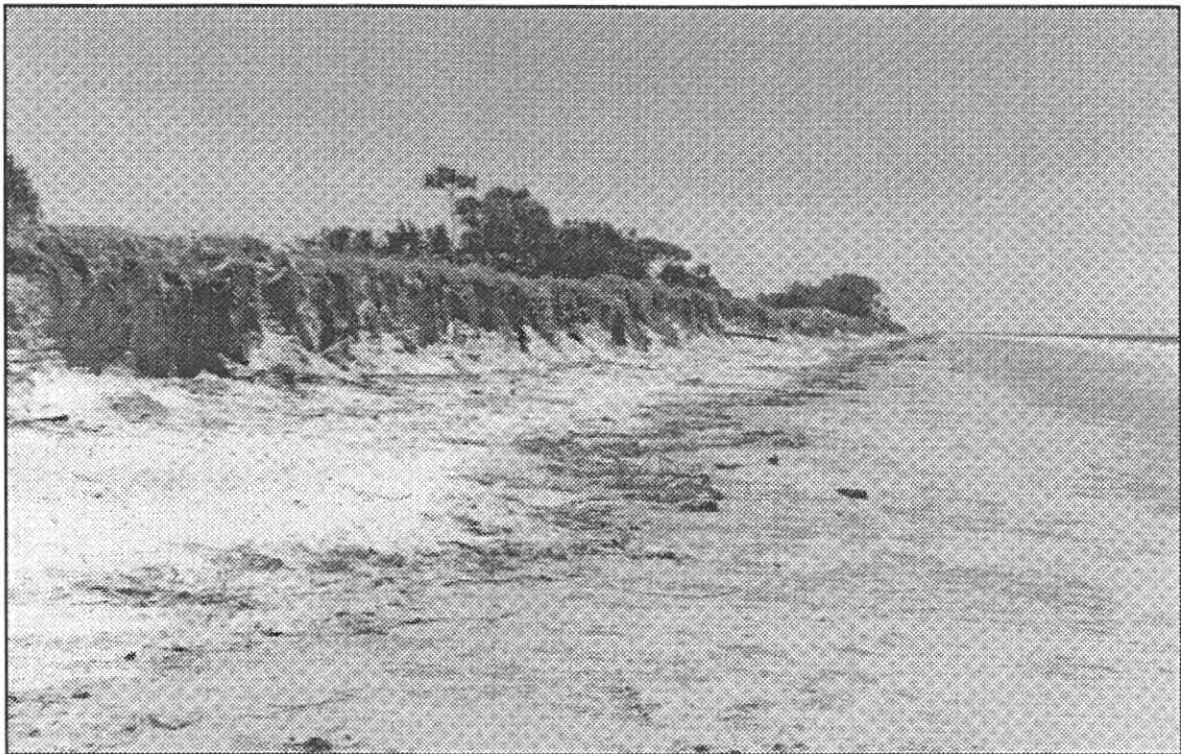
Figure 48

Moderate localised erosion was reported to have occurred at Bangalee, Yeppoon and Kemp Beach. See photographs in Figure 48. Some damage to the rock wall and extensive erosion and overtopping of the bund wall at Kinka Beach were also reported. See photographs in Figure 49.

Yeppoon. Beachside caravan park.

Bangalee.

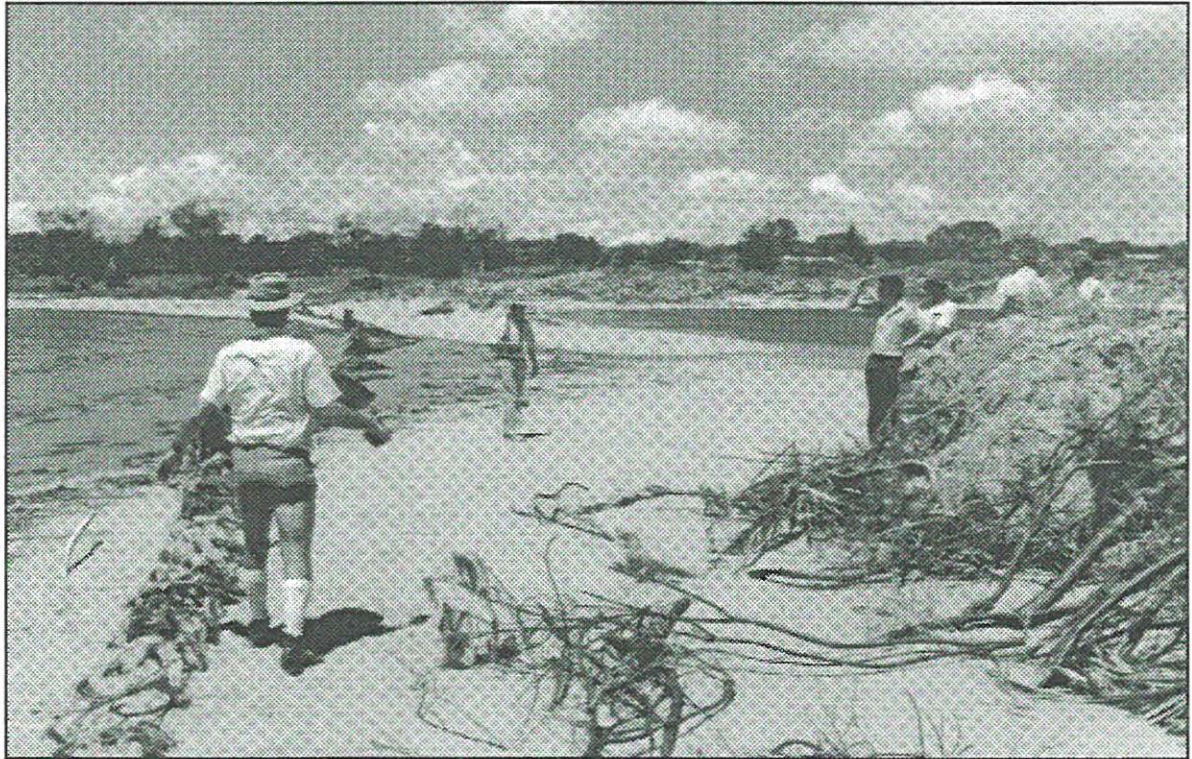
Figure 49

Kinka Beach.
