# TROPICAL CYCLONE INFORMATION SERVICE

Prepared by Coastal Services Unit, Environmental Sciences Division

## Tropical Cyclone Ingrid field inspections

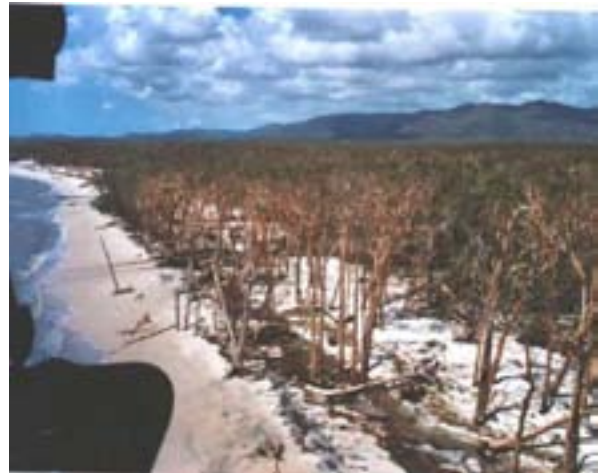
### Photo 1

**Looking south towards Friendly Point.**

**A 20km wide corridor of coastal vegetation was affected by TC Ingrid. Many trees were defoliated and some can be seen lying down. The beach is relatively steep and over-wash can be seen behind the first stand of trees.**

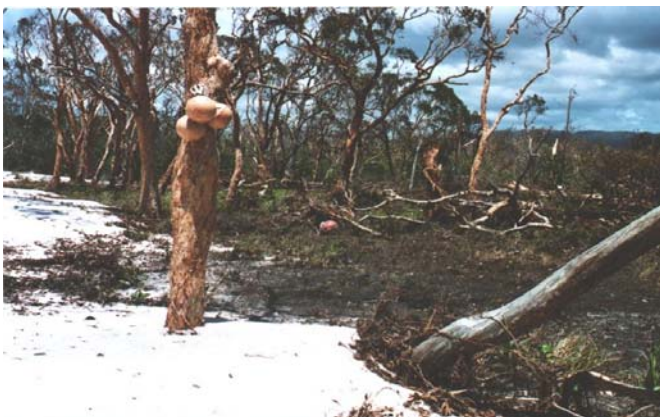
### Photo 2

**Just south of Chris Dean's property.**

**Looking inland across the direction of over-wash that has covered the base of the trees with about 0.5m of sand. Floats tied together with rope can be seen hanging in a tree and were most likely snagged as they floated past on the waves. This level correlates with the debris line found further inland.**

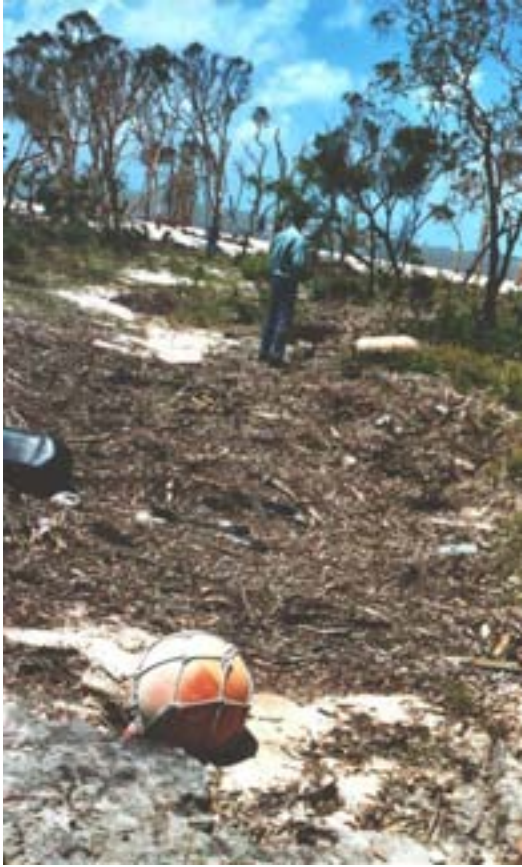
**Photo 3**  
*Just south of Chris Dean's property as in previous photo. Debris line of pumice, floats, containers, a 30kg gas tank, and vegetation was found approximately 80m inland at this location. It was deduced that the level of this debris line was somewhere between 3 and 4 metres above AHD.*

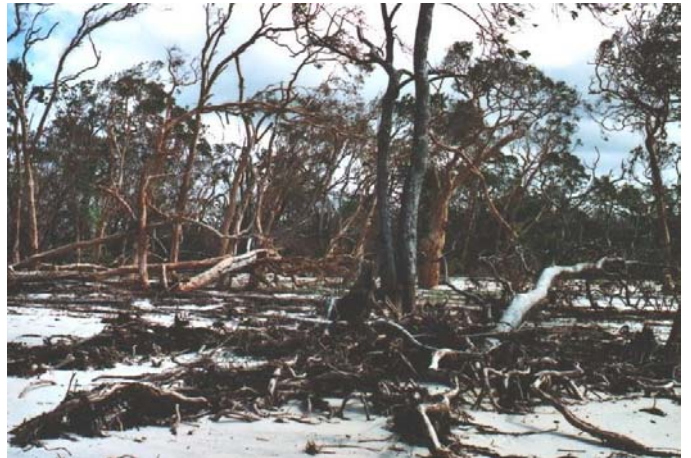
**Photo 4**  
*Vegetation on the frontal dune was destroyed and the dune was washed inland leaving behind an exposed 'coffee rock' substrata and previously buried vegetation.*

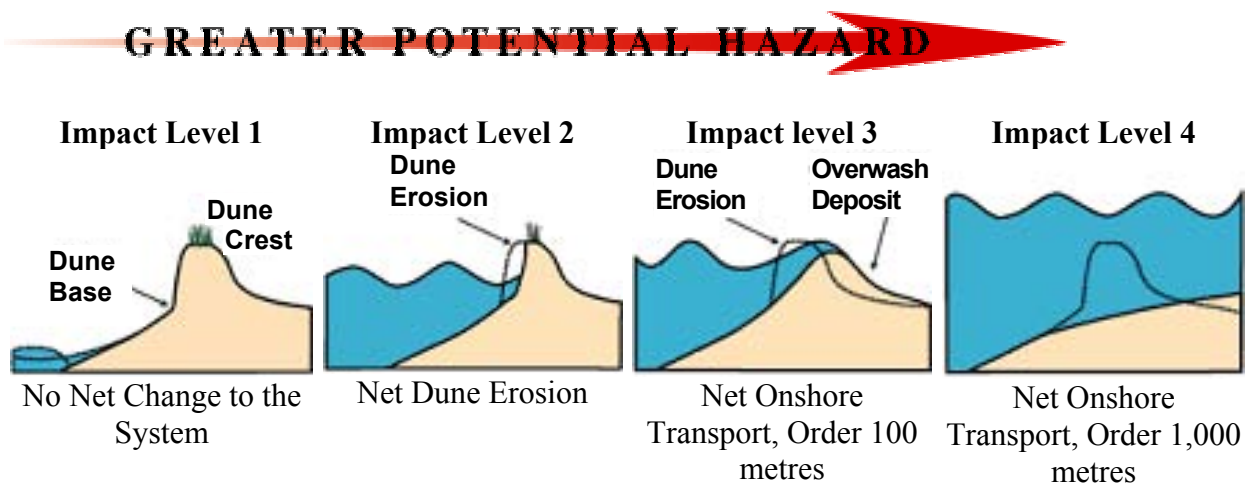
*Figure 4: USGS Inundation Hazard Scale*

For a natural beach system the USGS Inundation Hazard Scale applied to the Tropical Cyclone Ingrid event would be rated at Impact Level 3 (Overwash Regime) described in Figure 4:

The Impact Level 3 coastal hazard depicts a situation in which the wave runup exceeds the elevation of the dune, or in the absence of a dune, the beach berm. In this instance the system will be overtopped, transporting sand landward. This is a net change contributing to the migration of the frontal dune landward.

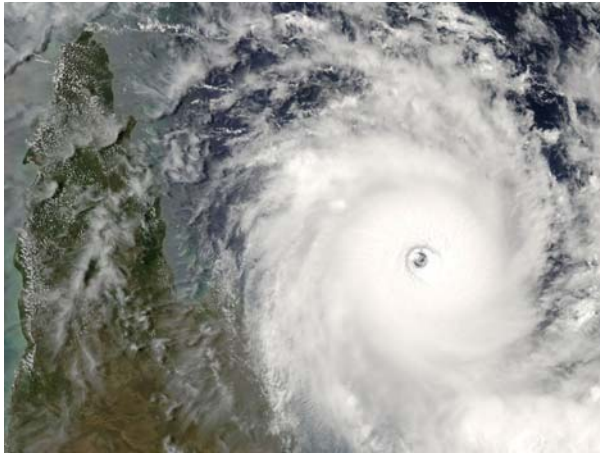
**Figure 5: Eye-wall of TC Ingrid 8/3/2005 07:00 UTC**

Satellites provide a welcome source of information in regard to the cyclone characteristics and behaviour.
