# 16.9 Pilot Transfer Arrangements – Marine Notice 04/2023

MARINE NOTICE

Marine Notice 2023/04

## Pilot transfer arrangements

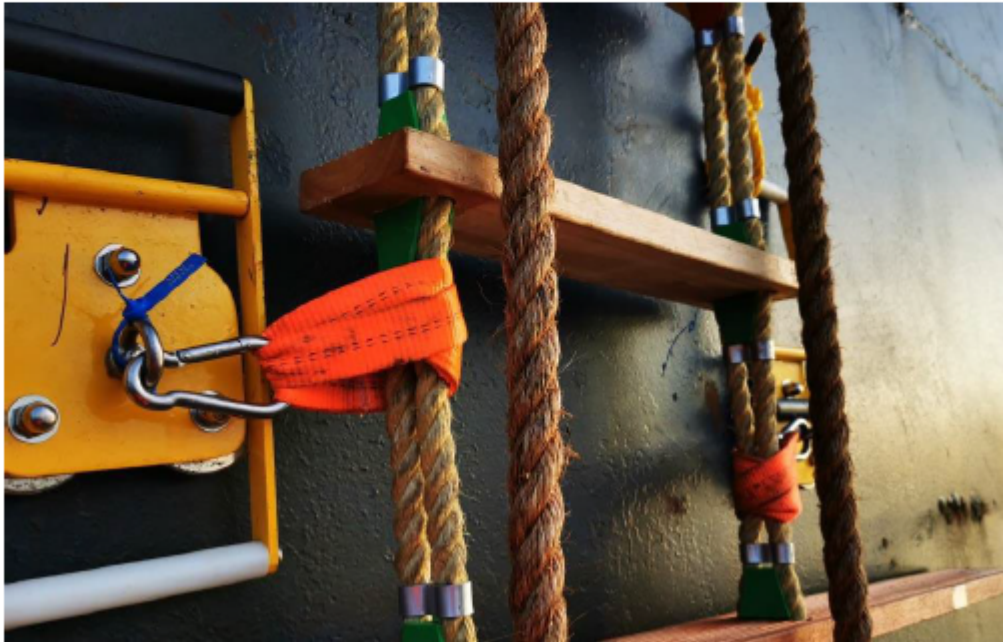
When using a combination pilot ladder arrangement, the pilot ladder and accommodation ladder are required to be secured to the ship's side. A common means of securing both the pilot ladder and accommodation ladders is with magnetic pads (refer to photo 1 below as an example).

*Photo 1: Example of securing both the pilot ladder and accommodation ladders with magnetic pads (Reproduced with permission from Fremantle Ports).*

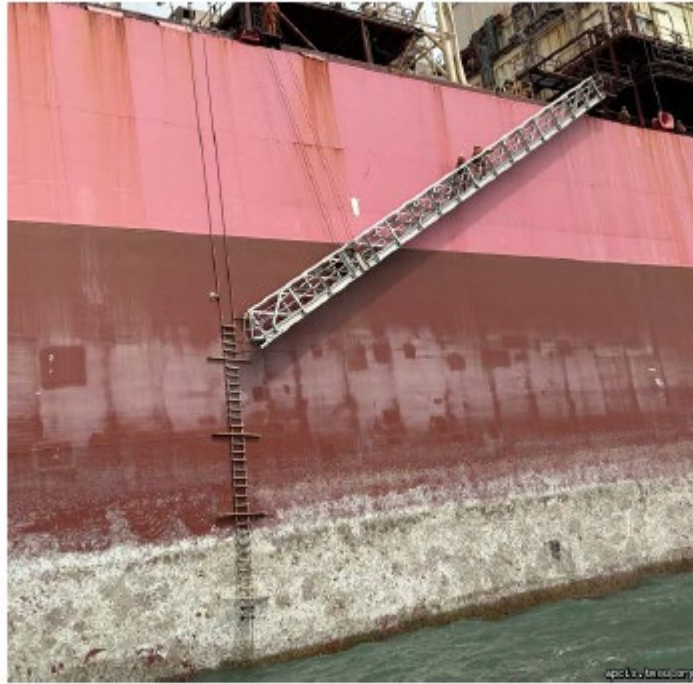
One common issue found is that the pilot ladder does not extend the required 2.0 m past the accommodation platform when a combination arrangement is used. Photo 2 illustrates an example of a pilot ladder not extending the required height past the platform.

*Photo 2: Example of non-compliant combination pilot ladder arrangements.*

As shown in photos 2 and 3 persons cannot climb the pilot ladder to a level where they can move safely onto the accommodation ladder.

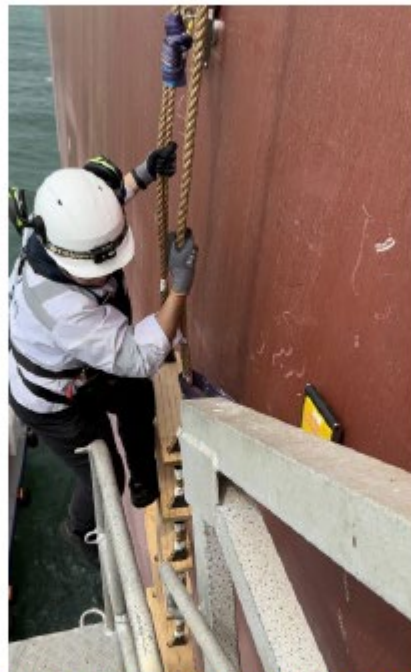
*Photo 3: Person unable to safely access accommodation ladder platform from pilot ladder.*

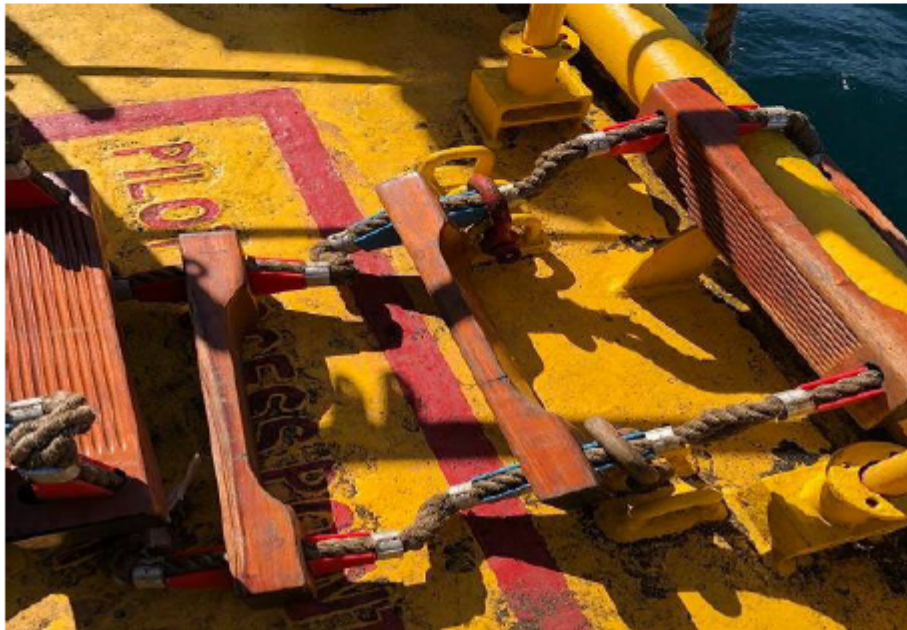
Photo 4 shows an example of an unsafe use of shackles to secure pilot ladders.

*Photo 4: Unsafe pilot ladder securing arrangements (Reproduced with permission from Fremantle Ports).*

The ladder's steps, spreaders or chocks should not be used to carry the weight of the ladder as they are not designed for this and do not have sufficient strength. For this reason, shackles, bars and tongues should not be used to secure the ladder to the deck. They will damage the ladder and put weight on the parts which are not designed to carry the weight.

It is common industry practice to use a rope stopper usually in the form of a rolling hitch knot between the pilot ladder sides ropes and the approved strong point on the main deck. This will transfer the weight of the ladder arrangement directly onto the designated strong point and will not damage the ladder.

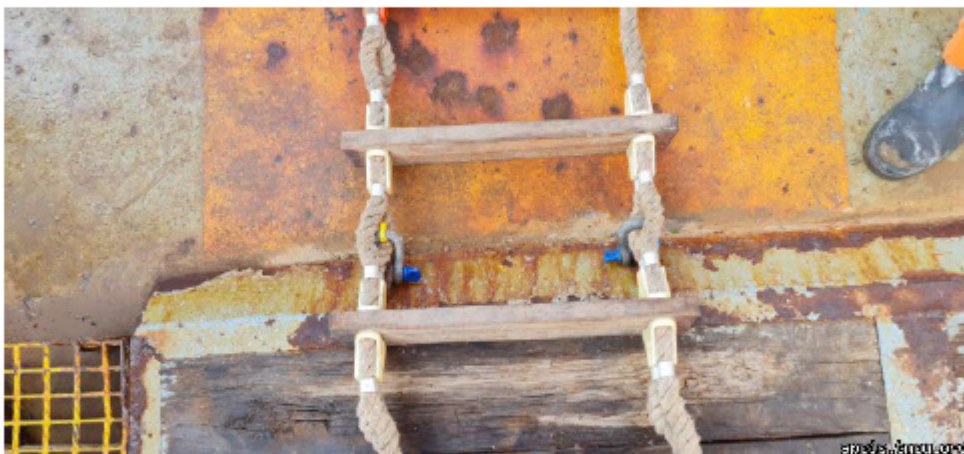
*Photo 5: Unsafe pilot ladder securing arrangements.*

Photos 5 shows the pilot ladder being secured to the strong point by using a shackle passed through the pilot ladder side ropes. This puts increased load on the single part of the side rope and the chock securing arrangements.

It is suggested that two strong (at least 2 x 24 kN) manila ropes be used to secure the pilot ladder. Photo 6 illustrates a method of tying a rolling hitch knot.

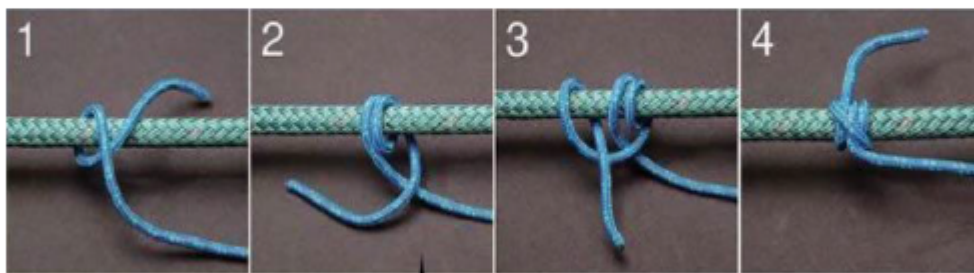
Photo 6: The rolling hitch knot. (Reproduced with permission from Fremantle Ports).

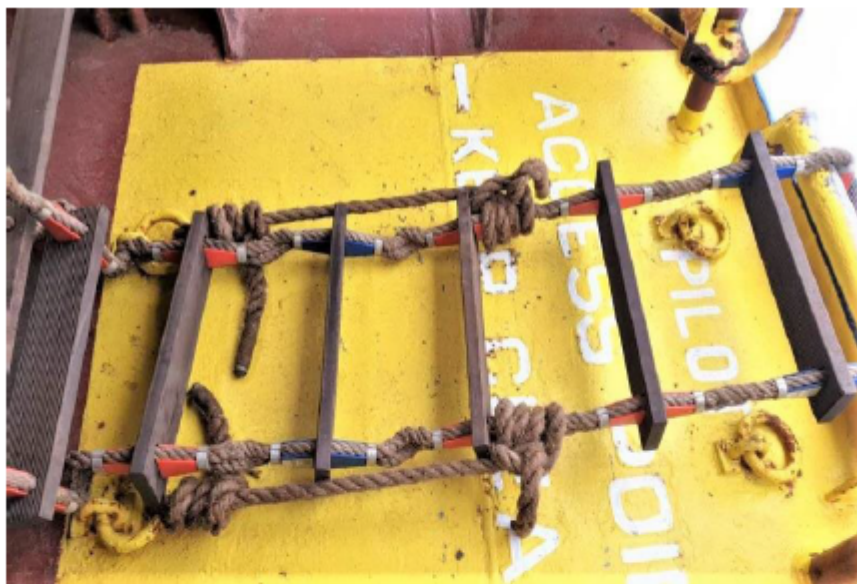
Photo 7 provides an example of rolling hitch knots being used to secure pilot ladders to approved main deck strong points.

Photo 7: Rolling hitch knots being used to secure pilot ladders to approved main deck strong points (Reproduced with permission from Fremantle Ports).

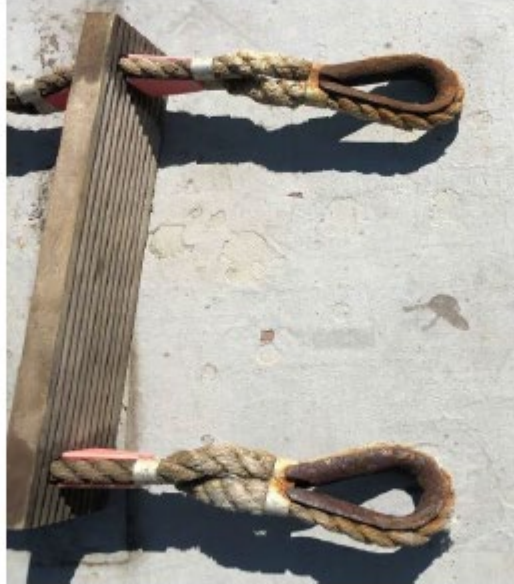
Common areas of defects can be the thimble ends of the pilot ladder. Corroded end point thimbles as illustrated in photo 9, can damage the side ropes leading to failure.

*Photo 9: Example of corroded end point thimbles (Reproduced with permission from Fremantle Ports).*

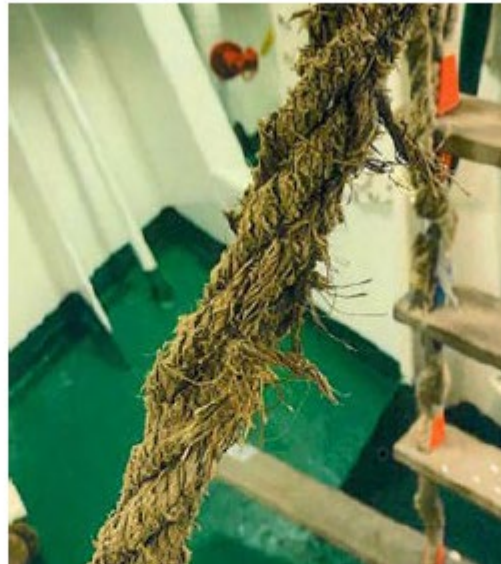
Another common area is the frayed or damaged side ropes as illustrated in photo 10. These should be detected during routine visual inspections.

*Photo 10: Frayed side rope.*

If side ropes are frayed, or in any way degraded the ladder should not be used.

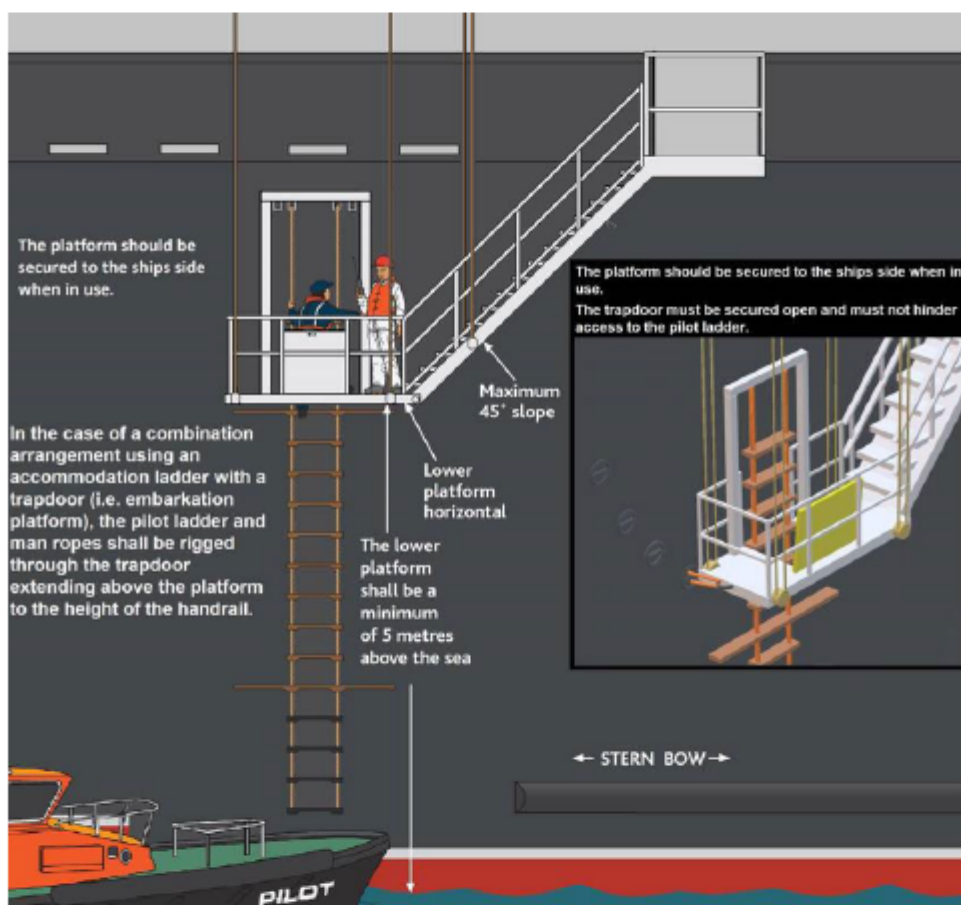
There has been an increase in ships fitted with trapdoor arrangements. The additional requirement for their use is "the pilot ladder and man ropes shall be rigged through the trapdoor extending above the platform to the height of the handrail".

Figure 1: Pilot card depicting trap door arrangements.

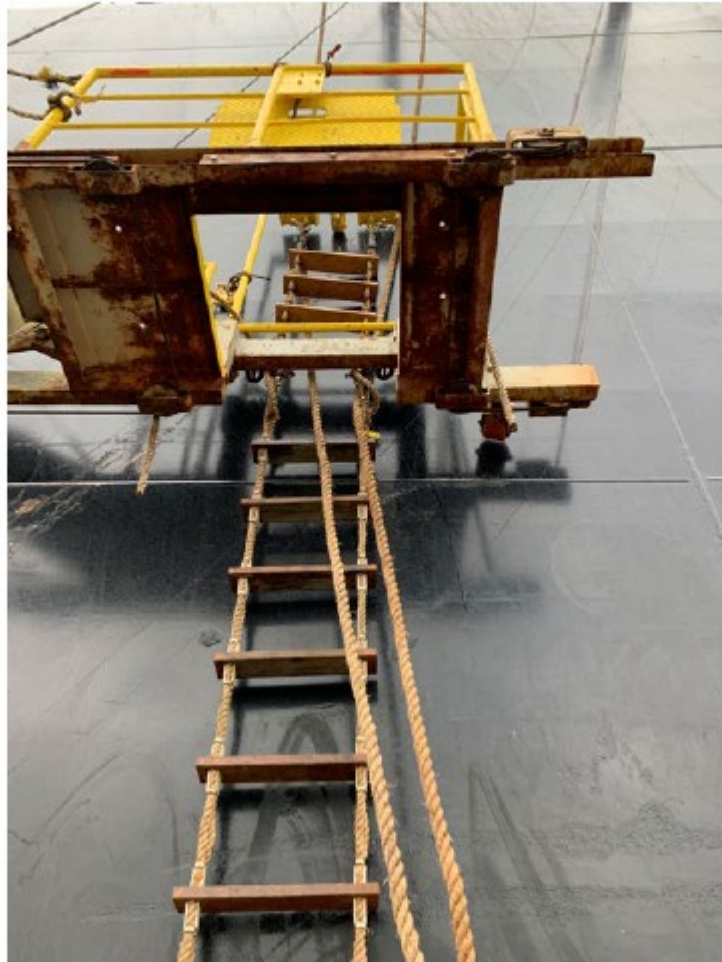
If the pilot ladder and man ropes are not rigged through the trapdoor this creates an unsafe arrangement for persons as illustrated in photo 11

*Photo 11: Unsafe trapdoor pilot transfer arrangement.*

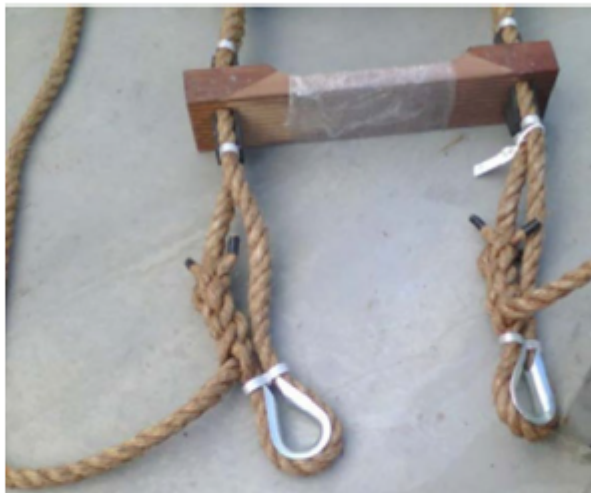
During recent PSC inspections AMSA surveyors have noted pilot ladders which have been constructed with splices in the side ropes.

Photo 12: Example of non-compliant pilot ladder with splices in side ropes.

Pilot ladders constructed like this are considered non-compliant by AMSA. Ship operators and masters are recommended to check their pilot ladders for splices in the side ropes. It should be noted by operators coming to Australian ports that the availability of compliant pilot ladders is limited in Australia. To prevent avoidable delays operators are recommended to have spare compliant pilot transfer arrangements onboard.
