# TUGUIN

stewart road to kennedy drive

# Tugun Bypass Environmental Impact Statement

## Technical Paper Number 4 Geotechnical Assessment

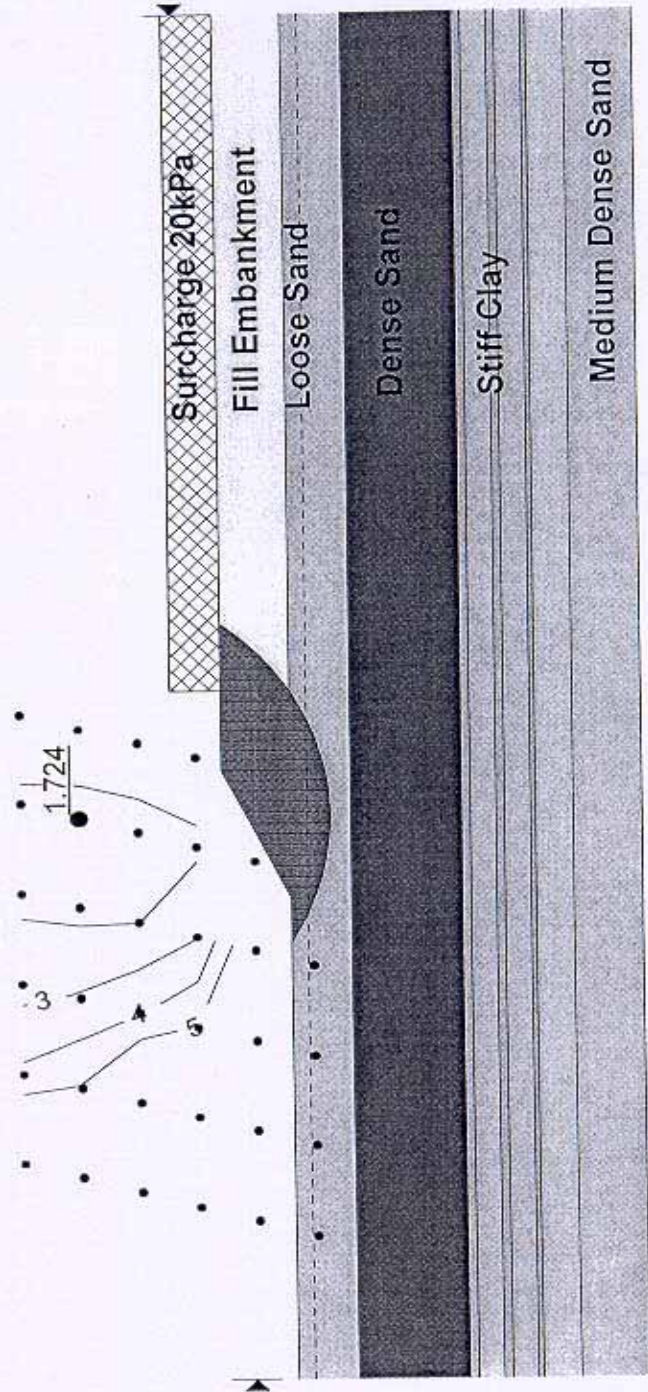
Soil Properties	18kN/m <sup>3</sup>	32deg.	5kPa
Fill Embankment	18kN/m <sup>3</sup>	28deg.	0kPa
Loose Sand	18kN/m <sup>3</sup>	30deg.	0kPa
Medium Dense Sand	18kN/m <sup>3</sup>	35deg.	0kPa
Dense Sand	18kN/m <sup>3</sup>	Cu=50kPa	
Stiff Clay
