Marine Notice 2023/04

Pilot transfer arrangements

Australian Maritime Safety Authority

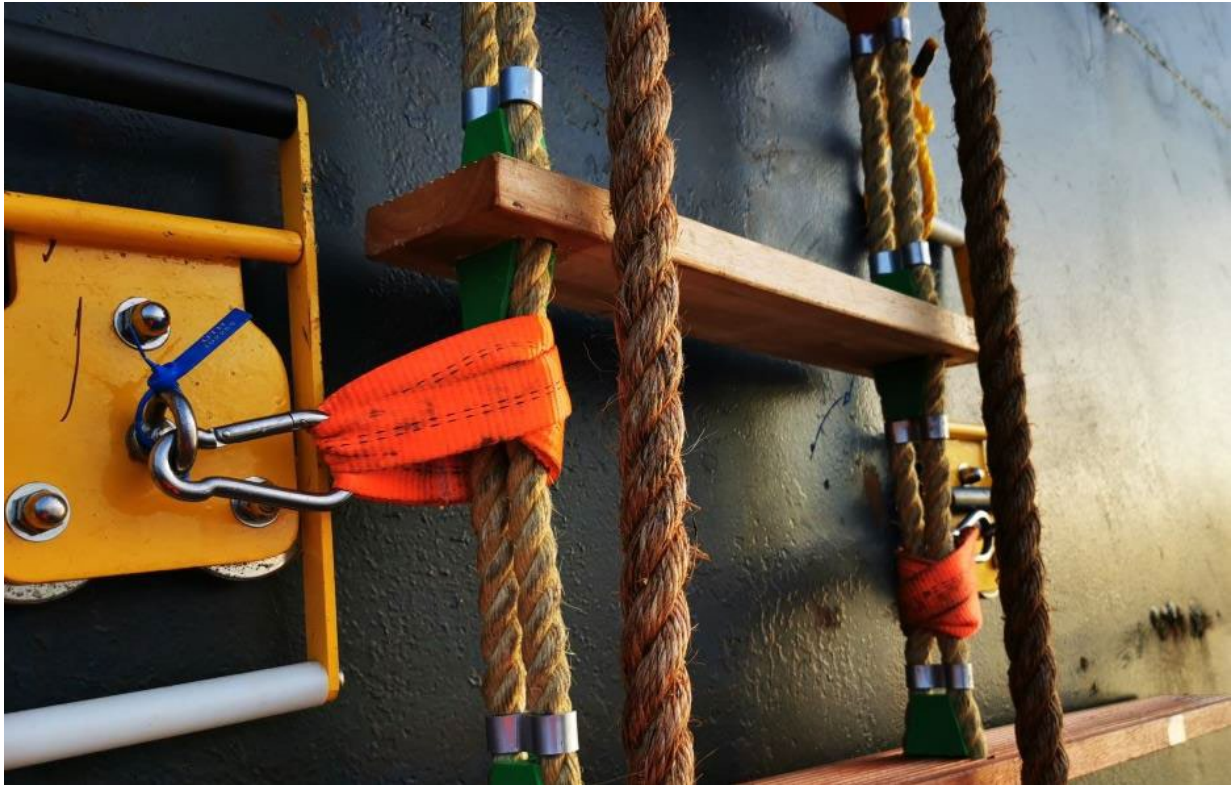
When using a combination pilot ladder arrangement, the pilot ladder and accommodation ladder are required to be secured to the ship's side. A common means of securing both the pilot ladder and accommodation ladders is with magnetic pads (refer to photo 1 below as an example).

Photo 1: Example of securing both the pilot ladder and accommodation ladders with magnetic pads (Reproduced with permission from Fremantle Ports).

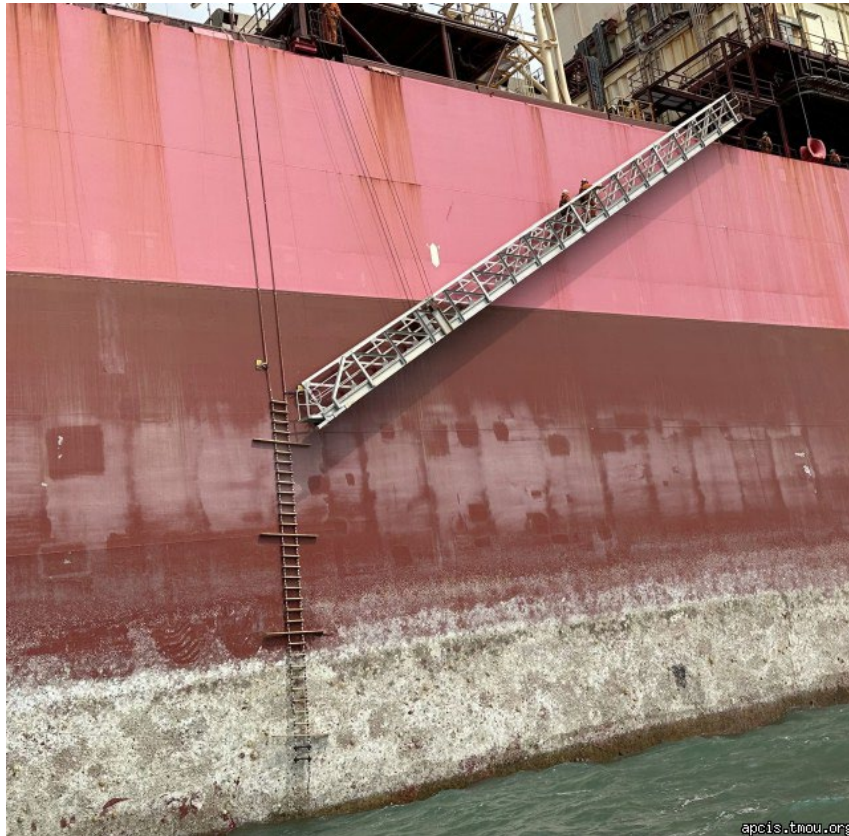
One common issue found is that the pilot ladder does not extend the required 2.0 m past the accommodation platform when a combination arrangement is used. Photo 2 illustrates an example of a pilot ladder not extending the required height past the platform.

Photo 2: Example of non-compliant combination pilot ladder arrangements.

As shown in photos 2 and 3 persons cannot climb the pilot ladder to a level where they can move safely onto the accommodation ladder.

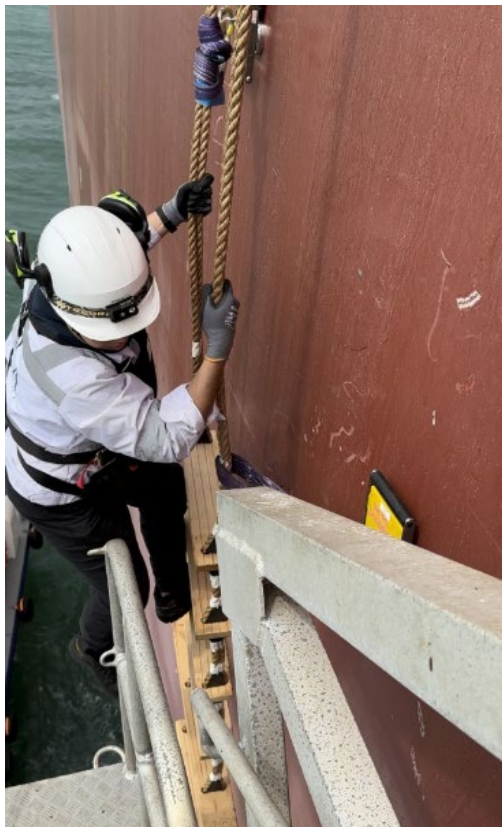
Photo 3: Person unable to safely access accommodation ladder platform from pilot ladder.

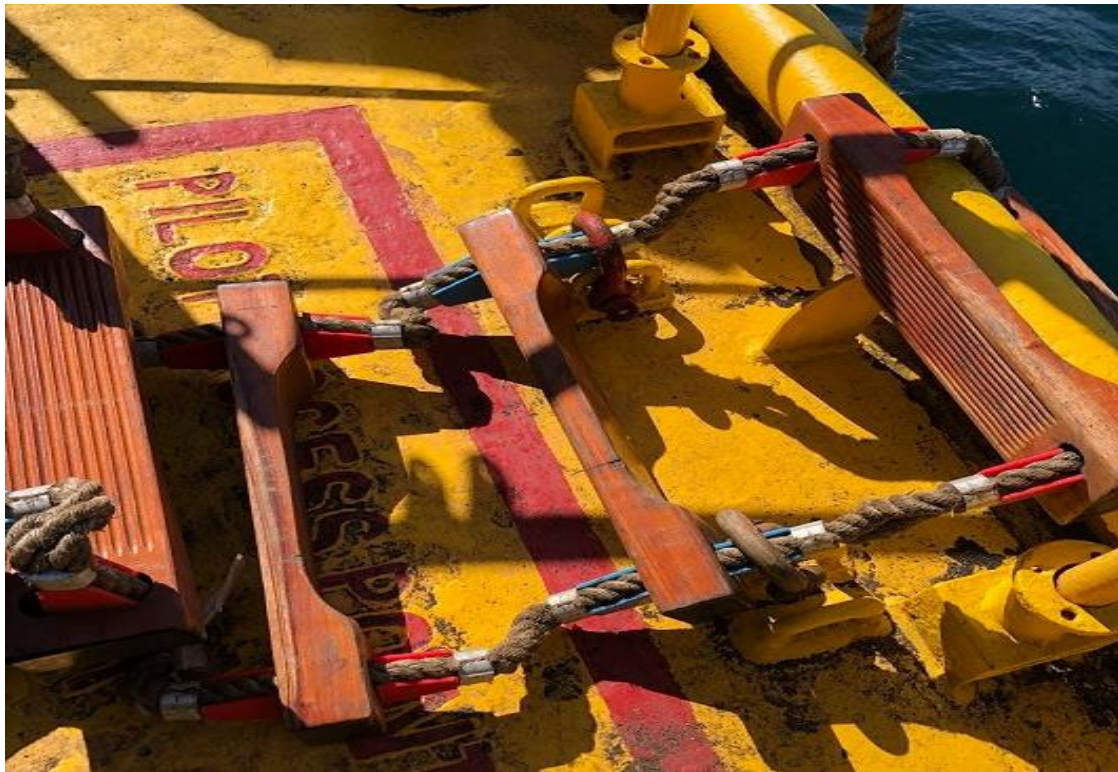
The ladder's steps, spreaders or chocks should not be used to carry the weight of the ladder as they are not designed for this and do not have sufficient strength. For this reason, shackles, bars and tongues should not be used to secure the ladder to the deck. They will damage the ladder and put weight on the parts which are not designed to carry the weight.

Photo 4 shows an example of an unsafe use of shackles to secure pilot ladders.

Photo 4: Unsafe pilot ladder securing arrangements (Reproduced with permission from Fremantle Ports).

It is common industry practice to use a rope stopper usually in the form of a rolling hitch knot between the pilot ladder sides ropes and the approved strong point on the main deck. This will transfer the weight of the ladder arrangement directly onto the designated strong point and will not damage the ladder.

It is suggested that two strong (at least 2 x 24 kN) manila ropes be used to secure the pilot ladder. Photo 6 illustrates a method of tying a rolling hitch knot.

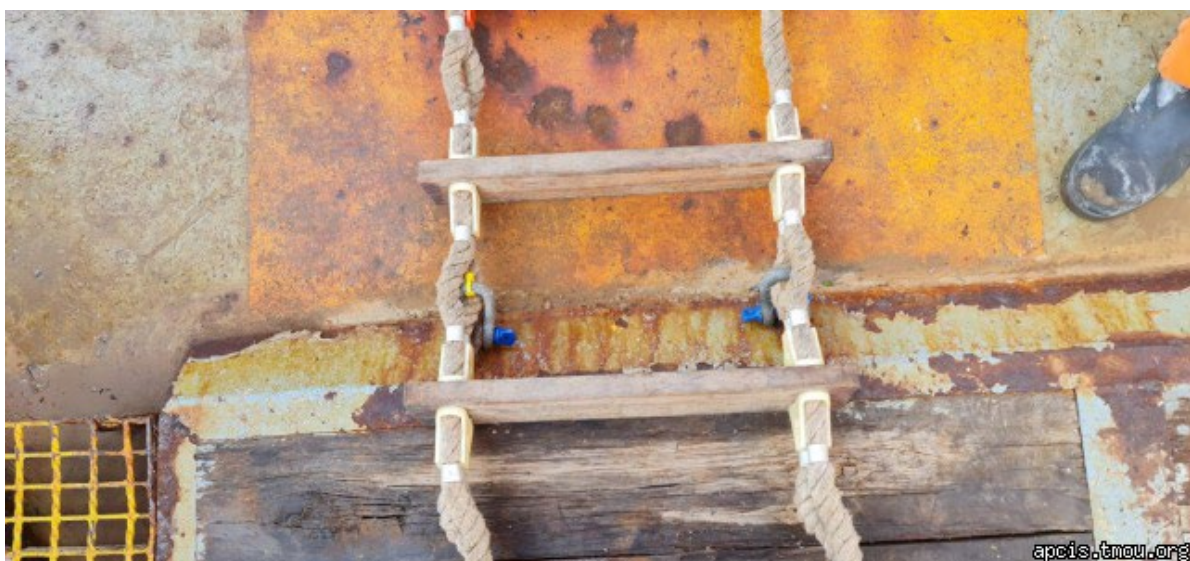
Photo 5: Unsafe pilot ladder securing arrangements.

Photos 5 shows the pilot ladder being secured to the strong point by using a shackle passed through the pilot ladder side ropes. This puts increased load on the single part of the side rope and the chock securing arrangements.

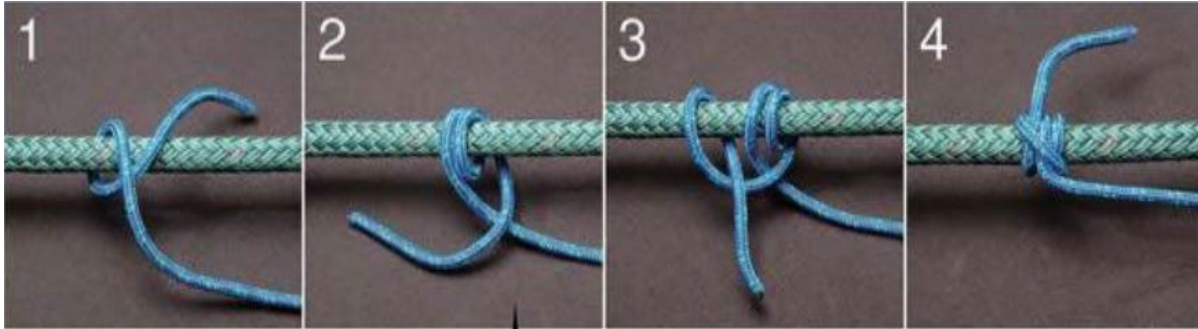
Photo 6: The rolling hitch knot. (Reproduced with permission from Fremantle Ports).

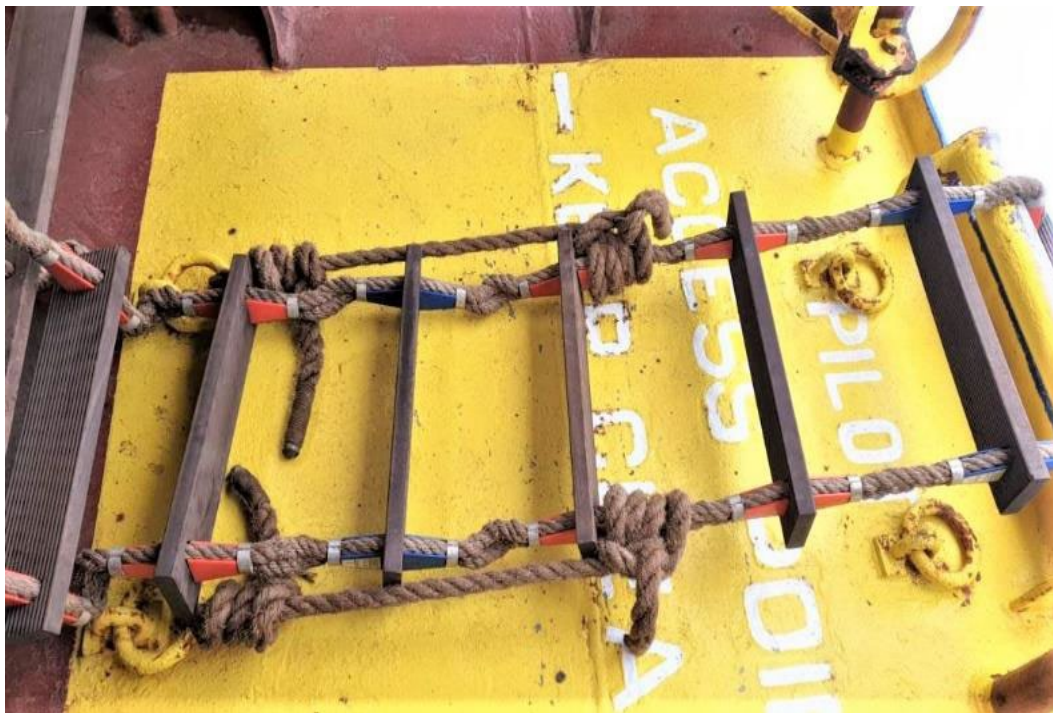
Photo 7 provides an example of rolling hitch knots being used to secure pilot ladders to approved main deck strong points.

Photo 7: Rolling hitch knots being used to secure pilot ladders to approved main deck strong points (Reproduced with permission from Fremantle Ports).

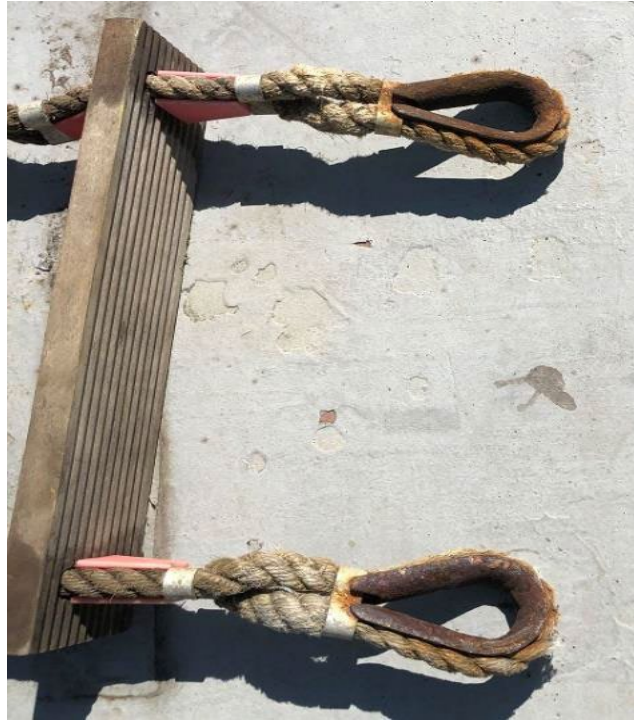
Common areas of defects can be the thimble ends of the pilot ladder. Corroded end point thimbles as illustrated in photo 9, can damage the side ropes leading to failure.

Photo 9: Example of corroded end point thimbles (Reproduced with permission from Fremantle Ports).

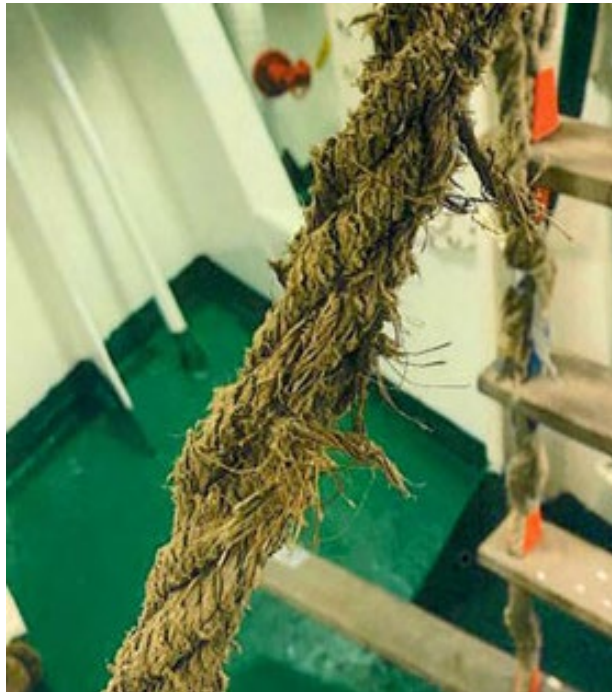
Another common area is the frayed or damaged side ropes as illustrated in photo 10. These should be detected during routine visual inspections.

Photo 10: Frayed side rope.

If side ropes are frayed, or in any way degraded the ladder should not be used.

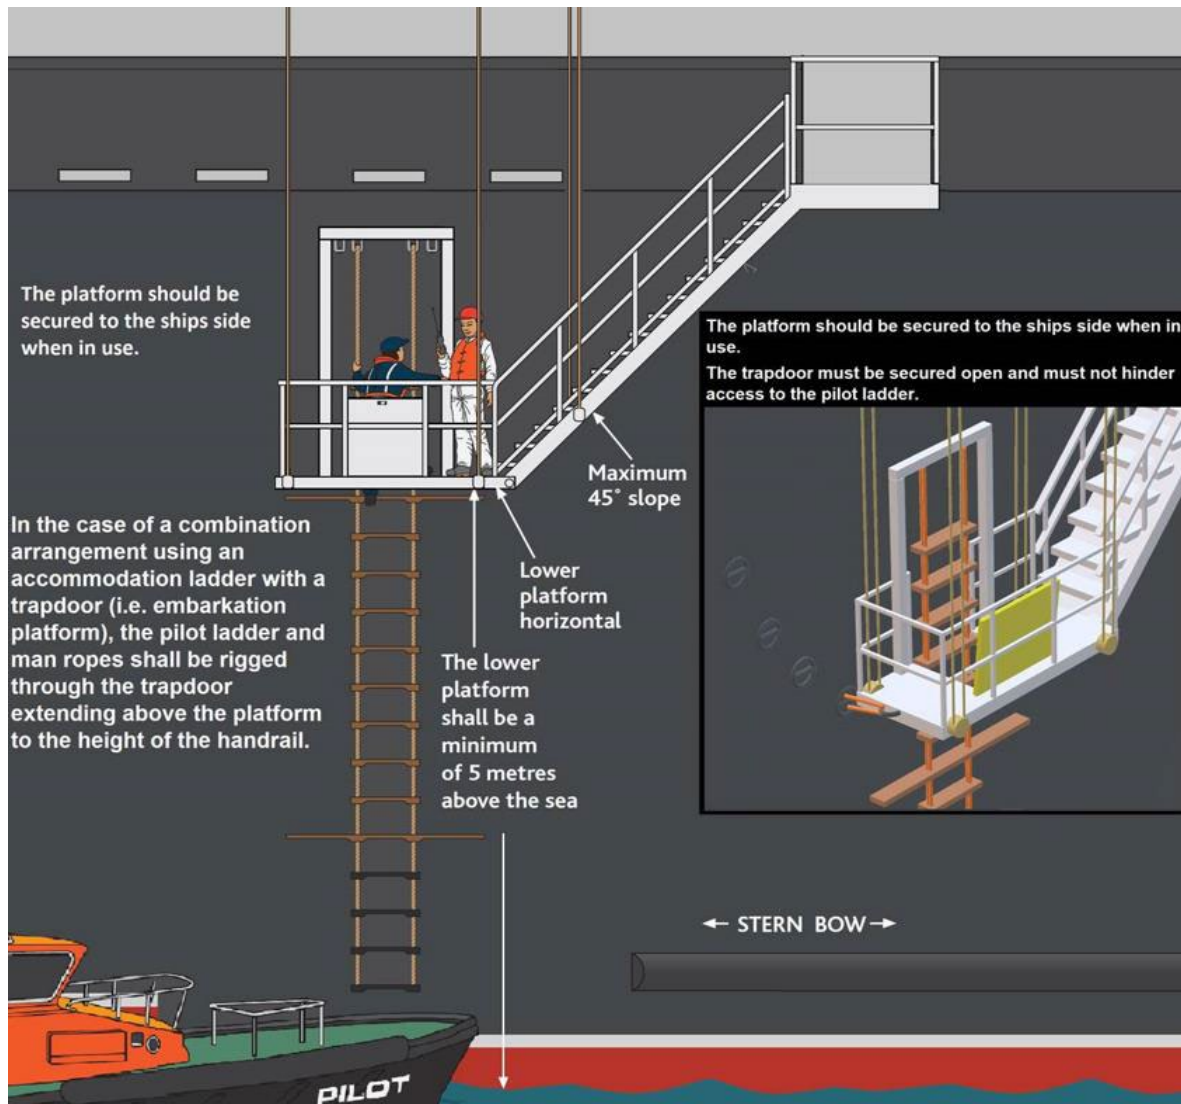
There has been an increase in ships fitted with trapdoor arrangements. The additional requirement for their use is "the pilot ladder and man ropes shall be rigged through the trapdoor extending above the platform to the height of the handrail".

Figure 1: Pilot card depicting trap door arrangements.

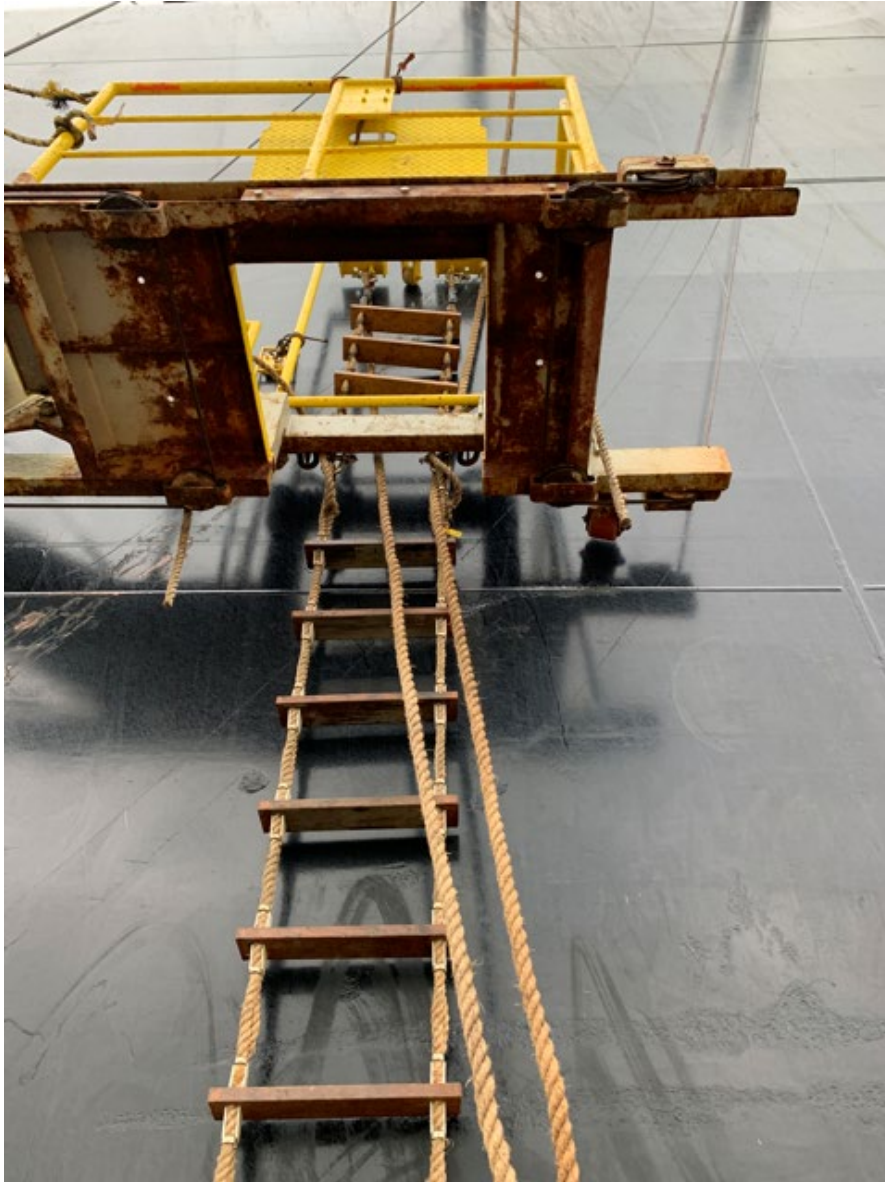
If the pilot ladder and man ropes are not rigged through the trapdoor this creates an unsafe arrangement for persons as illustrated in photo 11

Photo 11: Unsafe trapdoor pilot transfer arrangement.

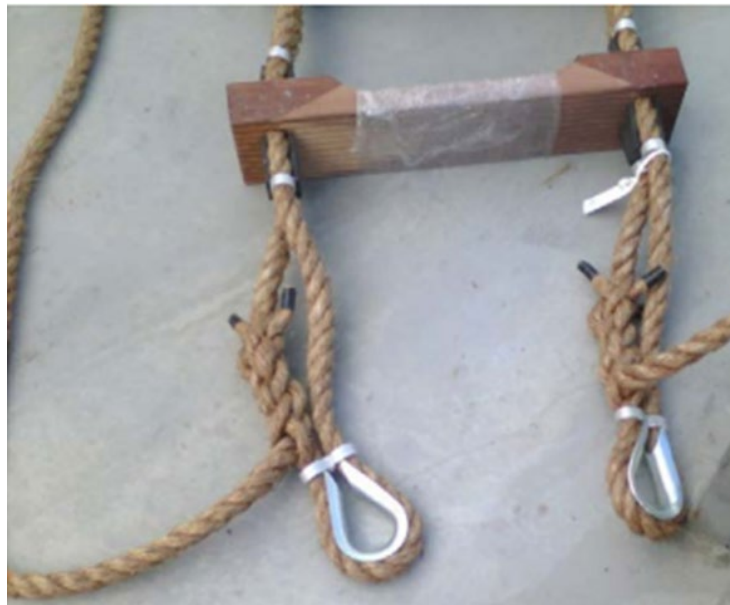
During recent PSC inspections AMSA surveyors have noted pilot ladders which have been constructed with splices in the side ropes.

Photo 12: Example of non-compliant pilot ladder with splices in side ropes.

Pilot ladders constructed like this are considered non-compliant by AMSA. Ship operators and masters are recommended to check their pilot ladders for splices in the side ropes. It should be noted by operators coming to Australian ports that the availability of compliant pilot ladders is limited in Australia. To prevent avoidable delays operators are recommended to have spare compliant pilot transfer arrangements onboard.
