## Case study 7: In-line bioreactor beds Wet Tropics

<b>Project leader and partnerships</b>	Jaragun EcoServices collaborating with James Cook University
<b>Funding source</b>	Department of Environment and Science (Queensland Government Reef Water Quality Program)
<b>Project length</b>	Three years (August 2017 – June 2020)
<b>Region</b>	Wet Tropics, Russell River Catchment (Babinda Swamp Drainage Area)
<b>Production system</b>	Sugarcane
<b>Date of installation</b>	Bioreactor 1: 29-30 Aug 2018, Bioreactor 2: 31 Aug- 1 Sep 2018
<b>Length of installation</b>	Four working days for installation (2 x bioreactors)
<b>Bioreactor type</b>	Twin in-line bioreactor beds (below floor/invert of drain)
<b>Project objective</b>	Research trial to quantify nitrate removal performance.

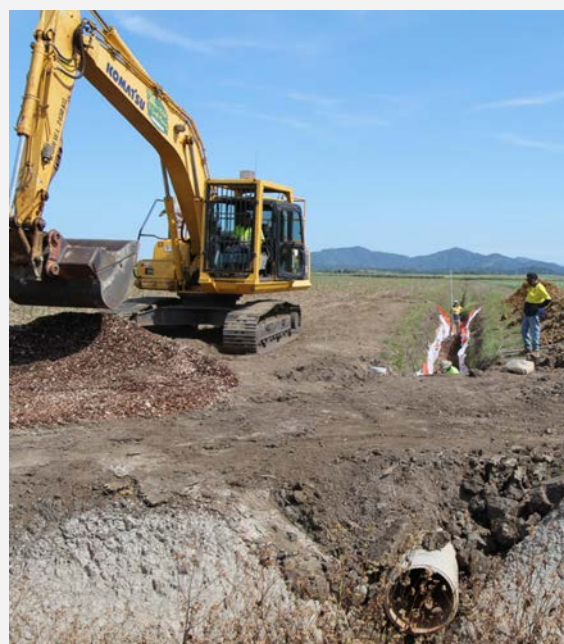
A hardwood woodchip mix was used (particle size approximately 50mm, predominantly *Eucalyptus tereticornis* sourced from Gympie, Queensland). The bioreactor beds were dug using an excavator, with a 0.9 m wide bucket (Figure 1).

**Figure 1** Construction of the in-line bioreactor bed within an agricultural drain.

Construction issues included use of heavy machinery along the soft edges of the agricultural drains causing bank collapse. Further collapse was limited by the excavator straddling the drains for construction. Geofabric was applied to reduce additional collapse and left in-situ post construction to reduce future erosion (e.g. from rainfall). Pooling of groundwater in the drain was removed by pump.
