Tropical Cyclone Yasi 2011

Post Cyclone Coastal Field Investigation

November 2012

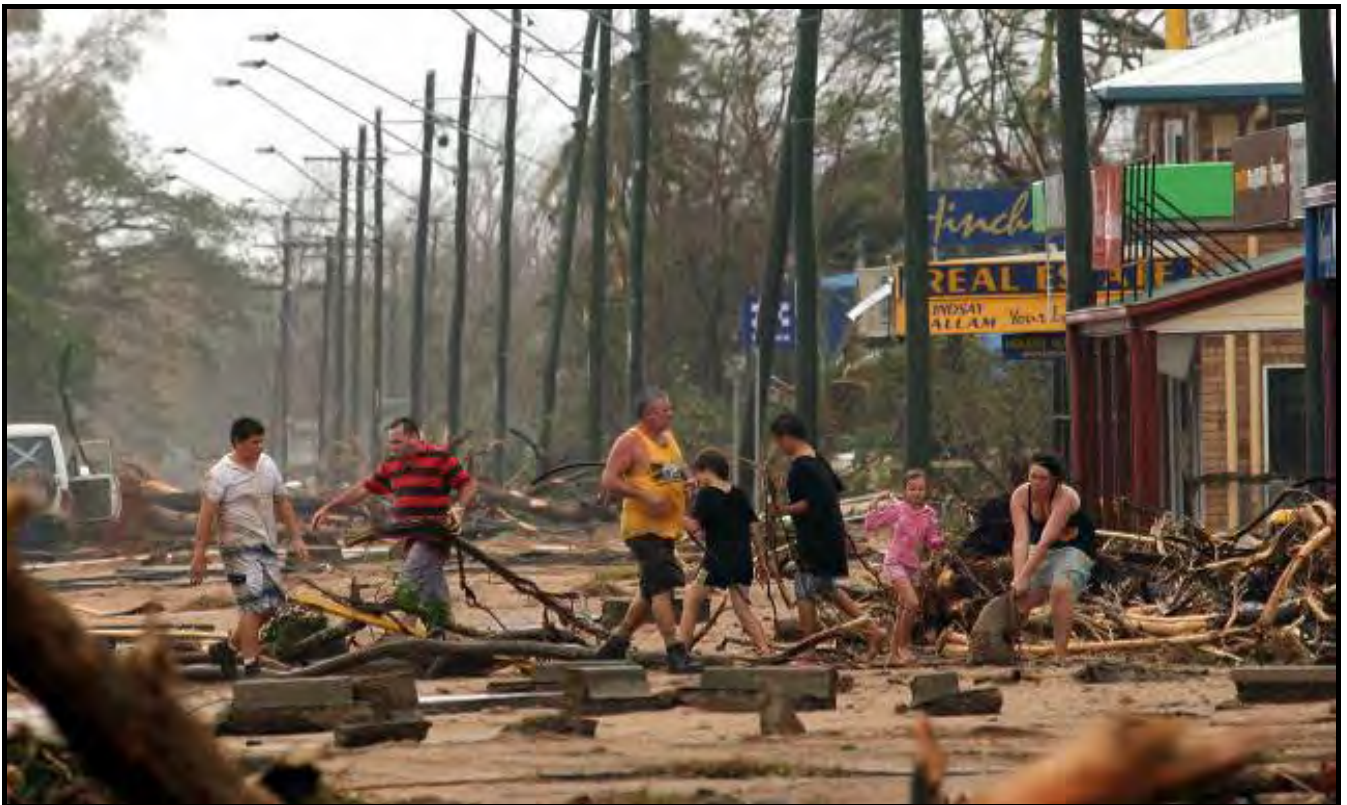
Photograph 4: Clean-up efforts commence in Cardwell following TC Yasi (Source: News Limited)

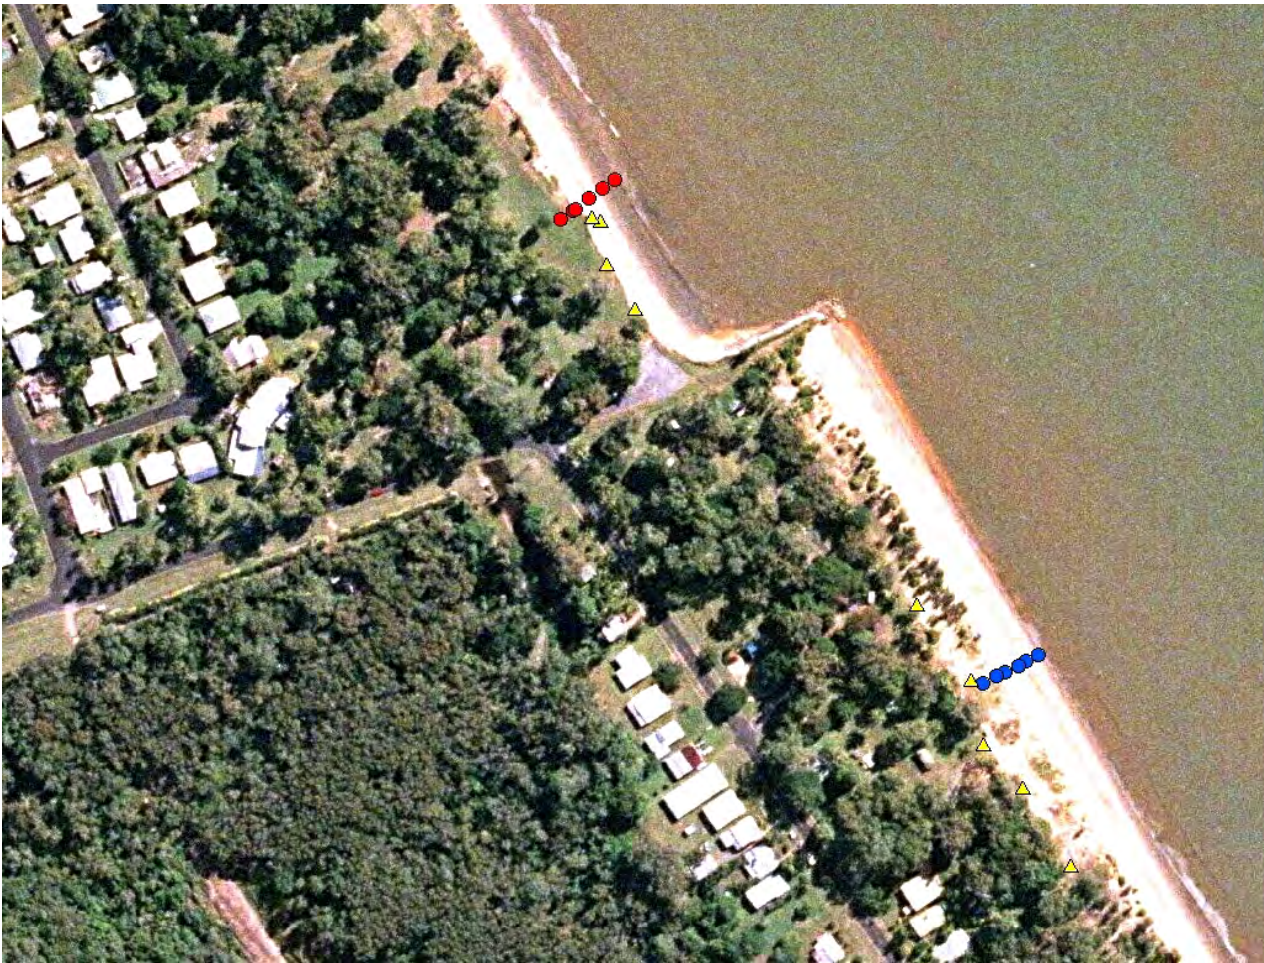
Debris Lines: Debris lines (predominantly pumice) indicative of inundation were found in the caravan park to the south of the groyne. Less convincing lines were found to the north of the groyne, but these were slightly lower than the height of the foredune which indicated these lines could have been from a high tide following TC Yasi.

Figure 16: Bramston Beach surveyed beach profiles and debris lines (yellow triangles)

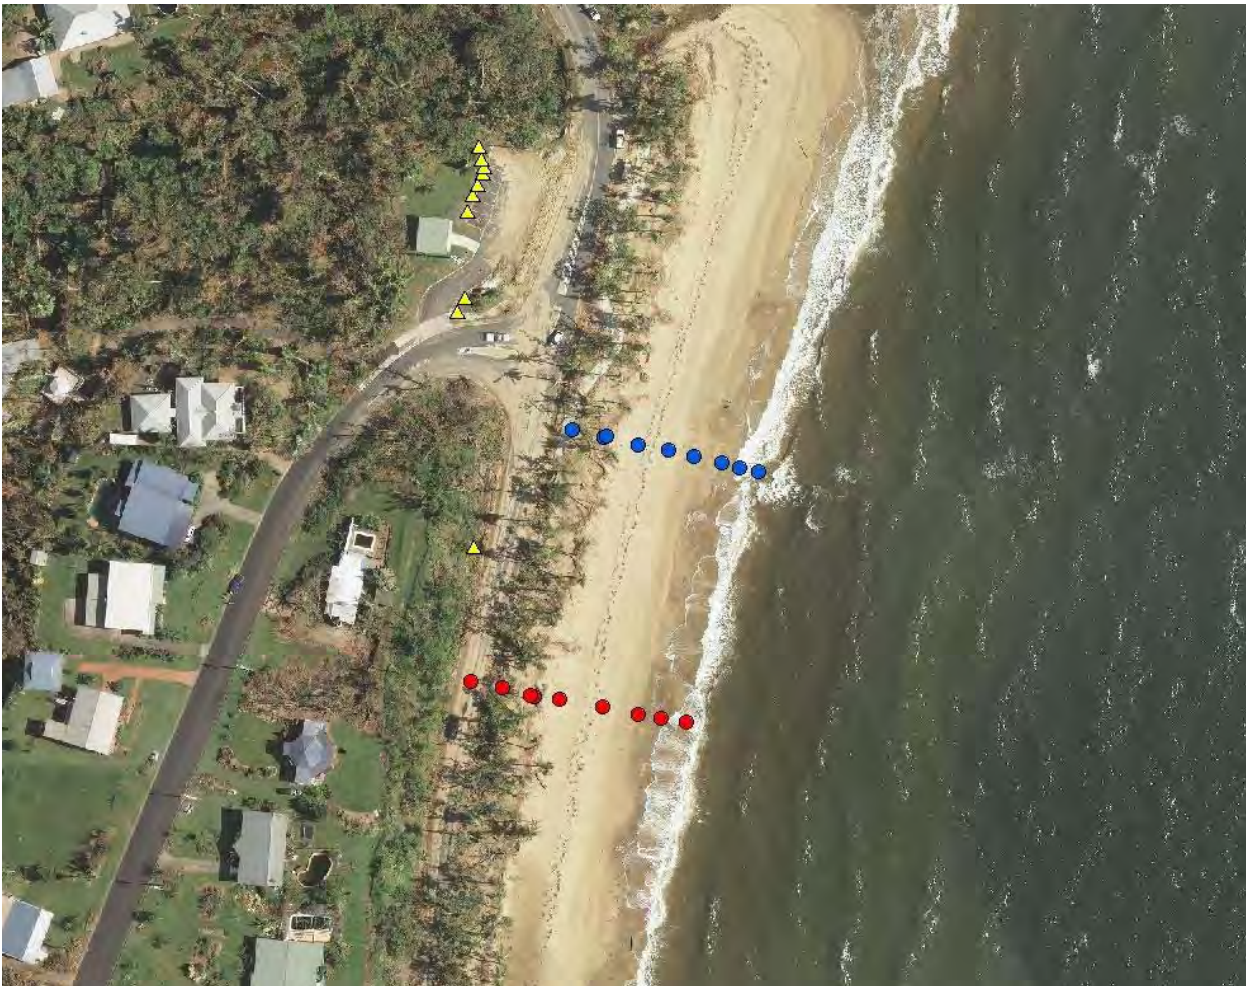
Cyclone impacts: Evidence of TC Yasi's impacts to the Bingil Bay region included vegetation damage and damage to the road connecting Bingil Bay and Clump Point. Evidence of the damaged road and debris lines located between Clump Point and Bingil Bay are an indication of the storm surge in this area. A peak surge of 2.97 metres above the predicted astronomical tide was recorded at Clump Point (3 kilometres to the south). The surveyed beach profile lines at Bingil Bay (Figure 20) did not extend to the debris line.

Figure 20: Bingil Bay surveyed beach profiles and debris lines (yellow triangles)

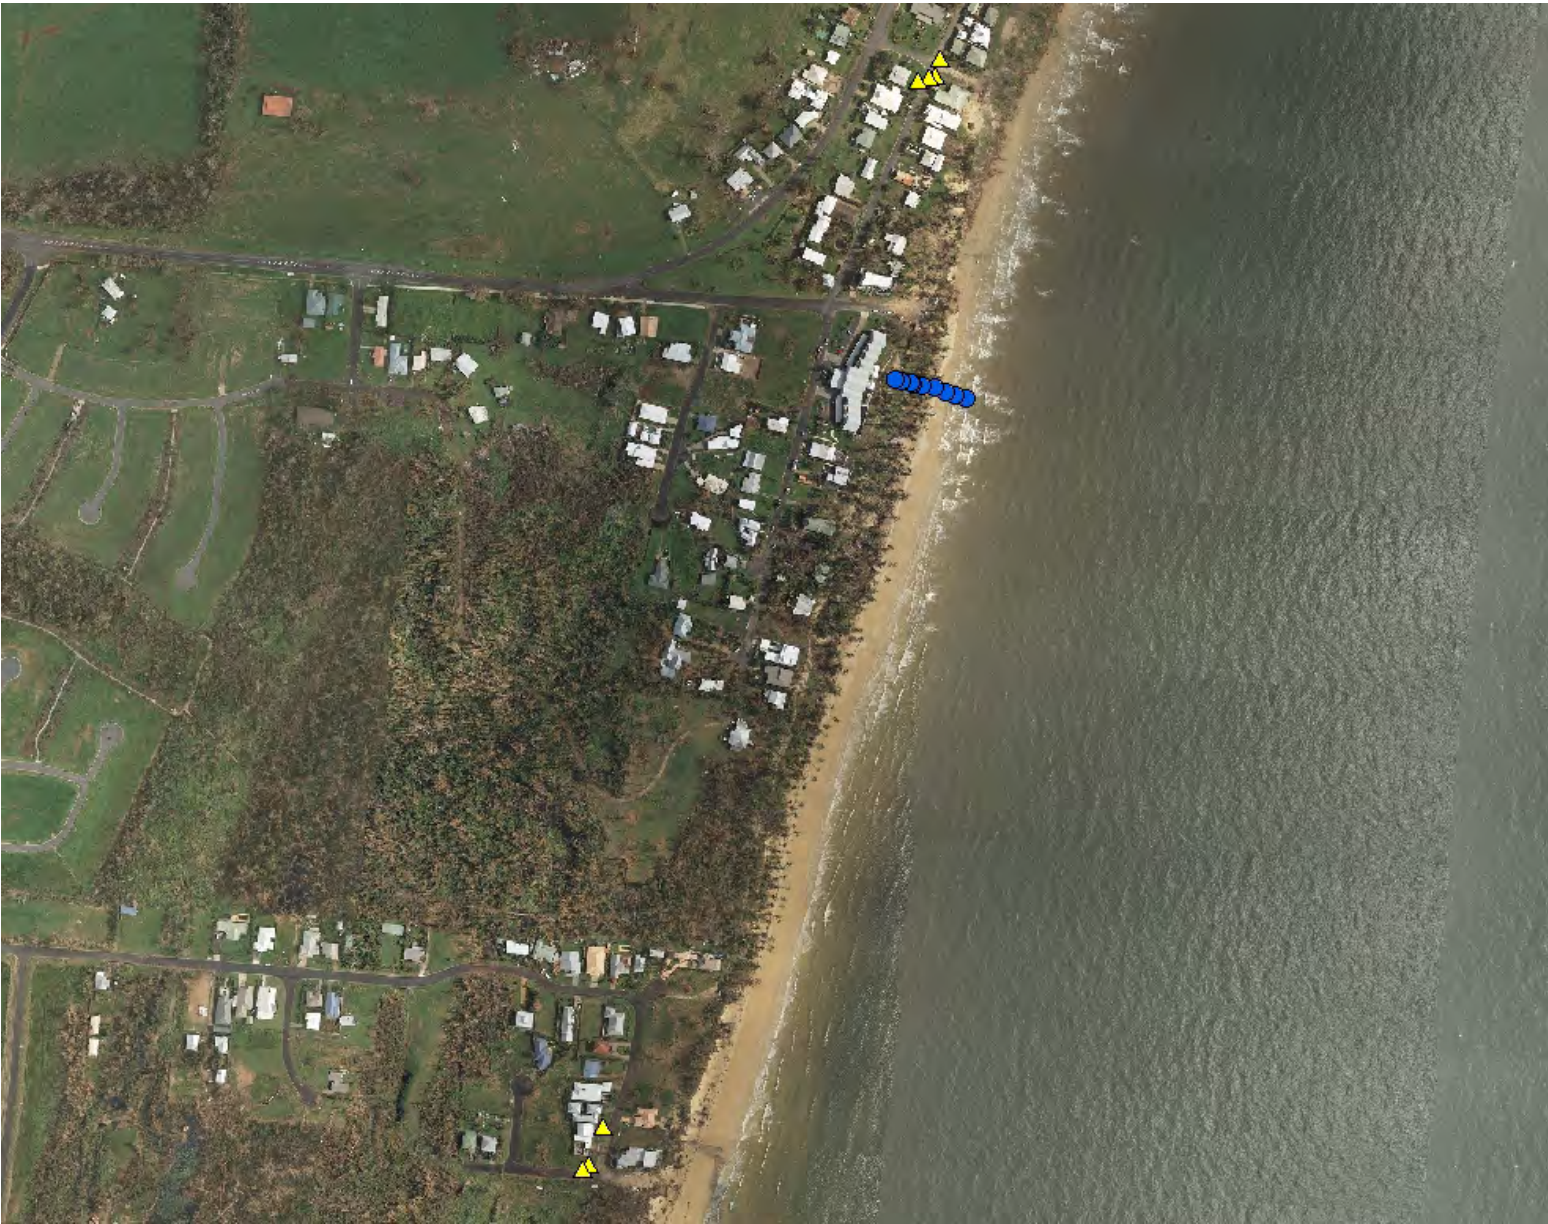
Debris Lines: Debris deposits of up to 1 metre high were found in low set beach front houses. Debris lines to a height of 3.5 metres AHD were recorded.

Figure 24: Mission Beach surveyed beach profile and debris lines (yellow triangles)

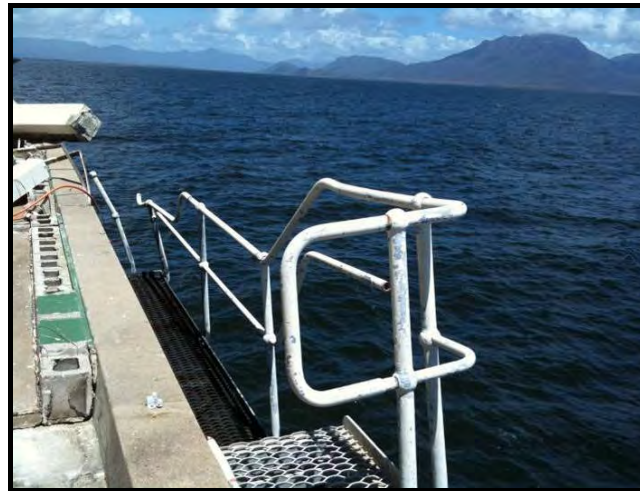
Photograph 33: DSITIA's offshore storm tide gauge at Lucinda - destroyed by TC Yasi (Source: DSITIA)

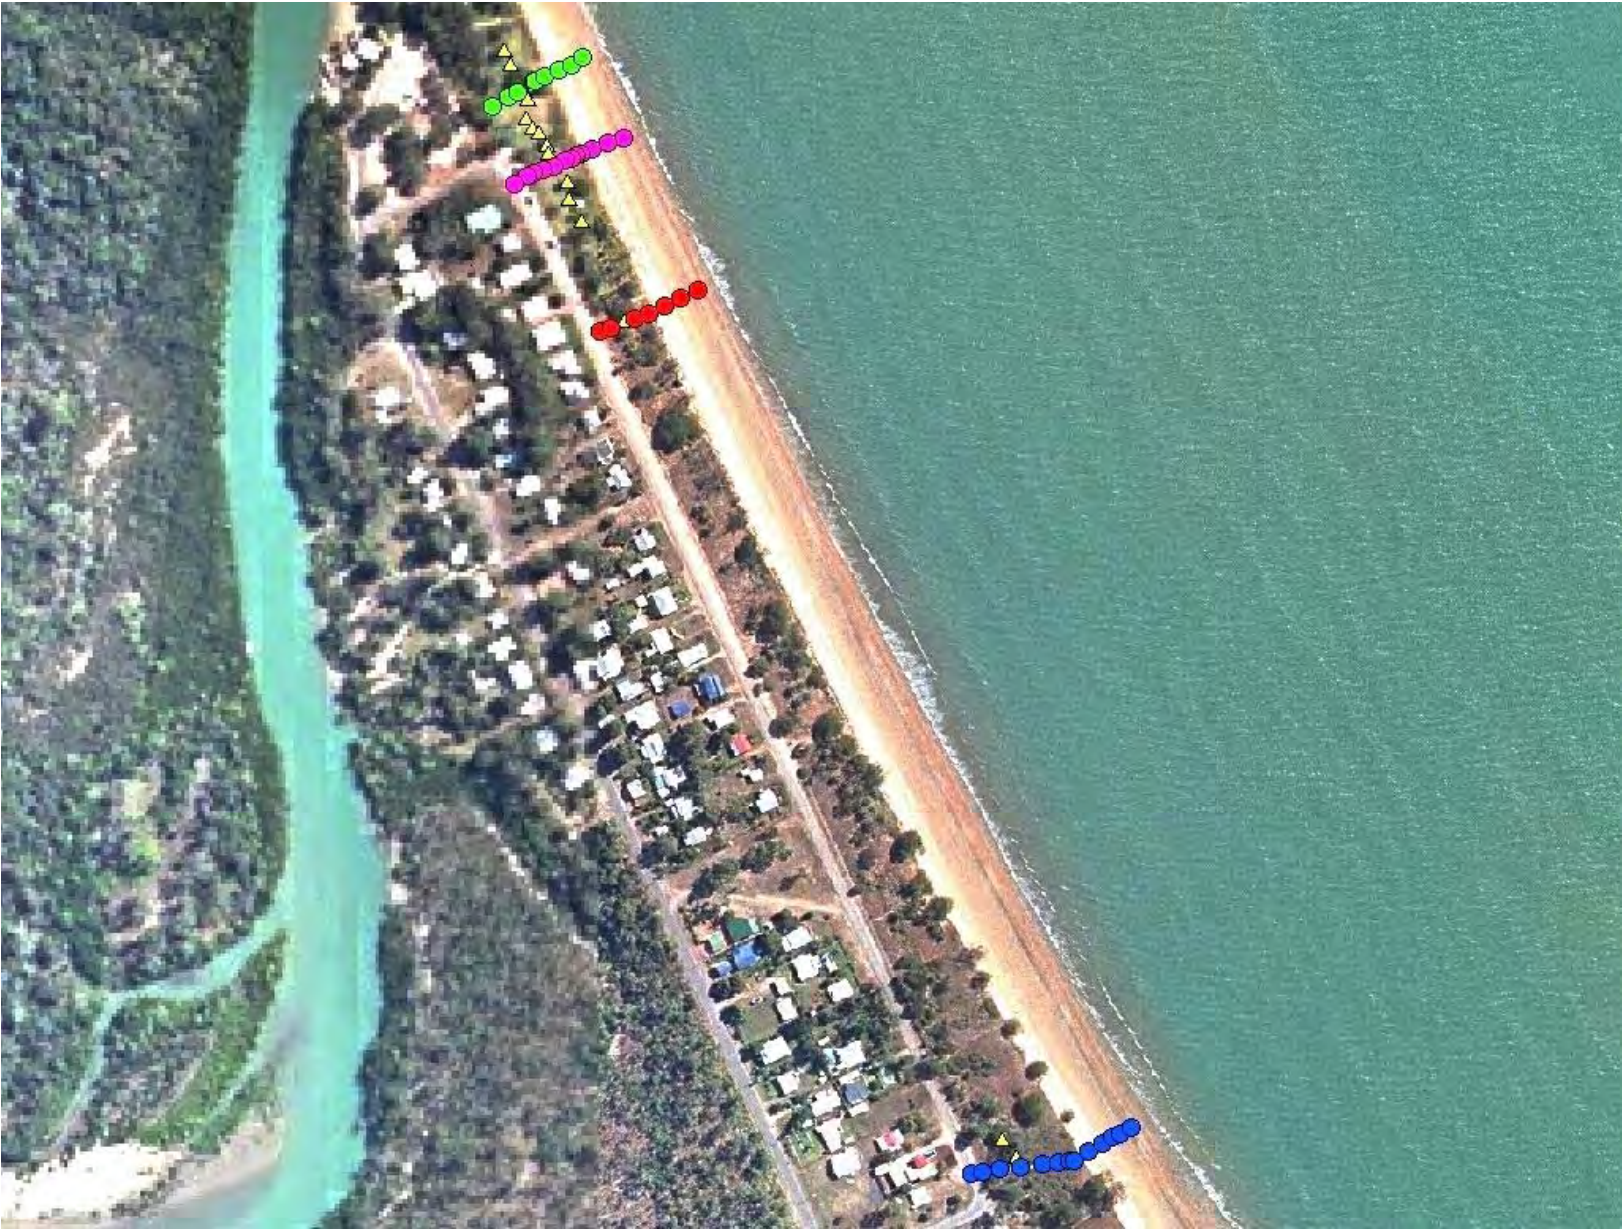
Cyclone impacts: TC Yasi had little effect on infrastructure or property at Balgal Beach, except for superficial damage to the playground near Tooth Street. A significant volume of sand was eroded from the dune system on the foreshore, leaving a scarp which varied vertically from 0.5–1 metre.

Figure 36: Balgal Beach surveyed beach profiles and debris lines (yellow triangles)

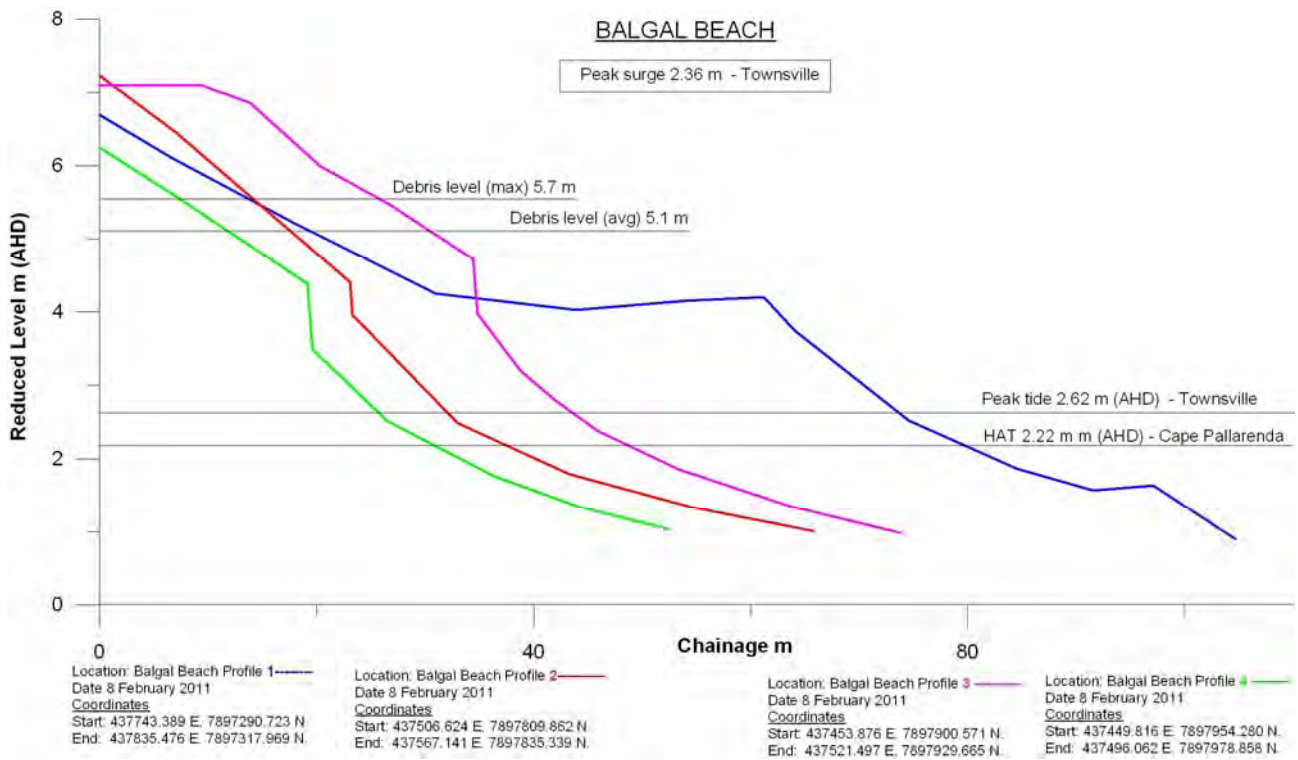
Figure 37: Beach profiles and debris levels surveyed at Balgal Beach

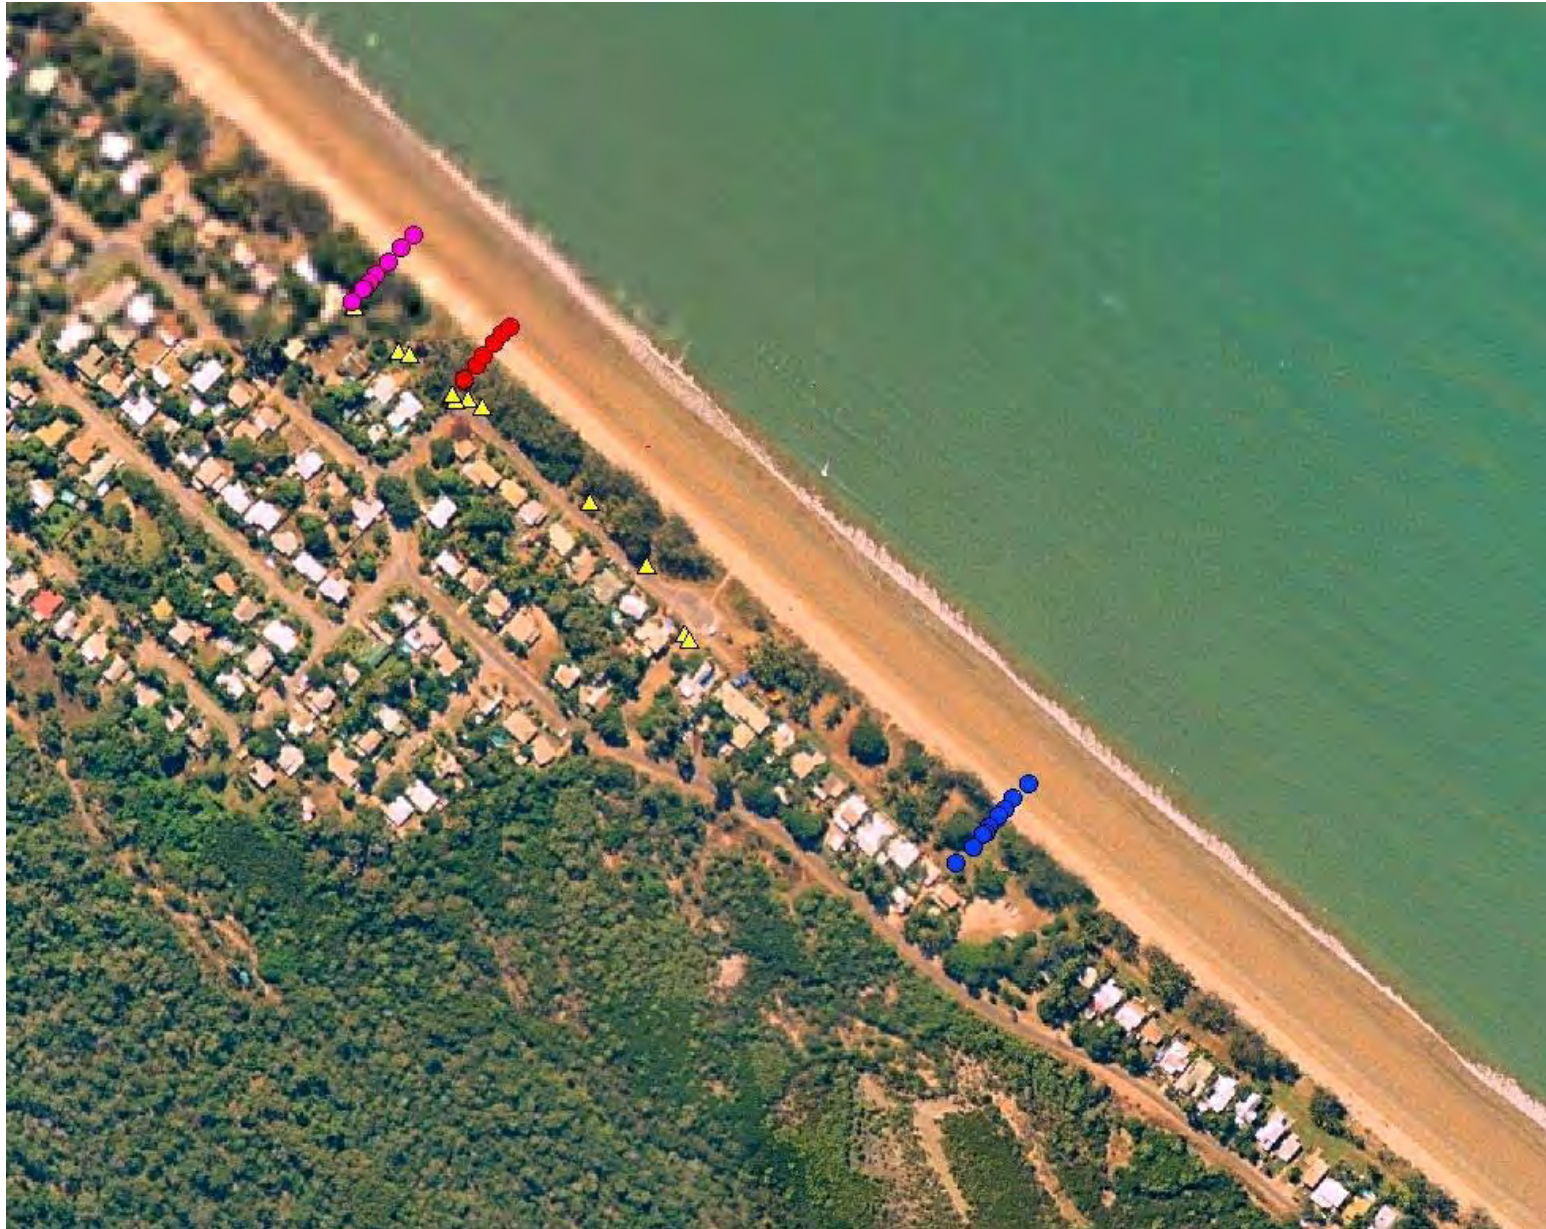
Cyclone impacts: The wind and storm surge associated with TC Yasi at Saunders Beach resulted in some sand infiltration across the foredune into the vegetated backdune, the foredune had also receded due to the storm activity between 2–10 metres. Approximately 50 per cent of the vegetation on the ocean-side of the foredune was undermined and ultimately collapsed due to the active sea state.

Figure 38: Saunders Beach surveyed beach profiles and debris lines (yellow triangles)

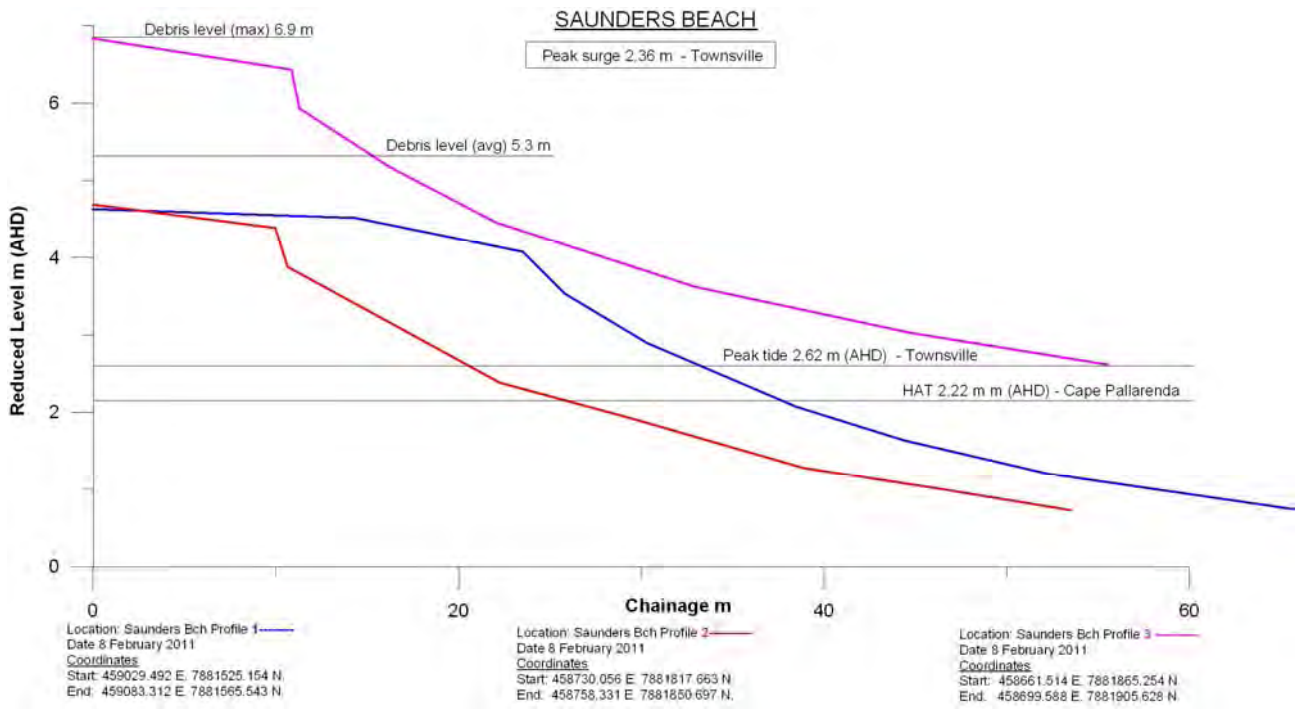
Figure 39: Beach profiles and debris levels surveyed at Saunders Beach

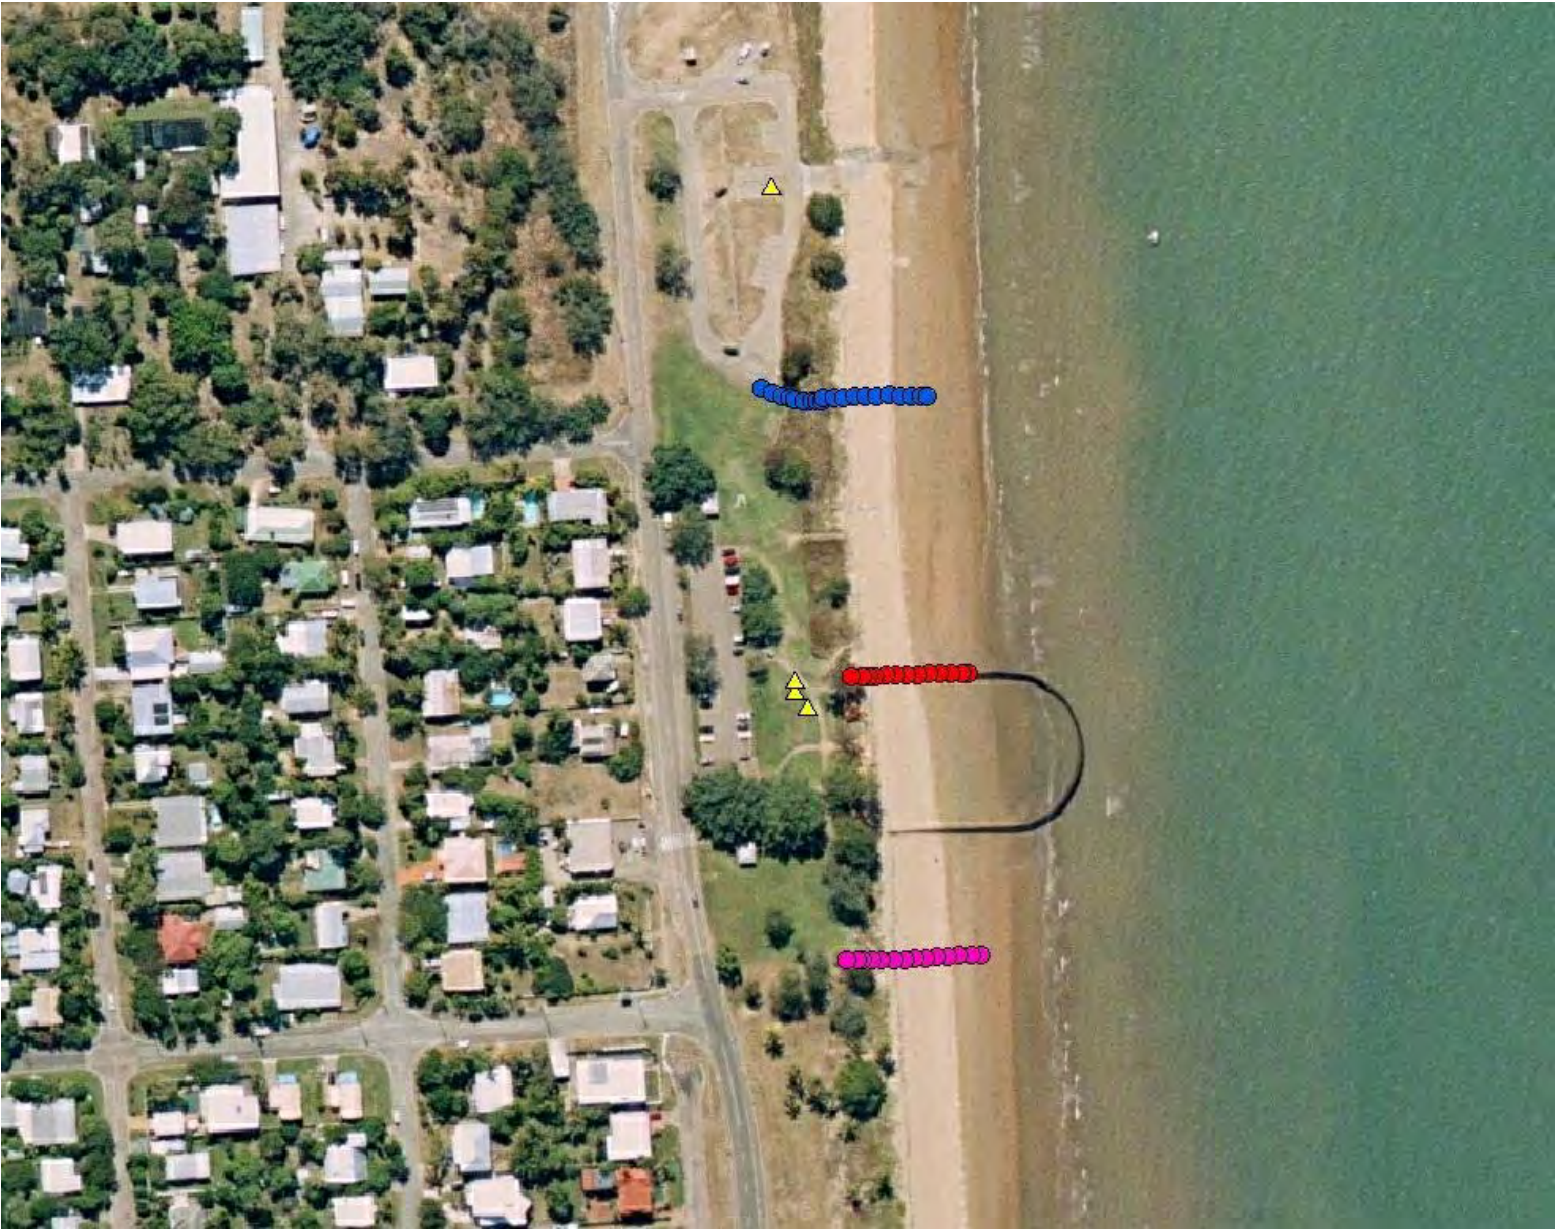
Cyclone impacts: Significant sand infiltration was notable at Pallarenda, but the rapid response of council made discerning the upper limits of the storm surge difficult. The previously intact swimming enclosure was destroyed and a yacht had been relocated to the foredune.

Figure 40: Pallarenda surveyed beach profiles and debris lines (yellow triangles)

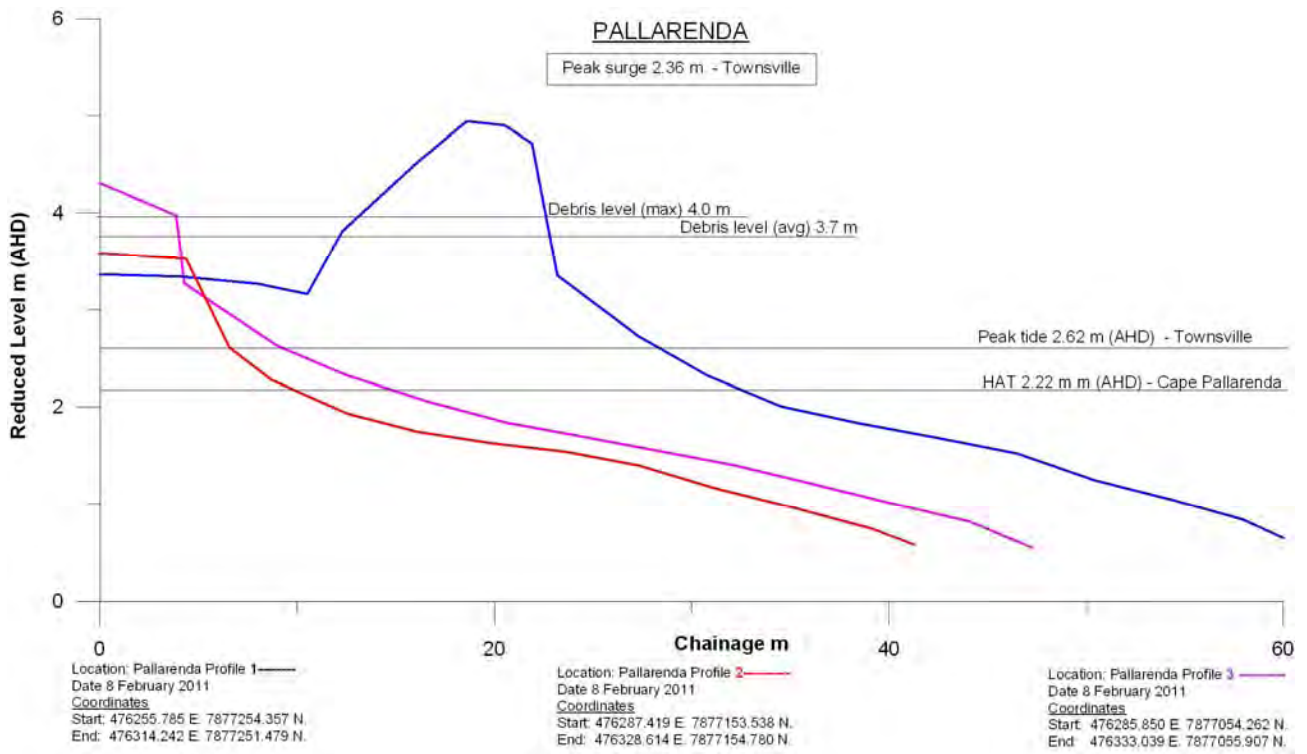
Figure 41: Beach profiles and debris levels surveyed at Pallarenda

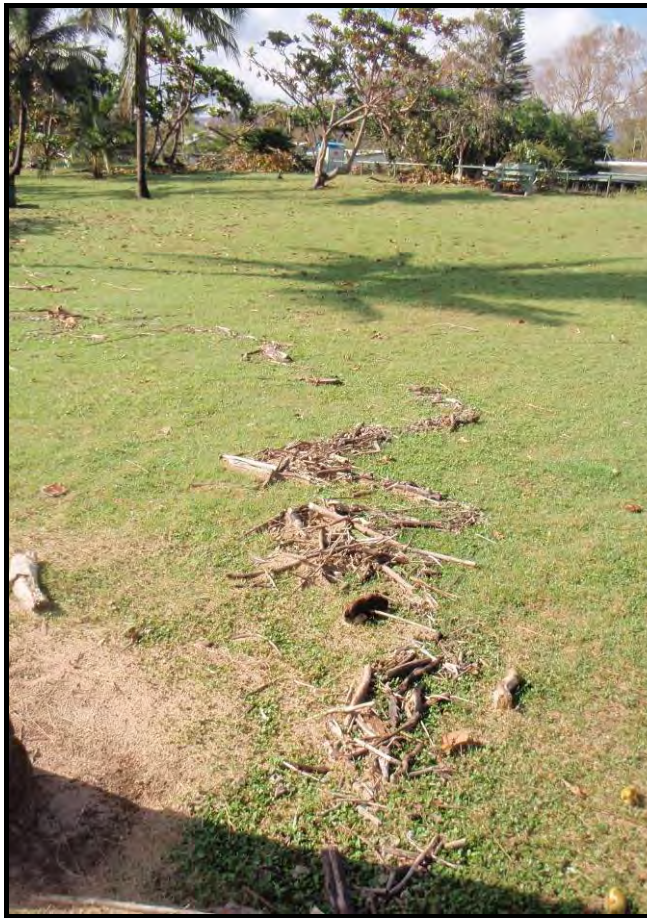
During the field inspection, debris lines were surveyed by the Coastal Impacts Unit at all locations identified in Section 3. The debris lines consisted mostly of pumice and vegetation as seen in photographs 41 and 42. Water marks on some structures (seawalls / public amenities) were also surveyed where relevant. A Real-Time-Kinematic (RTK) differential GPS system was used to measure (± 0.02 metres) the elevation of the debris lines using known Permanent Survey Marks (PSMs) which relate the debris levels to Australian Height Datum (AHD). The surveyed inundation levels are presented in Table 5.

Photograph 41: Debris line used to survey storm tide inundation level (Source: DSITIA)

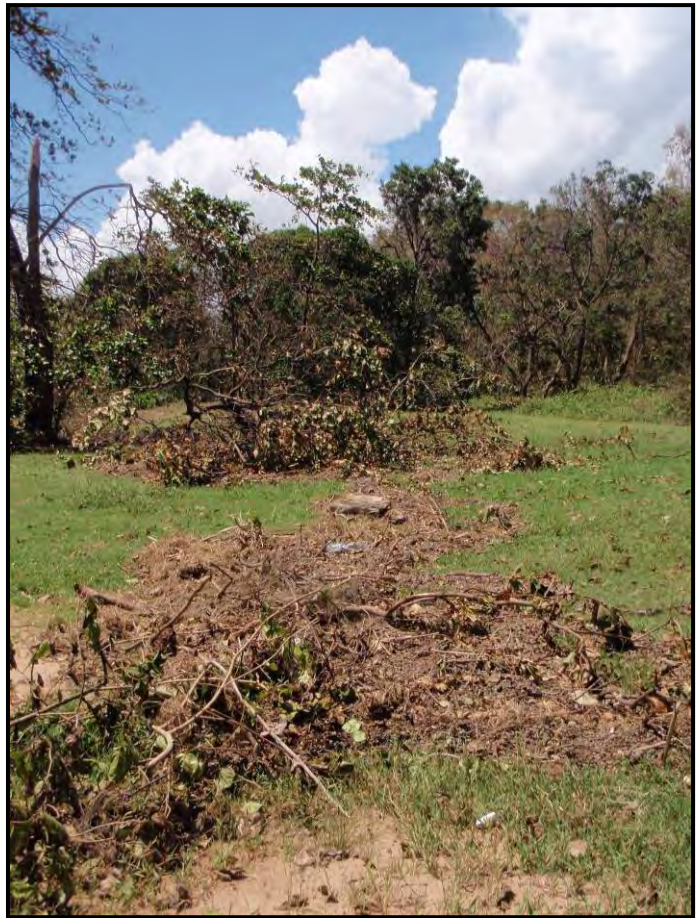
Photograph 42: Debris line used to survey storm tide inundation level (Source: DSITIA)

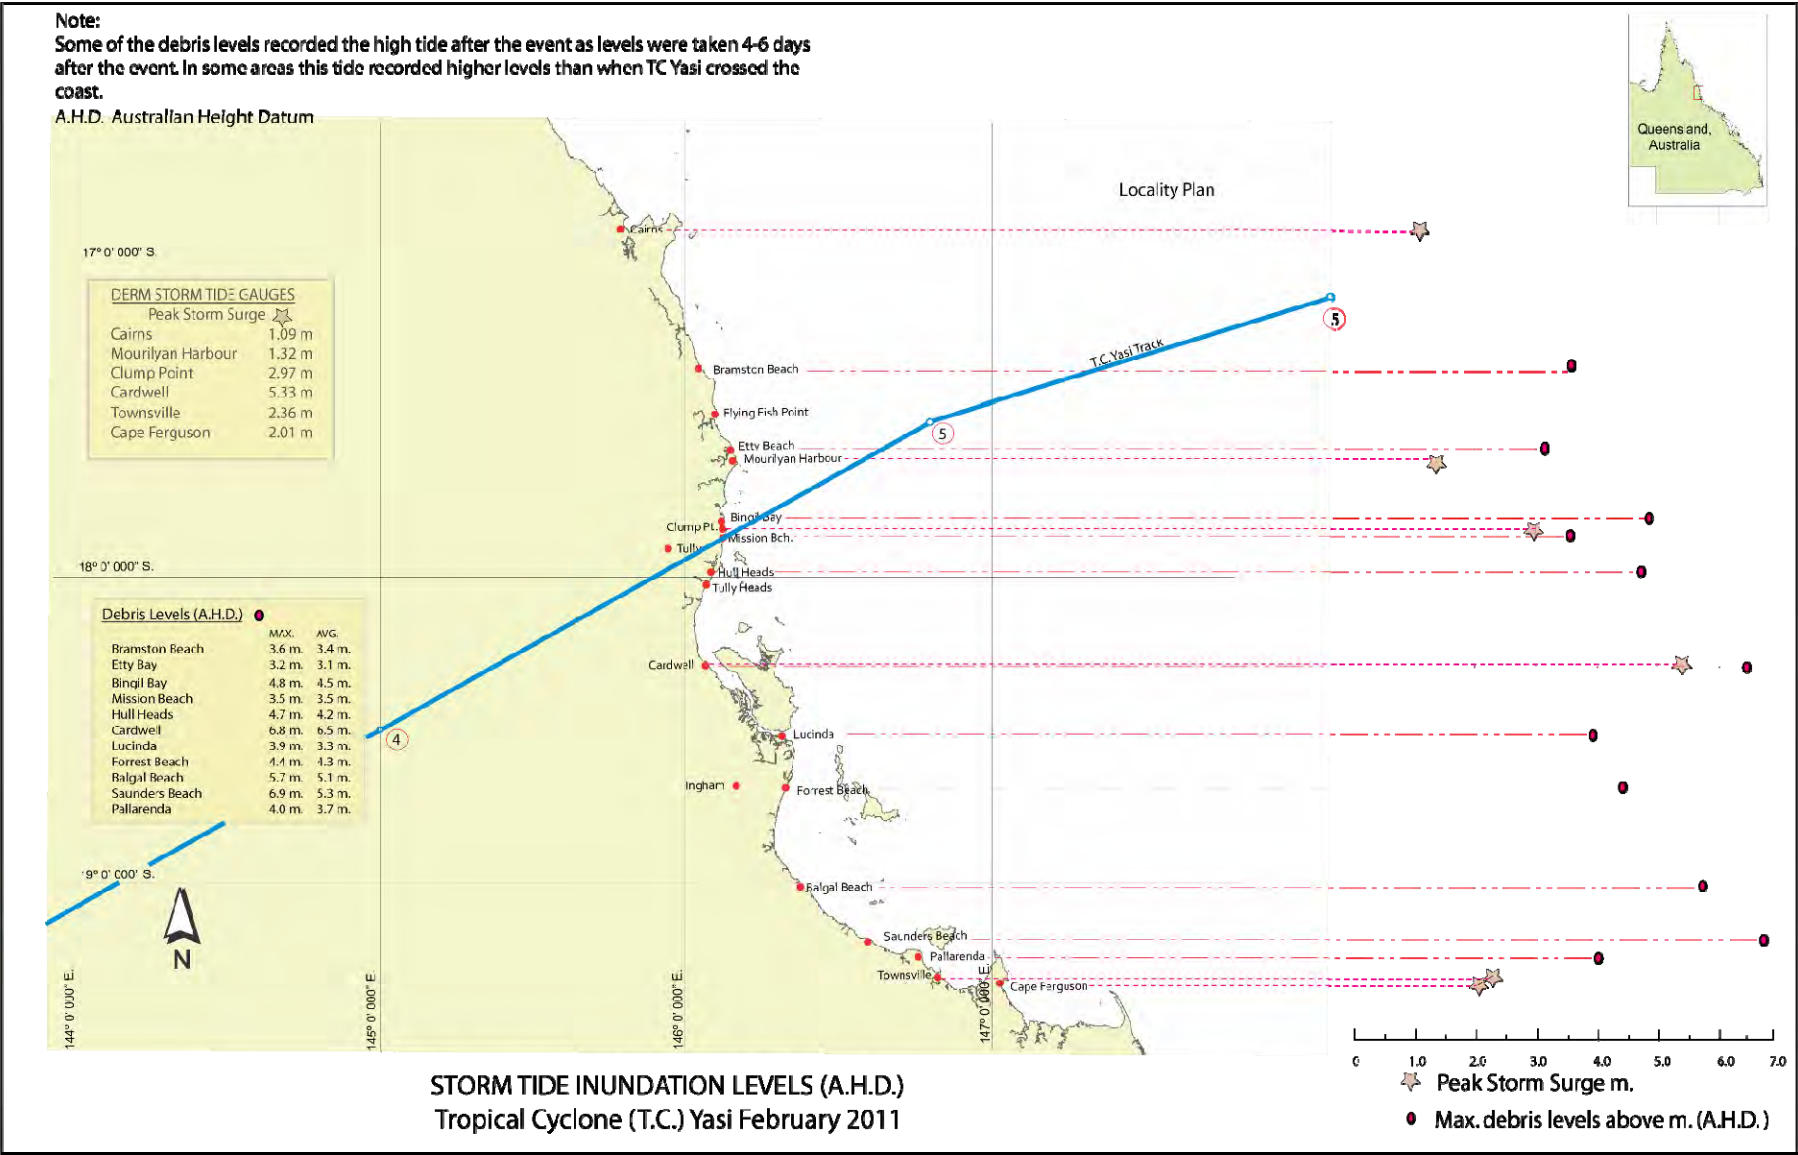
Location	TC Winfred (metres AHD) 1986	TC Larry (metres AHD) 2006	TC Yasi (metres AHD) 2011
Etty Bay	3.7	4.5	3.2
Bingil Bay	–	5.2	4.9
Clump Point		3.9	–
Mission Beach	2.6	3.5	3.5
Hull / Tully Heads	–	3.2	4.7
Cardwell	–		6.9

Figure 43: Storm tide inundation levels surveyed following TC Yasi
