Tropical Cyclone Larry

Supplementary Coastal Field Investigation

Coastal Sciences technical report

April 2007

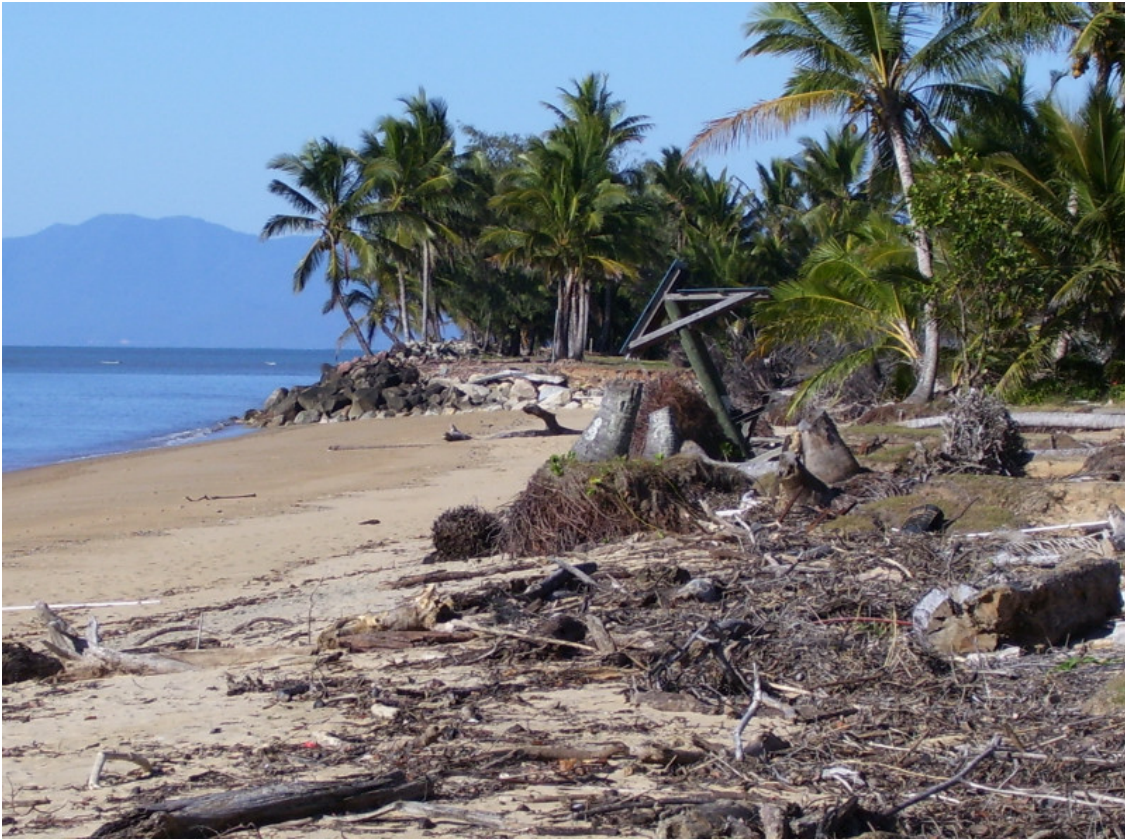
Tully Heads

The beach on the southern side of the boat ramp was in good condition, with a gentle slope from the vegetation line to mid way down the beach where the gradient increases and then flattens out in the intertidal zone. The erosion on this side of the boat ramp varies from about 0.5m to 1m high around the bases of the palm trees.

Looking south from the boat ramp

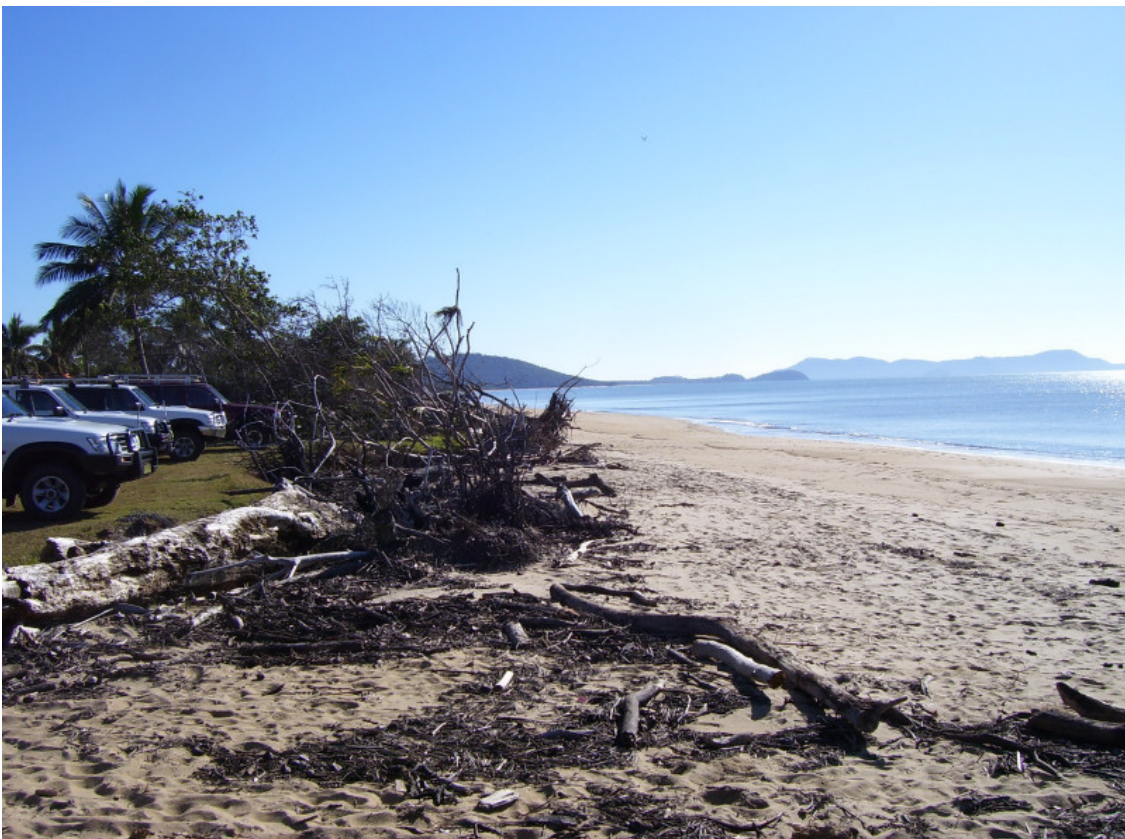
The beach on the northern side of the boat ramp, in front of the caravan park, was in a worse condition. The slope of the beach was still gentle, though the level of the beach was much lower, than the beach on the southern side of the boat ramp. A large amount of sand had been dumped in front of the caravan park, along the vegetation line, likely for beach nourishment, though no work had started. Due to the deposition of this sand, it was hard to determine the size of the scarp that is threatening the caravan park, however a 2m scarp was evident just on the northern end of the rock adjacent to the boat ramp.

Looking north from the boat ramp

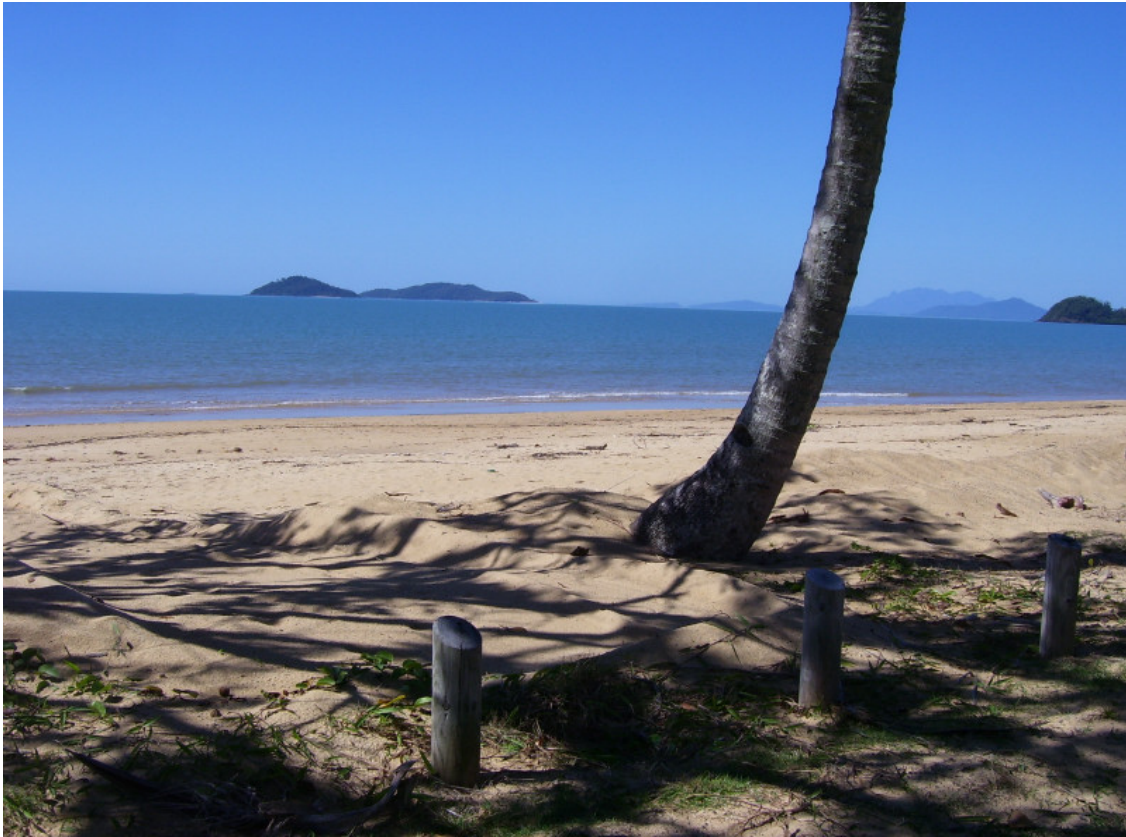
South Mission Beach – Beach Profile 9

base of the trees. The beach slope from the small crest and swale to the water was gentle. There was little erosion visible in the area, though the sand dumped around the trees suggests that there may have been some erosion. See Figure 12 for the location of beach profile 9.

Beach profile 9 along Kennedy Esplanade

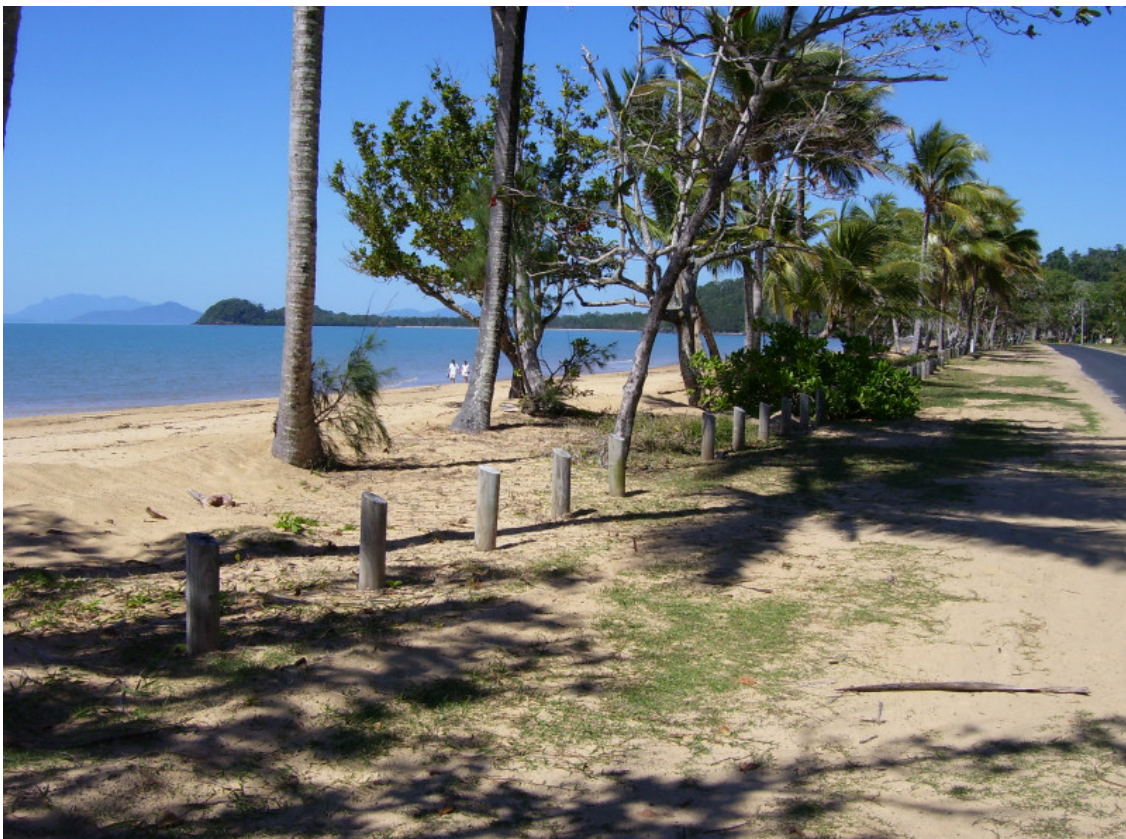
Beach profile 9 along Kennedy Esplanade

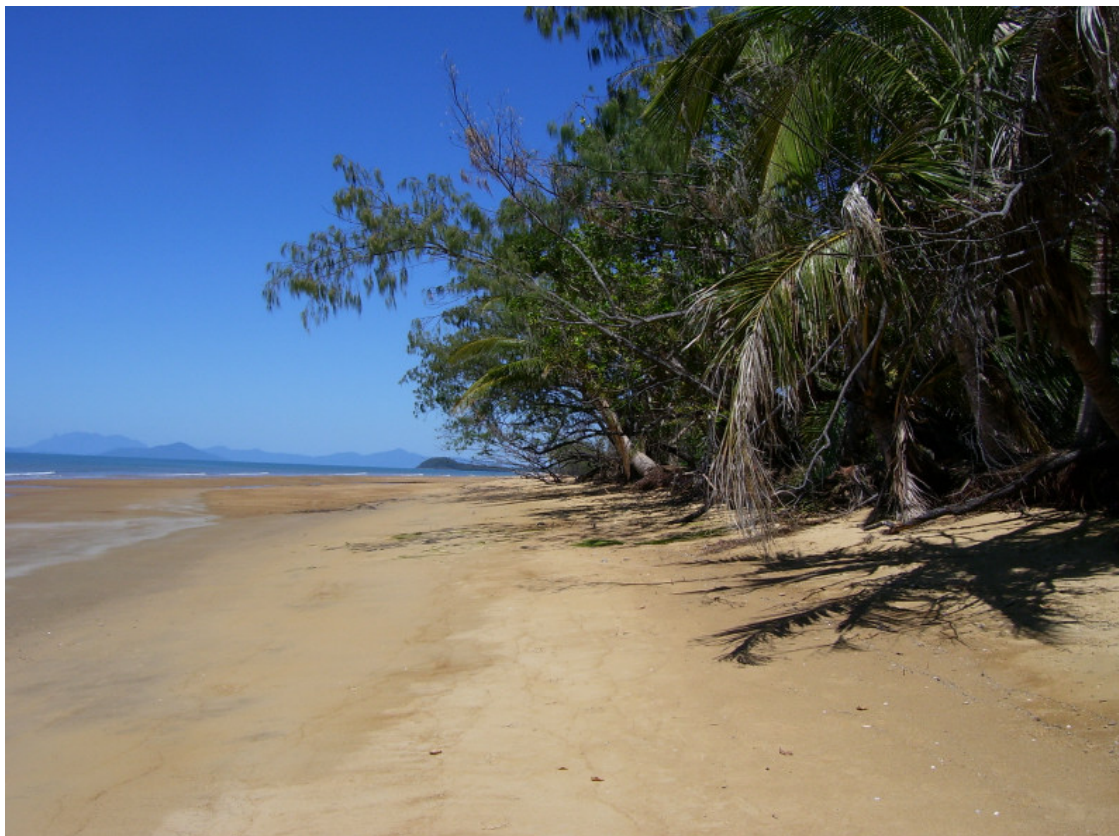
Looking south from the park at the southern end of Wongaling Beach

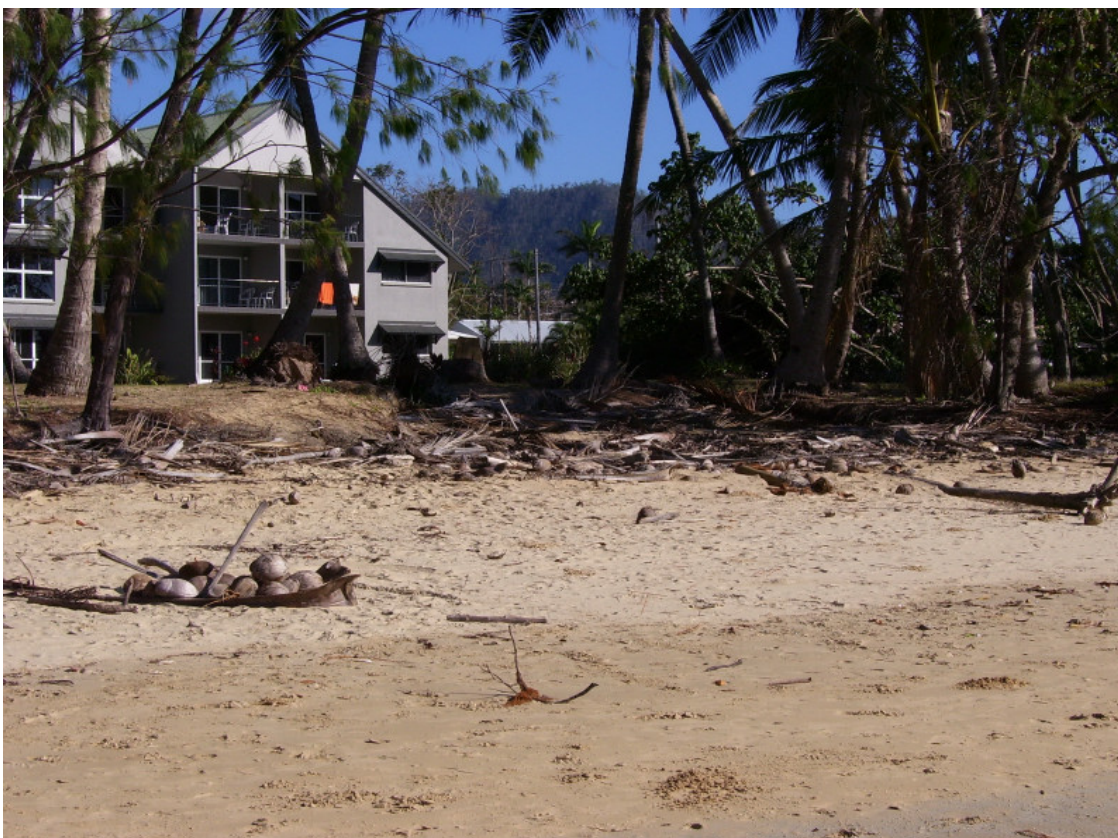
Replicate of photo taken in the March report of Castaways

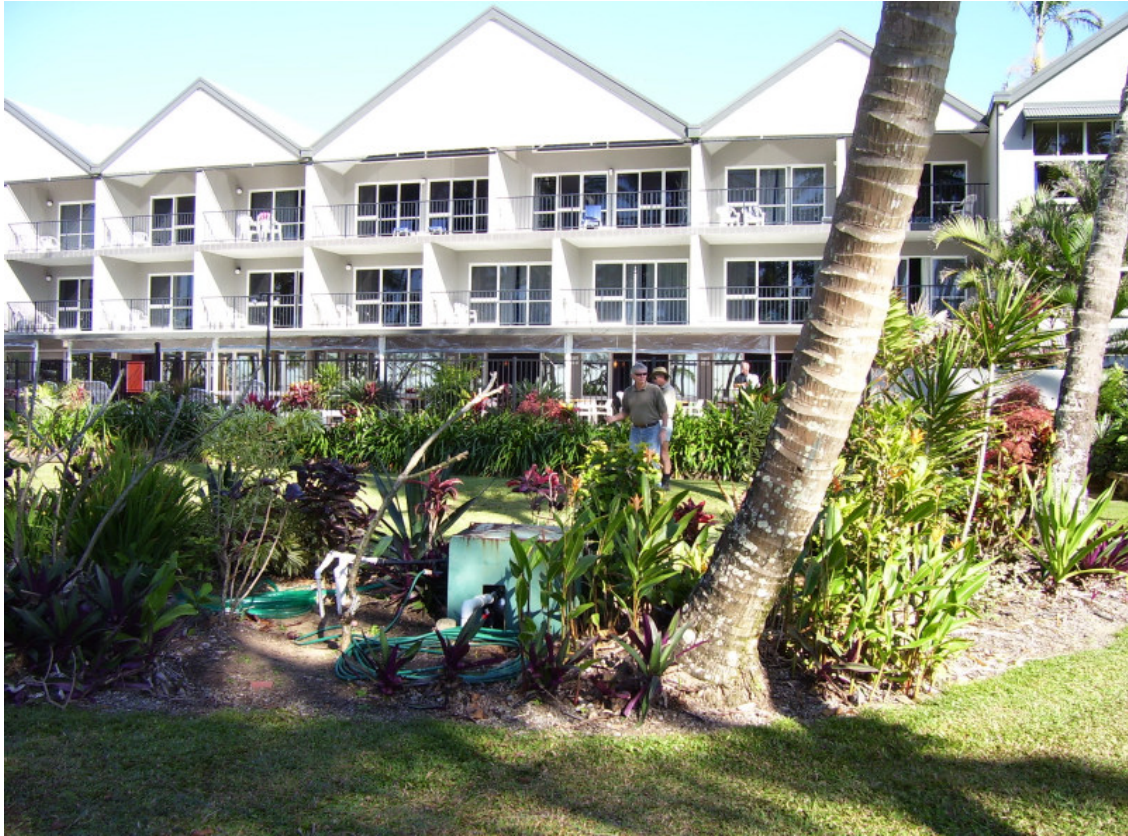
Location of inundation line in front of the pool at Castaways (when men are standing)

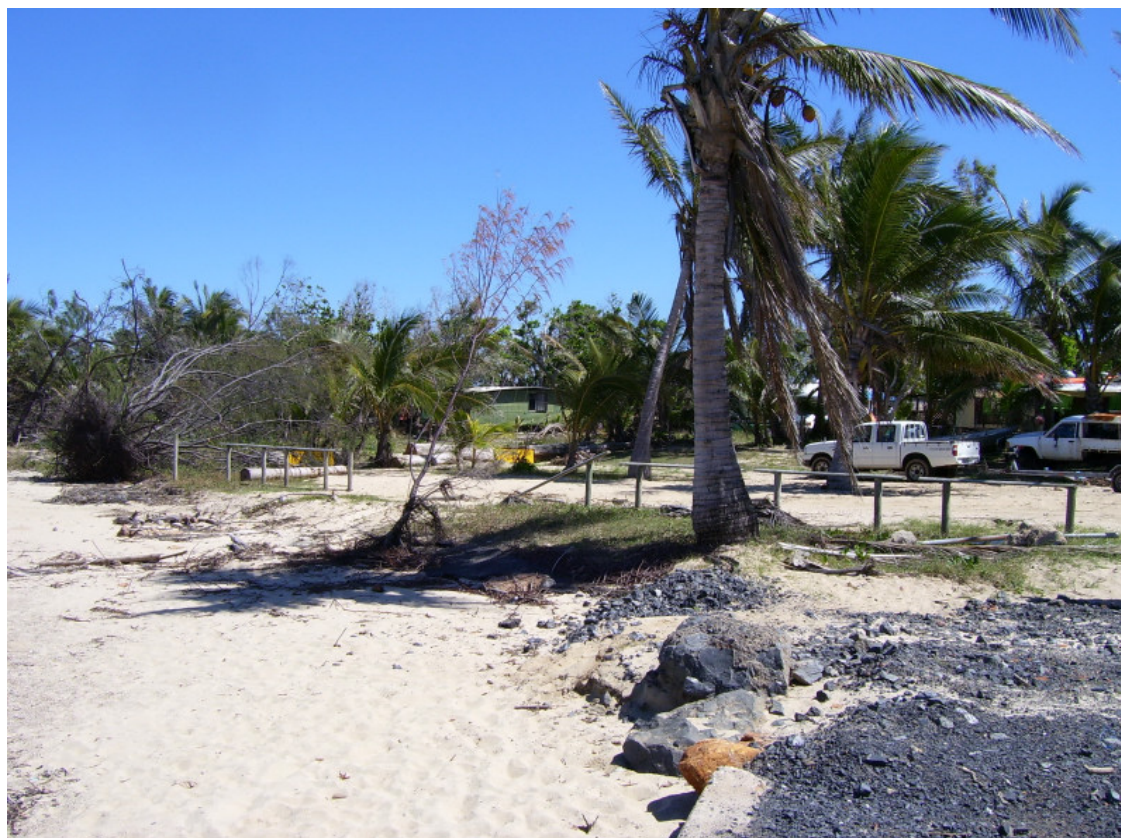
Cowley Beach

Cowley beach is about 19km south of Innisfail and was getting towards the region of maximum winds to the south of the cyclone track. The beach profile survey was conducted approximately at the site of a COPE site. This is at the northern end of Cowley beach. The slope from the vegetation was steeper than other beaches in the region, and then it flattens out at the intertidal zone. Some sand shoals were present around the observed watermark, in the near shore area. The inspection took place about 2 hours prior to low tide.

Looking at the caravan park on the southern side of the boat ramp

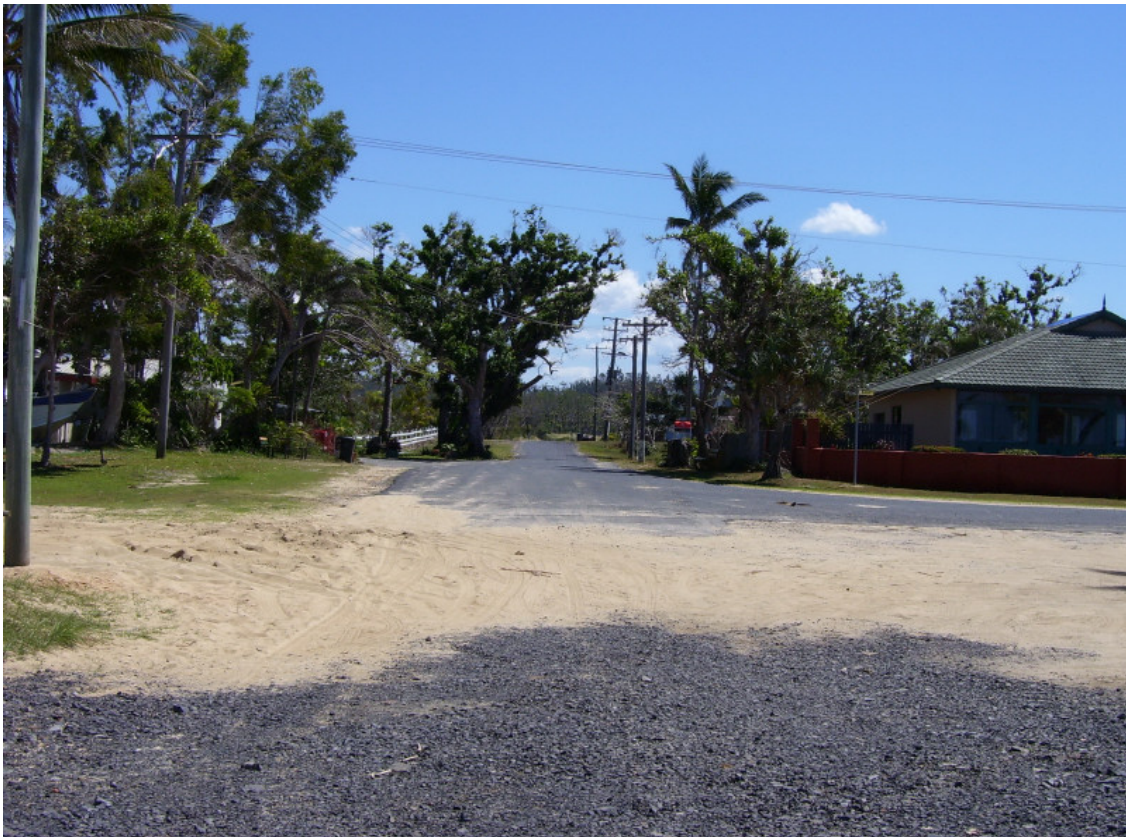
Looking down Bambrook Avenue, the house of the right had water in the back yard and the pump box as shown in the next photo

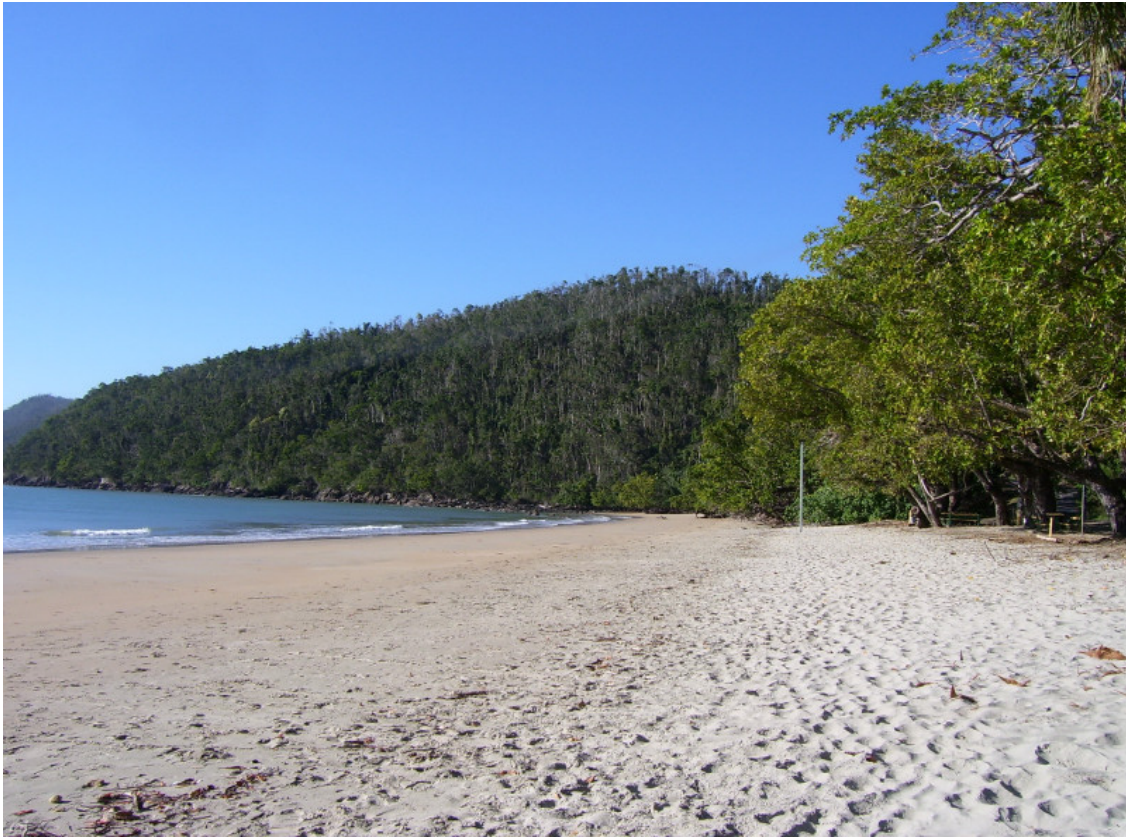
Etty Bay is located just south of Innisfail and in close proximity to where TC Larry crossed the coast. The beach was in a good condition, with a gentle beach slope from the upper beach to the middle of the beach, it then flattens out into the intertidal zone. There was no erosion scarp present. There was a small amount of debris present around the palm tree line at the back of the beach. No sand shoals or bars were observed in the offshore or near shore area; however it was close to high tide at the time of the inspection.

Looking south, from in front of the stinger net winch

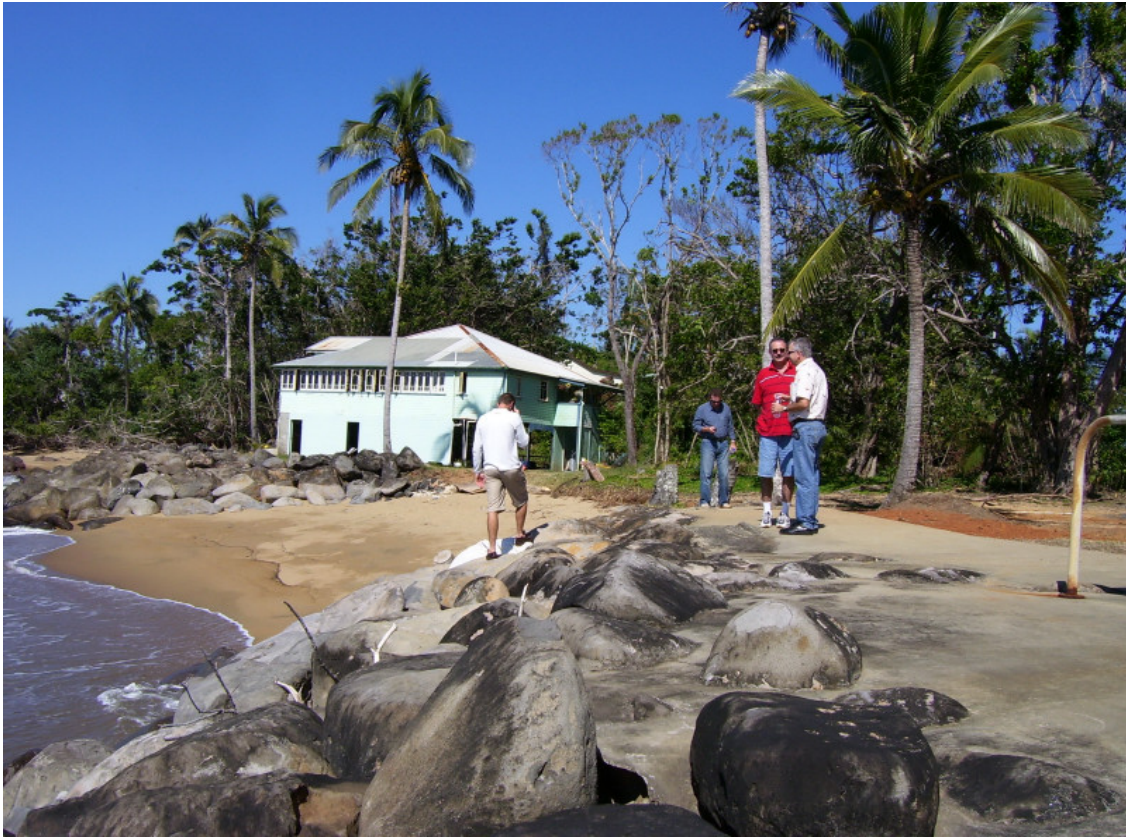
Looking south from in front of the toilet block at the southern end of Flying Fish Point

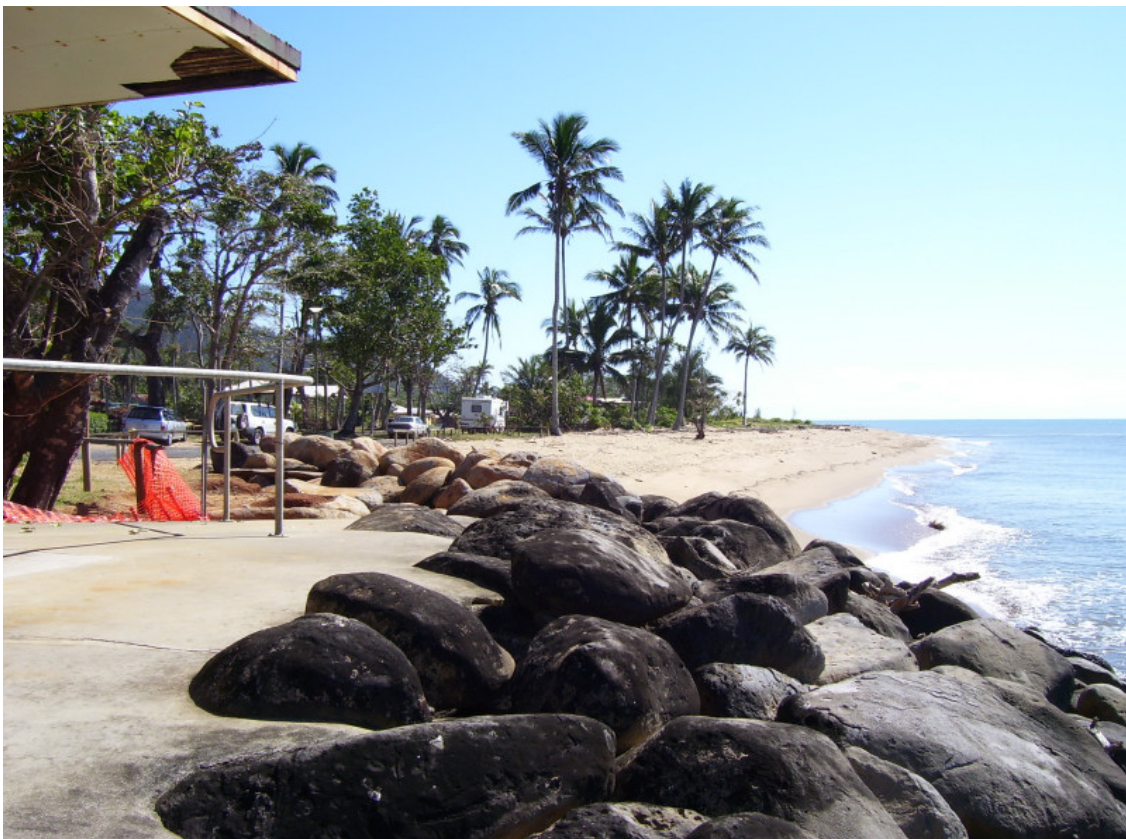
Looking north from in front of the toilet block at the southern end of Flying Fish Point

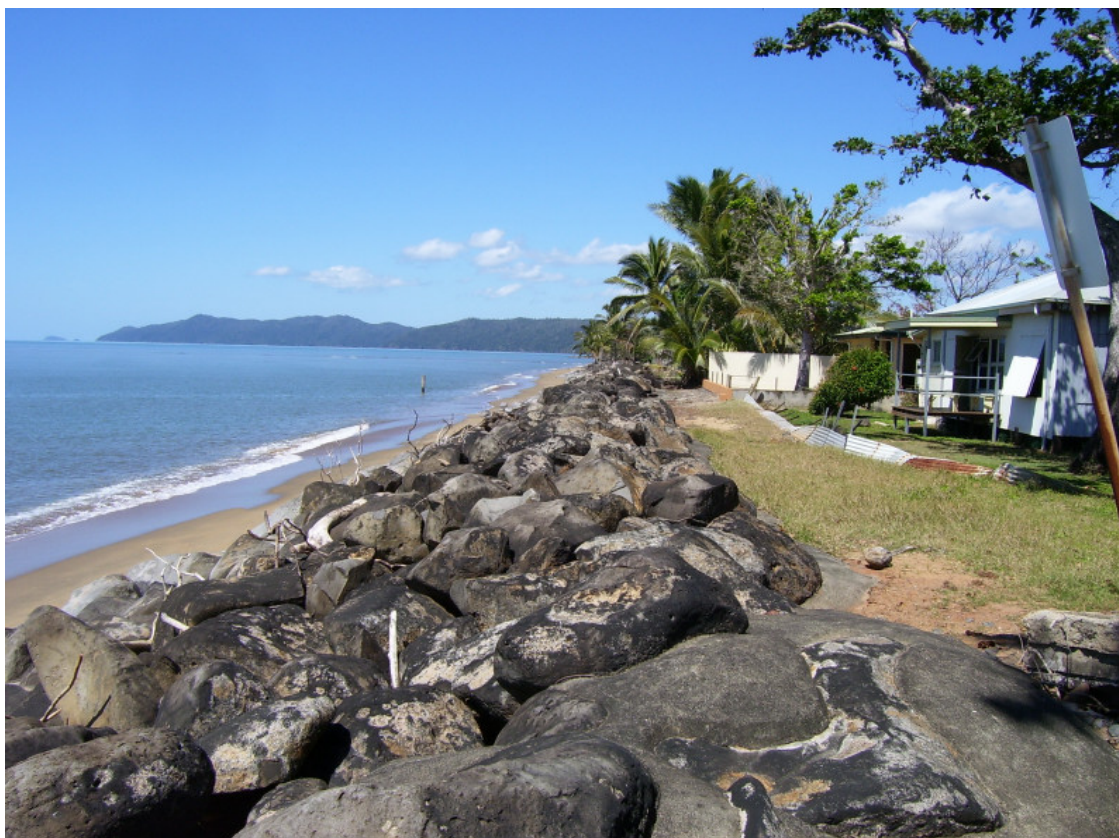
Flying Fish Point – Rockwall

The rockwall at the northern end of Flying Fish Point was in good condition. There was erosion behind the rock, though this was not as significant as the erosion behind the wall at the toilet block to the south. The erosion behind the wall is about 0.2m to 0.3m in depth, and is a narrow strip of erosion. The beach here was in a good condition, with a gentle slope into the intertidal zone. No sand bars or shoals were evident at this location.

Looking south from the corner of George Street and the Esplanade

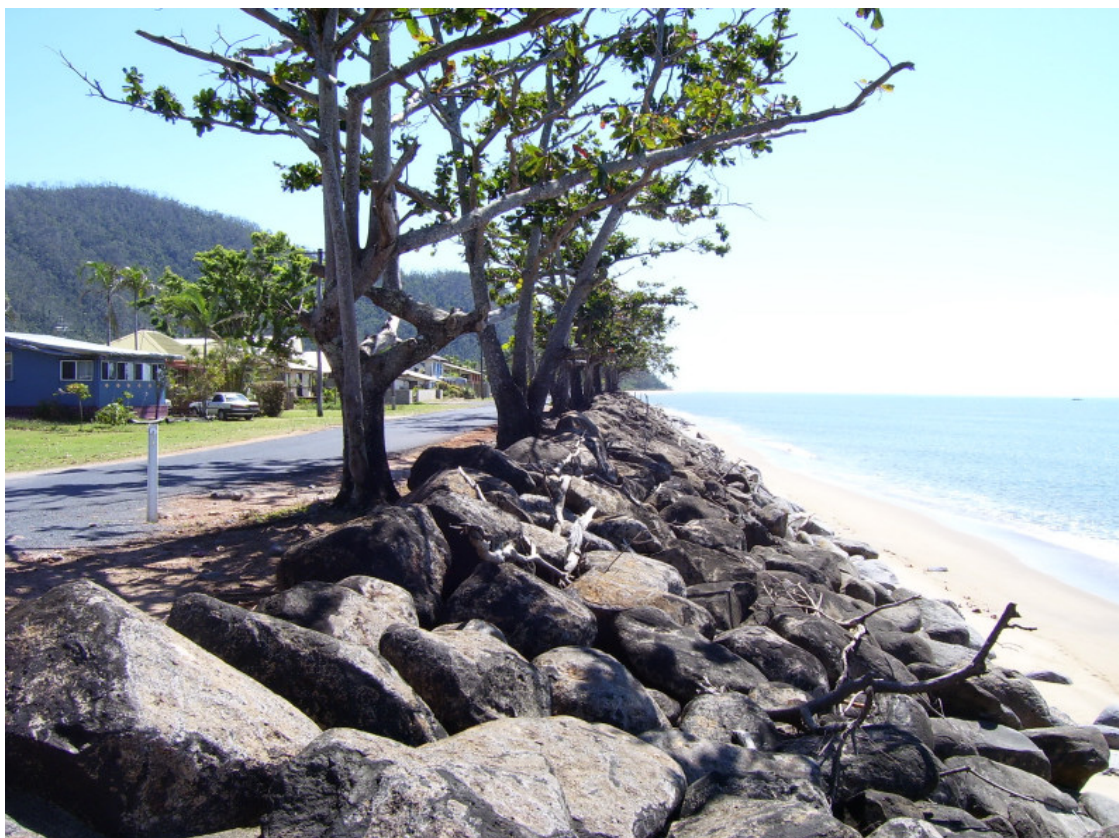
Looking north from the corner of George Street and the Esplanade
