# Report: Level 1 emergency exercise

**Exercise location:** Anglo American Aquila Coal Mine

**QMRS-focused event exercise date:** Wednesday, 13 September 2023

**Mine-focused event exercise date:** Tuesday, 7 November 2023

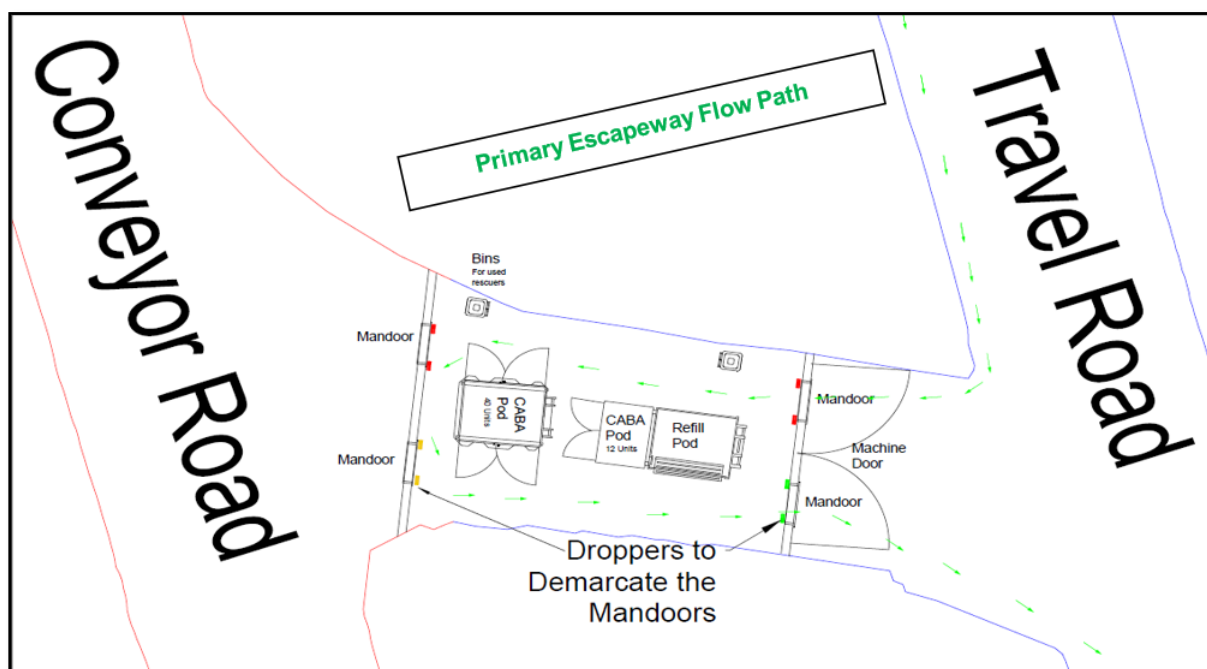
Figure 21: Example of a primary COB at Aquila Mine

Change-over Bays (COBs) are provided underground at 1300m intervals. In an emergency requiring CMWs to use their belt worn SCSR, a second SCSR is collected from the crib room caches in the working areas. The crew members then drive or walk to the COB closest to their work area. A differential pressure inside the COB, created by the difference in velocity pressure between the roadway ventilation and the air in the COB, provides a safe environment for the change over from SCSR to CABA. A regulated air-curtain at the entrance to the COB reduce the risk of contamination from polluted air outside the COB. These air showers are manually adjustable to ensure minimum usage of compressed air, including preventing any discharge when not used in an emergency or to reduce noise for communication purposes. A further planned enhancement is the use of a central diffuser to eradicate the noise issue.
