Fitzroy Resources Carborough Downs Coal Mine

Level 1 exercise report

Exercise location	Fitzroy Resources Carborough Downs Coal Mine
QMRS focused event exercise date	Sunday 30 October 2022
Mine focused event exercise date	Wednesday 23 November 2022
Report author	Geoff Nugent Inspector of Coal Mines and Chair 2022 State Emergency Exercise, Executive Management Committee

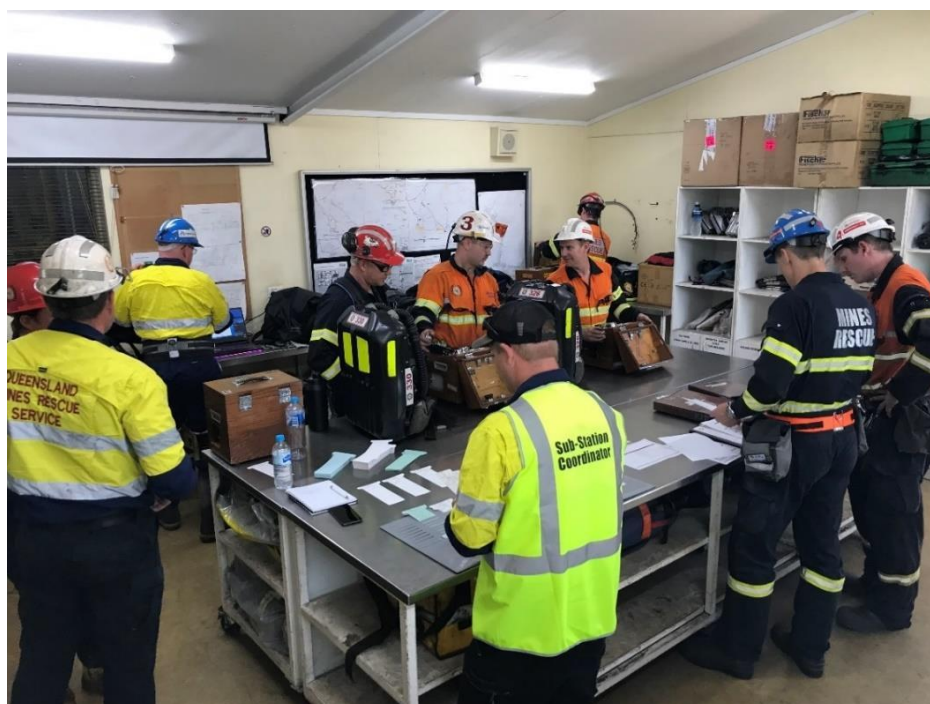
Figure 8 QMRS Substation Resource Management and testing BG4 Breathing apparatus

- Re familiarisation of team members in the structure of equipment deployment and requirements for testing if devices travel by road to a site. This should be done to validate the equipment is fit for use e.g., testing BG4's on the RZ25 or RZ7000 after travelling in trailers. May have jostled something loose.

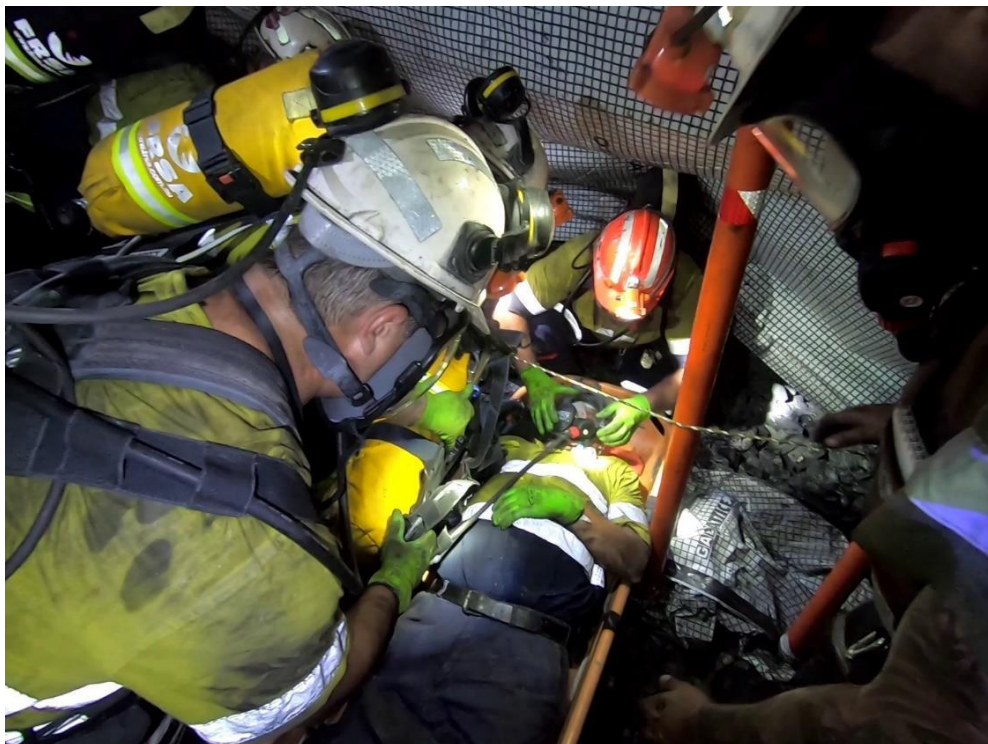
Figure 17 CABA being placed on injured CMW

1055hrs (Roadheader)	6ct Cribroom	- Performed change over from SCSR to CABA	- Crew were rushing the changeover/panicked - Attempted to start the SMV, attempted to call CRO - They cleaned the area once changeover was completed - During changeover CMWs headstraps become twisted, - CMW took off the CABA and changed it to a new CABA
----------------------	--------------	---	--
