Identifying acid sulfate soils

This and other science notes are available from the Queensland Government website www.qld.gov.au – search ‘science notes’ or for further information about this science notes series phone **13 QGOV** (13 74 68) – Ask for science notes – L61. Other science notes related to this topic include:

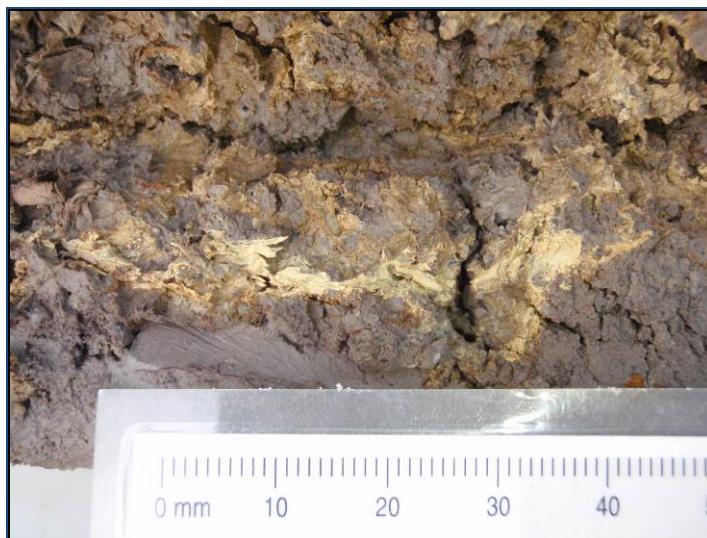
Jarosite is a yellow mineral and is the most conclusive field indicator that iron sulfides in acid sulfate soils are oxidising and forming sulfuric acid (Figure 1). Jarosite requires very acidic conditions (pH <3.7) to form.

Figure 1. Jarosite in a soil core from far north Queensland. The yellow mineral is soft to touch.

Zones of permanent or temporary ASS oxidation will often contain yellow and orange mottling. The yellow mottle is the mineral jarosite, and the orange shades will be various other iron oxide minerals. PASS may underlie disturbed ASS (Actual ASS or AASS), or the top of the PASS layer may simply be seasonally oxidised due to water table fluctuations. The thickness of the mottled layer, its degree of development, the soil moisture, and field test results will help to distinguish AASS.

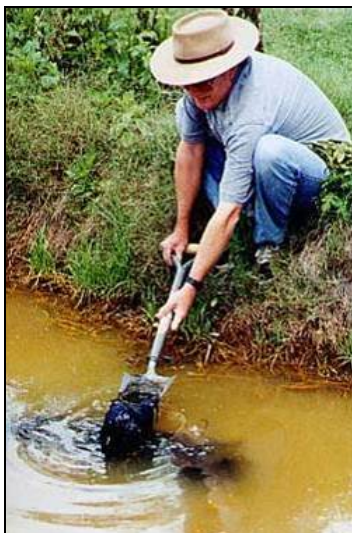
Monosulfides are unstable iron sulfides (FeS and related compounds) that can form at the bottom of slow-moving or still waters in acid sulfate soil prone areas, for instance in the bottom of paddock drains and residential canals (Figure 2).

Figure 2. MBOs in a coastal waterway.

MBOs look like a black gel and are very easy to disturb. When they are disturbed (by human activity or by flooding) they react within minutes, consuming dissolved oxygen and producing acid as they break down in the water.

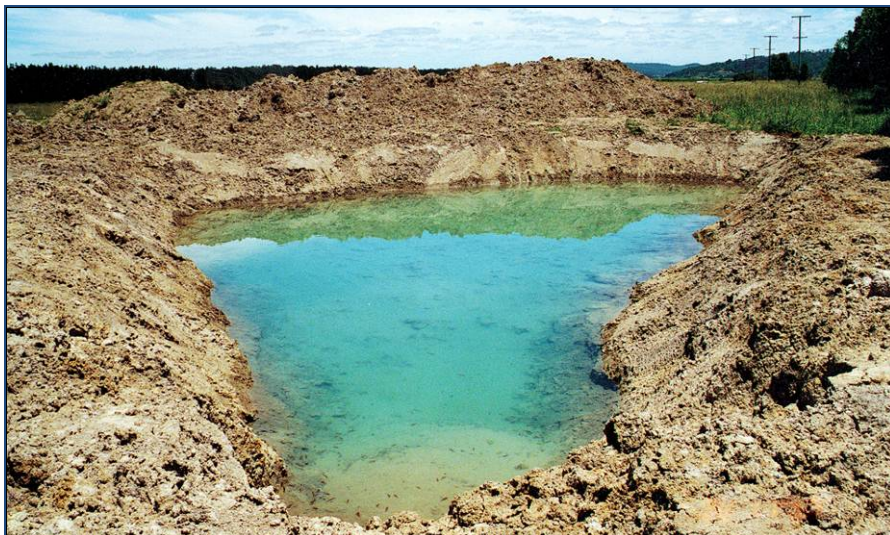
When sulfuric acid reaches a water body, the water can become highly acidic (pH <4). Clear blue-green water indicates the presence of soluble aluminium and iron (Figure 3). When aluminium from the soil moves into the water, it can cause suspended particles to clump together and drop to the bottom of the water body. This results in water with a deceptively healthy-looking appearance.

Figure 3 - Clear blue-green water with acid conditions and high aluminium content in a coastal farm dam.

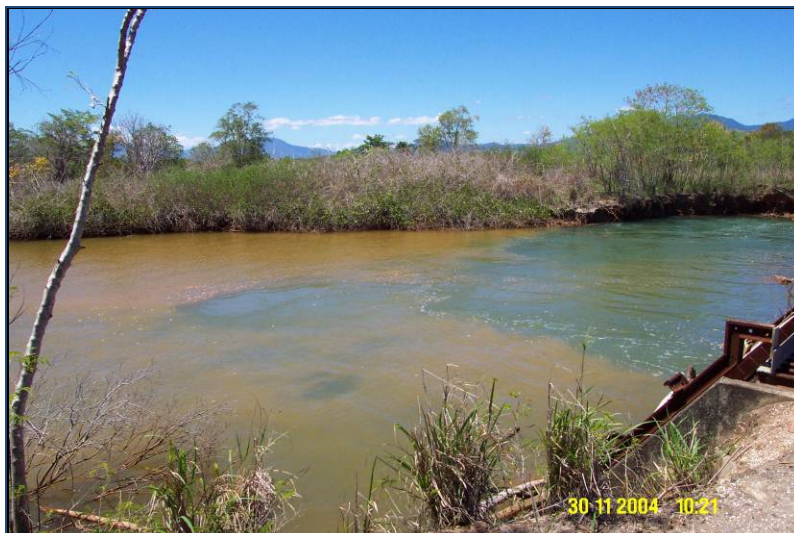
A by-product of the oxidation of acid sulfate soils is the production of rust-coloured iron stains and oily-looking bacterial scums. When acid water mixes with water of a higher pH, the dissolved iron in the water precipitates as a rust-red scum, which can smother and kill vegetation and aquatic organisms (Figure 4). During iron scum formation, oxygen is removed from the water, resulting in low dissolved oxygen levels. This can be a potential cause of fish kills.

Figure 4 – Iron-contaminated water from ASS-affected land meeting incoming tidal waters in an impounded treatment area, East Trinity, far north Queensland.
