ADVICE

Issued by Brisbane Maritime Region on 19 April 2022

Area: Brisbane pilotage area
Locality: Brisbane River
Activity: Post-2022 Flood - Submerged Objects

QUEENSLAND NOTICE TO MARINERS
Issued by Maritime Safety Queensland
SUBMERGED FLOOD DEBRIS ADVICE
ENTRANCE CHANNEL TO LYTTON
2022 BRISBANE RIVER FLOOD

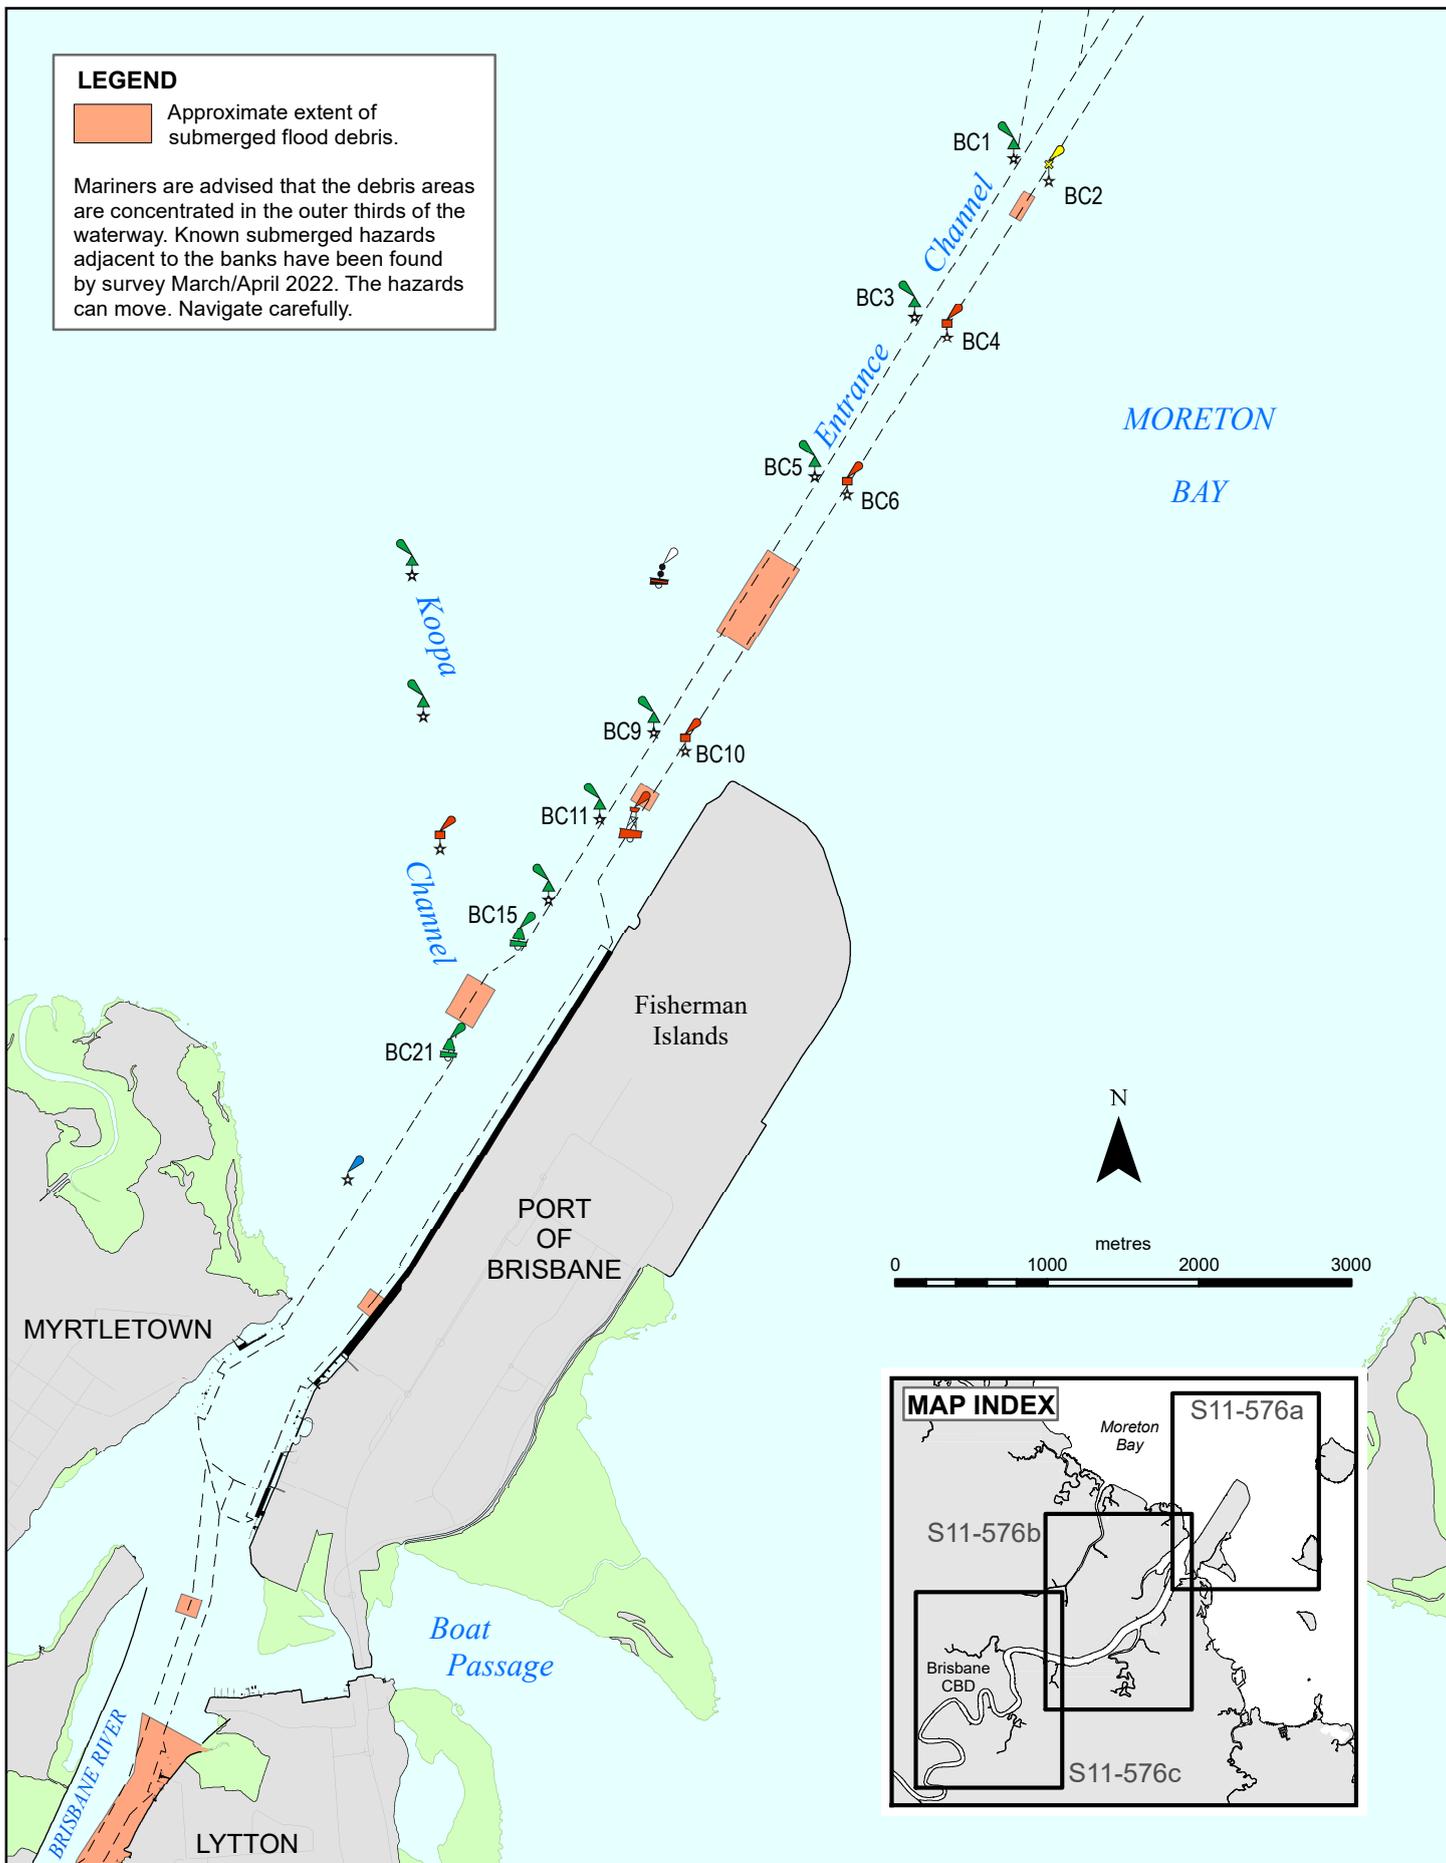
Map S11- 576a

Approximate extent of submerged flood debris.

Mariners are advised that the debris areas are concentrated in the outer thirds of the waterway. Known submerged hazards adjacent to the banks have been found by survey March/April 2022. The hazards can move. Navigate carefully.

These objects may pose a hazard to navigation when anchoring, trawling and during other sub-surface activities in these areas. Unusual currents may also exist in the area. Mariners should navigate with due caution when operating in close proximity to these locations.

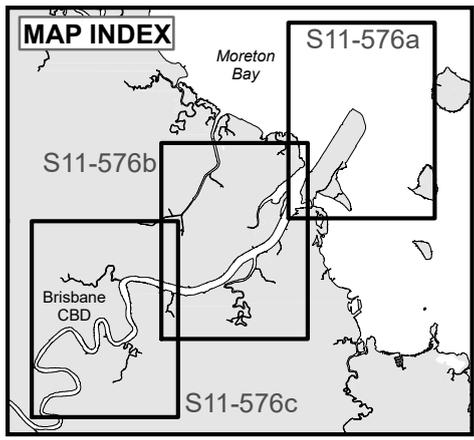
Map S11- 576b

Approximate extent of submerged flood debris.

Mariners are advised that the debris areas are concentrated in the outer thirds of the waterway. Known submerged hazards adjacent to the banks have been found by survey March/April 2022. The hazards can move. Navigate carefully.

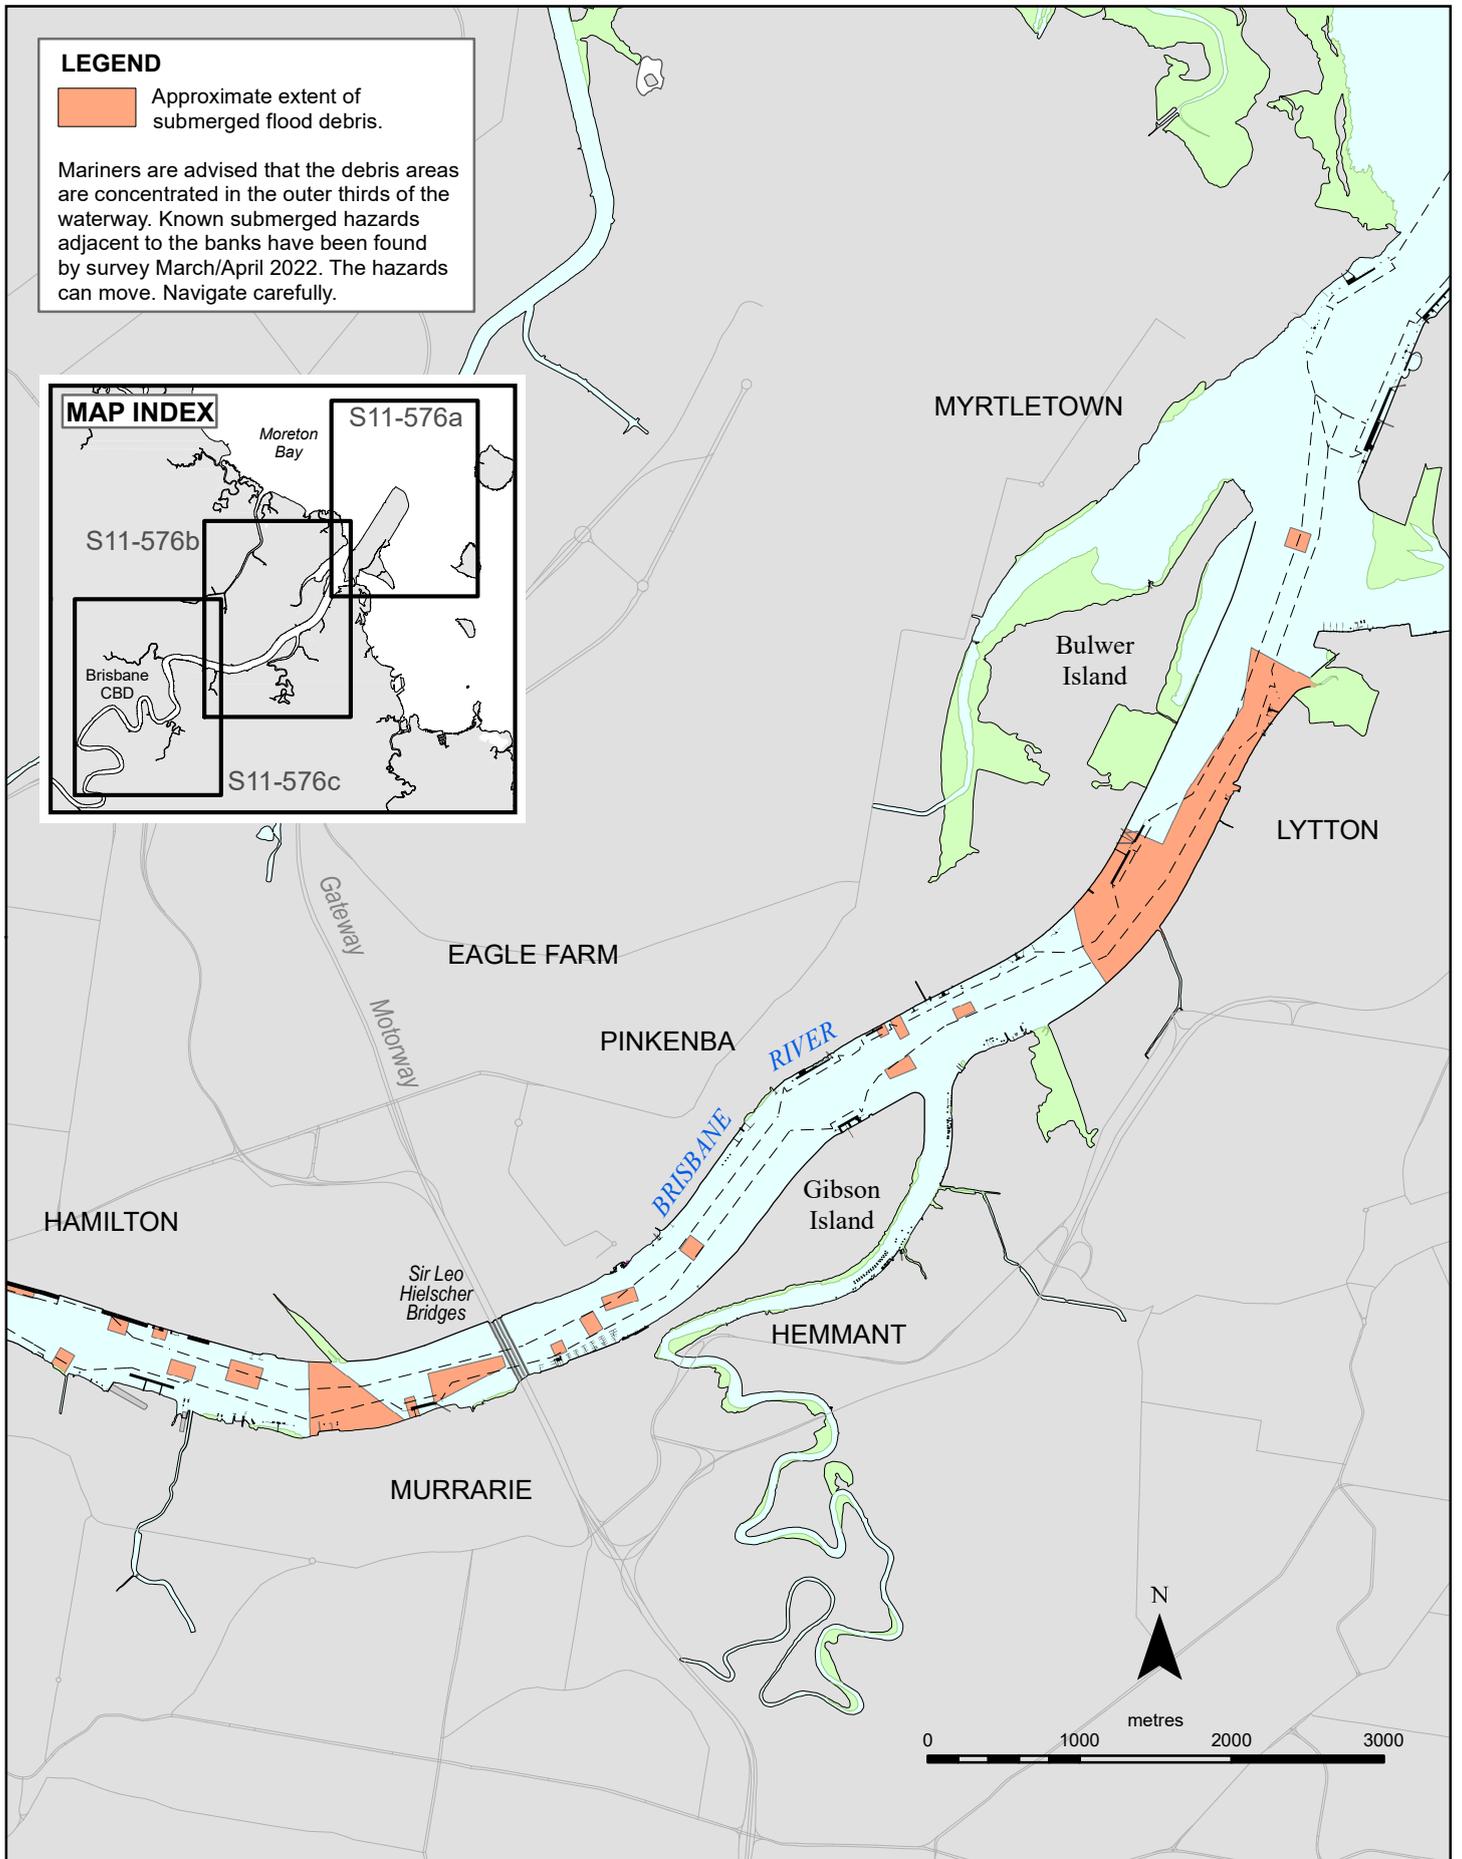
QUEENSLAND NOTICE TO MARINERS
Issued by Maritime Safety Queensland
SUBMERGED FLOOD DEBRIS ADVICE
LYTTON TO HAMILTON
2022 BRISBANE RIVER FLOOD

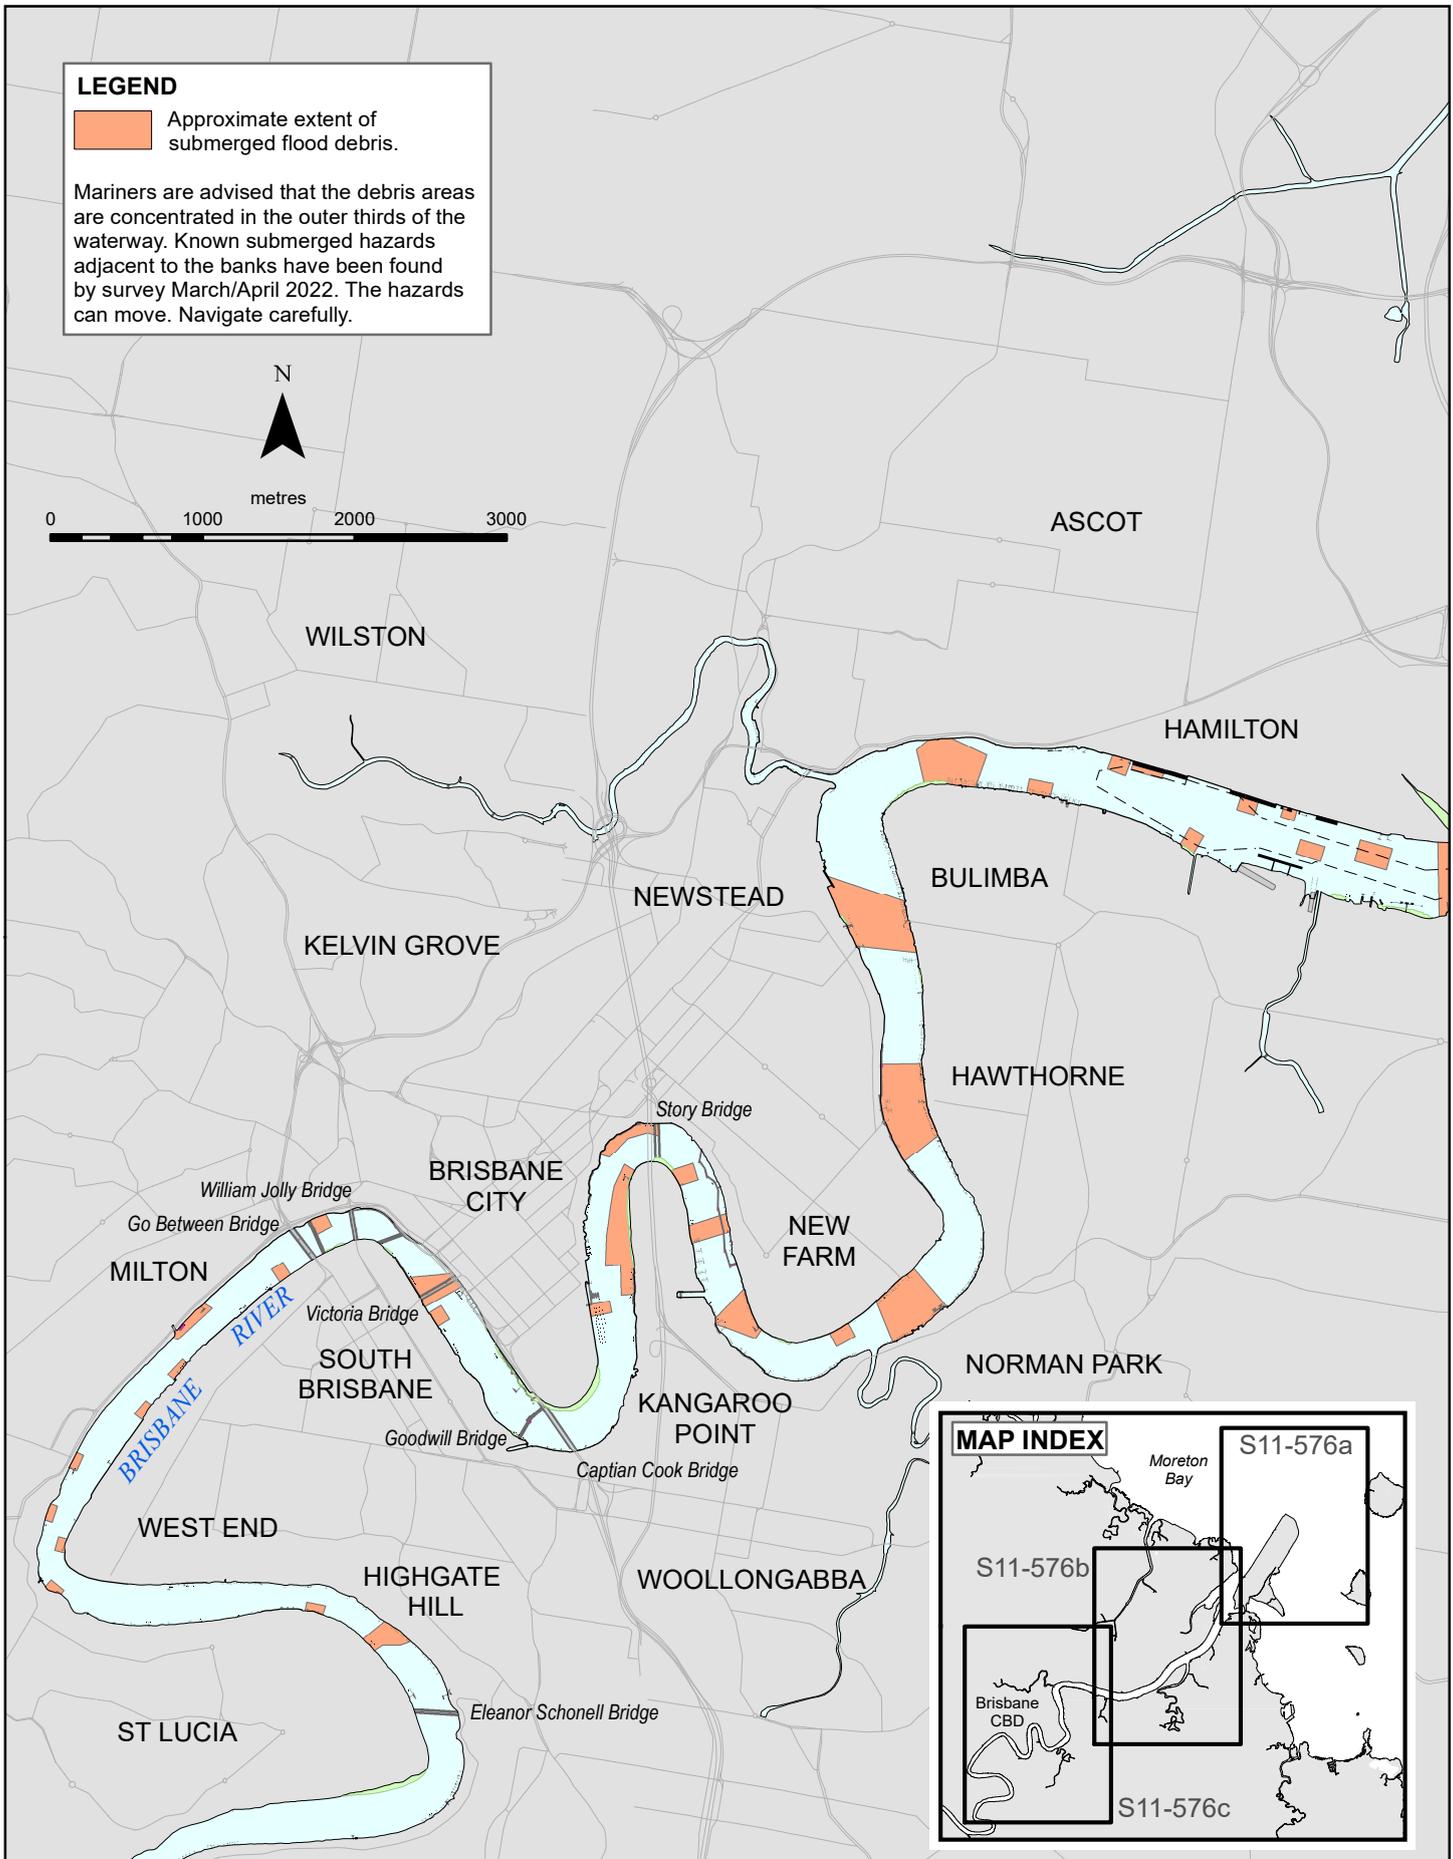
Map S11- 576c

Approximate extent of submerged flood debris.

Mariners are advised that the debris areas are concentrated in the outer thirds of the waterway. Known submerged hazards adjacent to the banks have been found by survey March/April 2022. The hazards can move. Navigate carefully.

QUEENSLAND NOTICE TO MARINERS
Issued by Maritime Safety Queensland
SUBMERGED FLOOD DEBRIS ADVICE
HAMILTON TO ST LUCIA
2022 BRISBANE RIVER FLOOD
