Environmental Health Assessment Report

Tara Complaint Investigation Report

Queensland Gas Company

January 2013

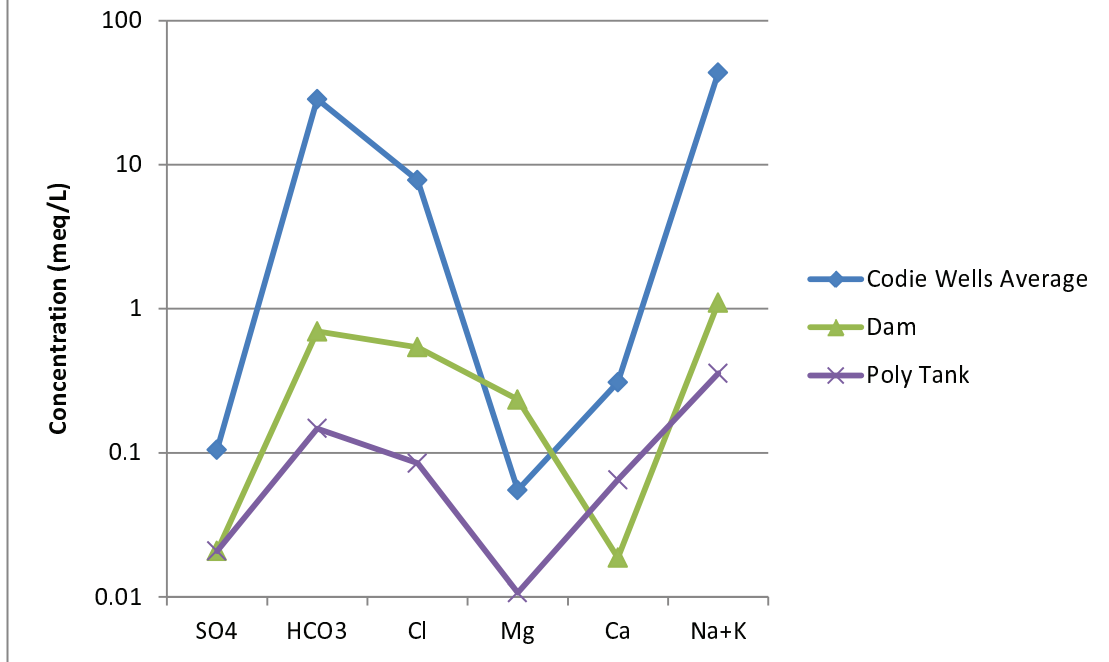
E 1. Major Ion Plot - Lot 1

Ion profiles for the Lots are provided in Schoeller Diagrams (*Annex E*), which does not indicate similarity between the CSG water and the dam and poly tank water indicating that the reported concentrations are not linked to CSG water, rather localised environmental conditions.
